ELEPHANT BUTTE RESERVOIR

1999 RESERVOIR SURVEY

U.S. Department of the Interior
Bureau of Reclamation

**Sedimentation and River Hydraulics Group
Water Resources Services
Technical Service Center
Denver, Colorado**

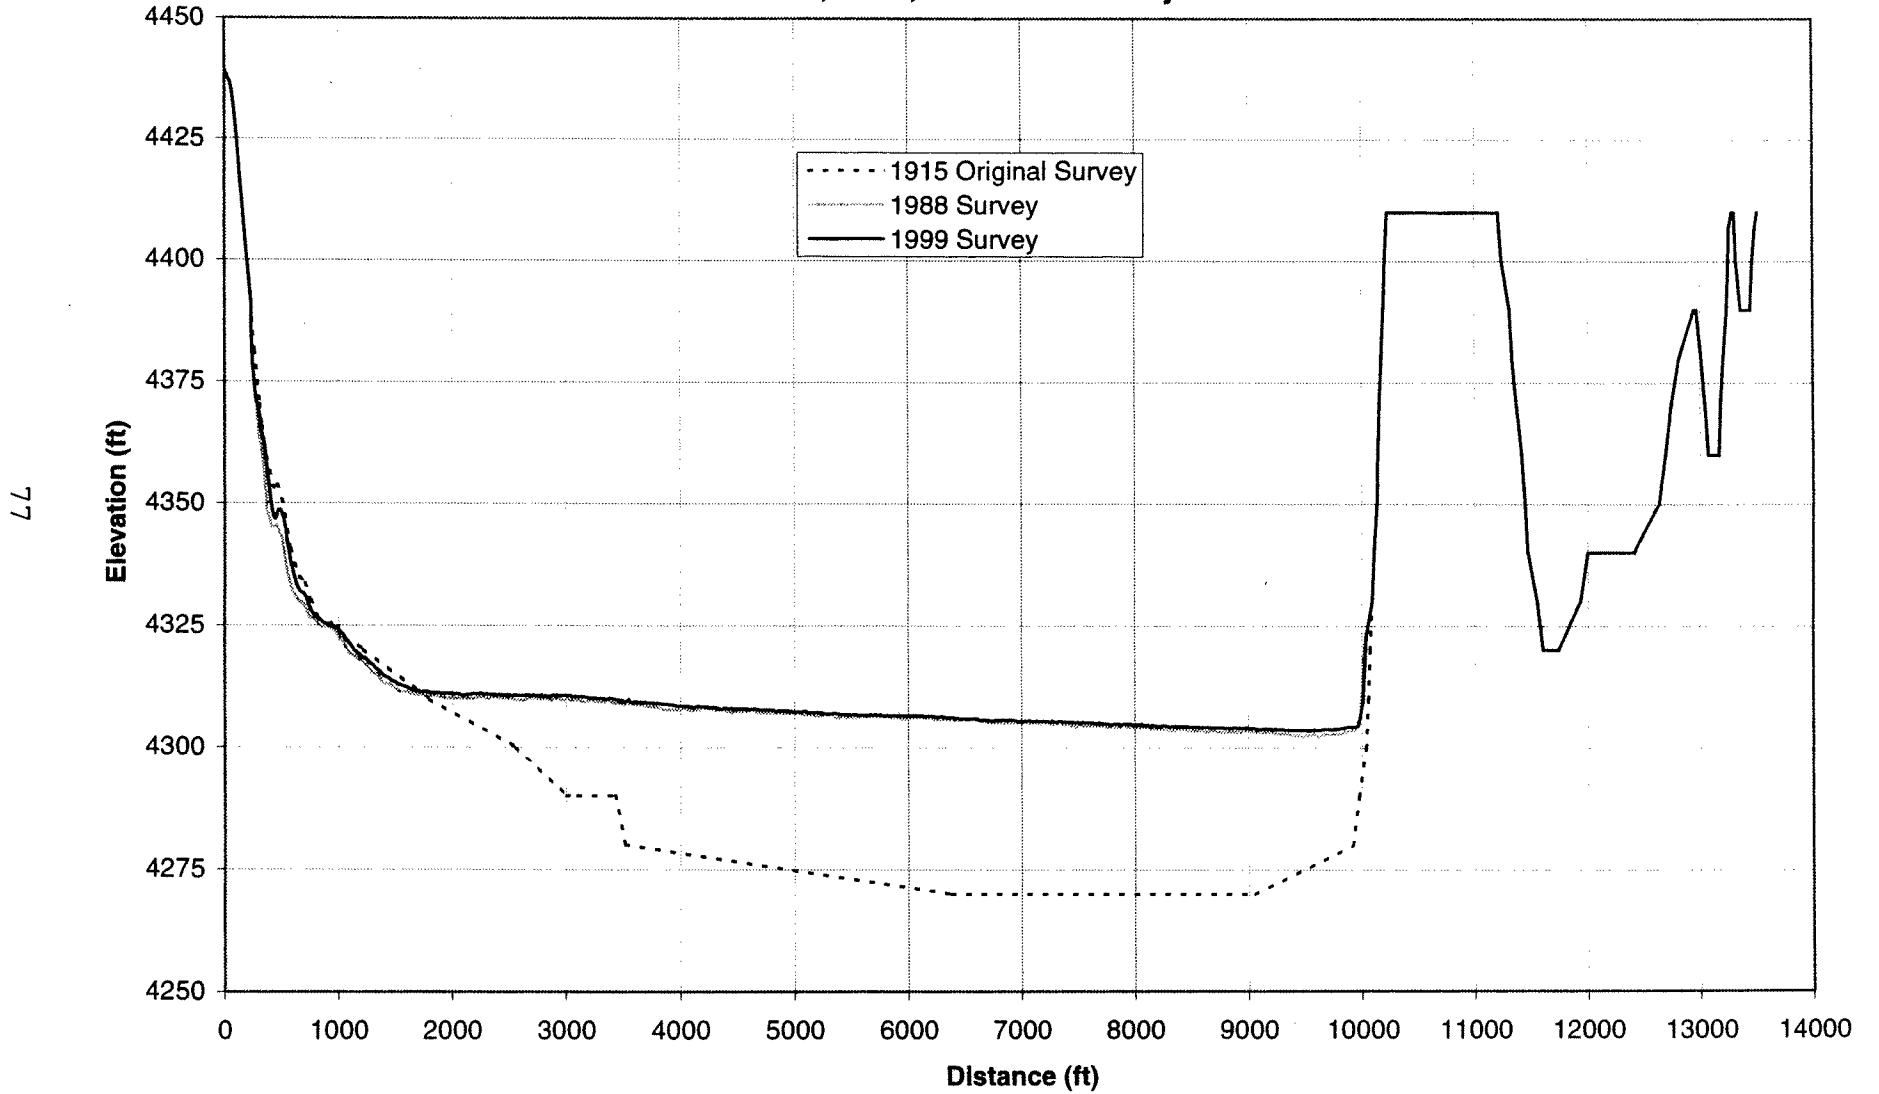
**Elephant Butte Sediment Range Profile: Rangeline 67
1915, 1988, and 1999 Surveys**

Figure 43. - Sedimentation range profiles for 1915, 1988, and 1999, range 67.

Ground profiles of the 82 reservoir sedimentation ranges are shown on figures 20 through 101. These profiles illustrate the general lateral distribution of sediments in the reservoir. Plots are from left to right looking upstream to be consistent with previous survey reports. The plots illustrate the survey results from the original, 1988, and 1999 surveys. The original and other profiles do not fully agree in the lateral direction for all ranges mainly due to the fact the original profiles were

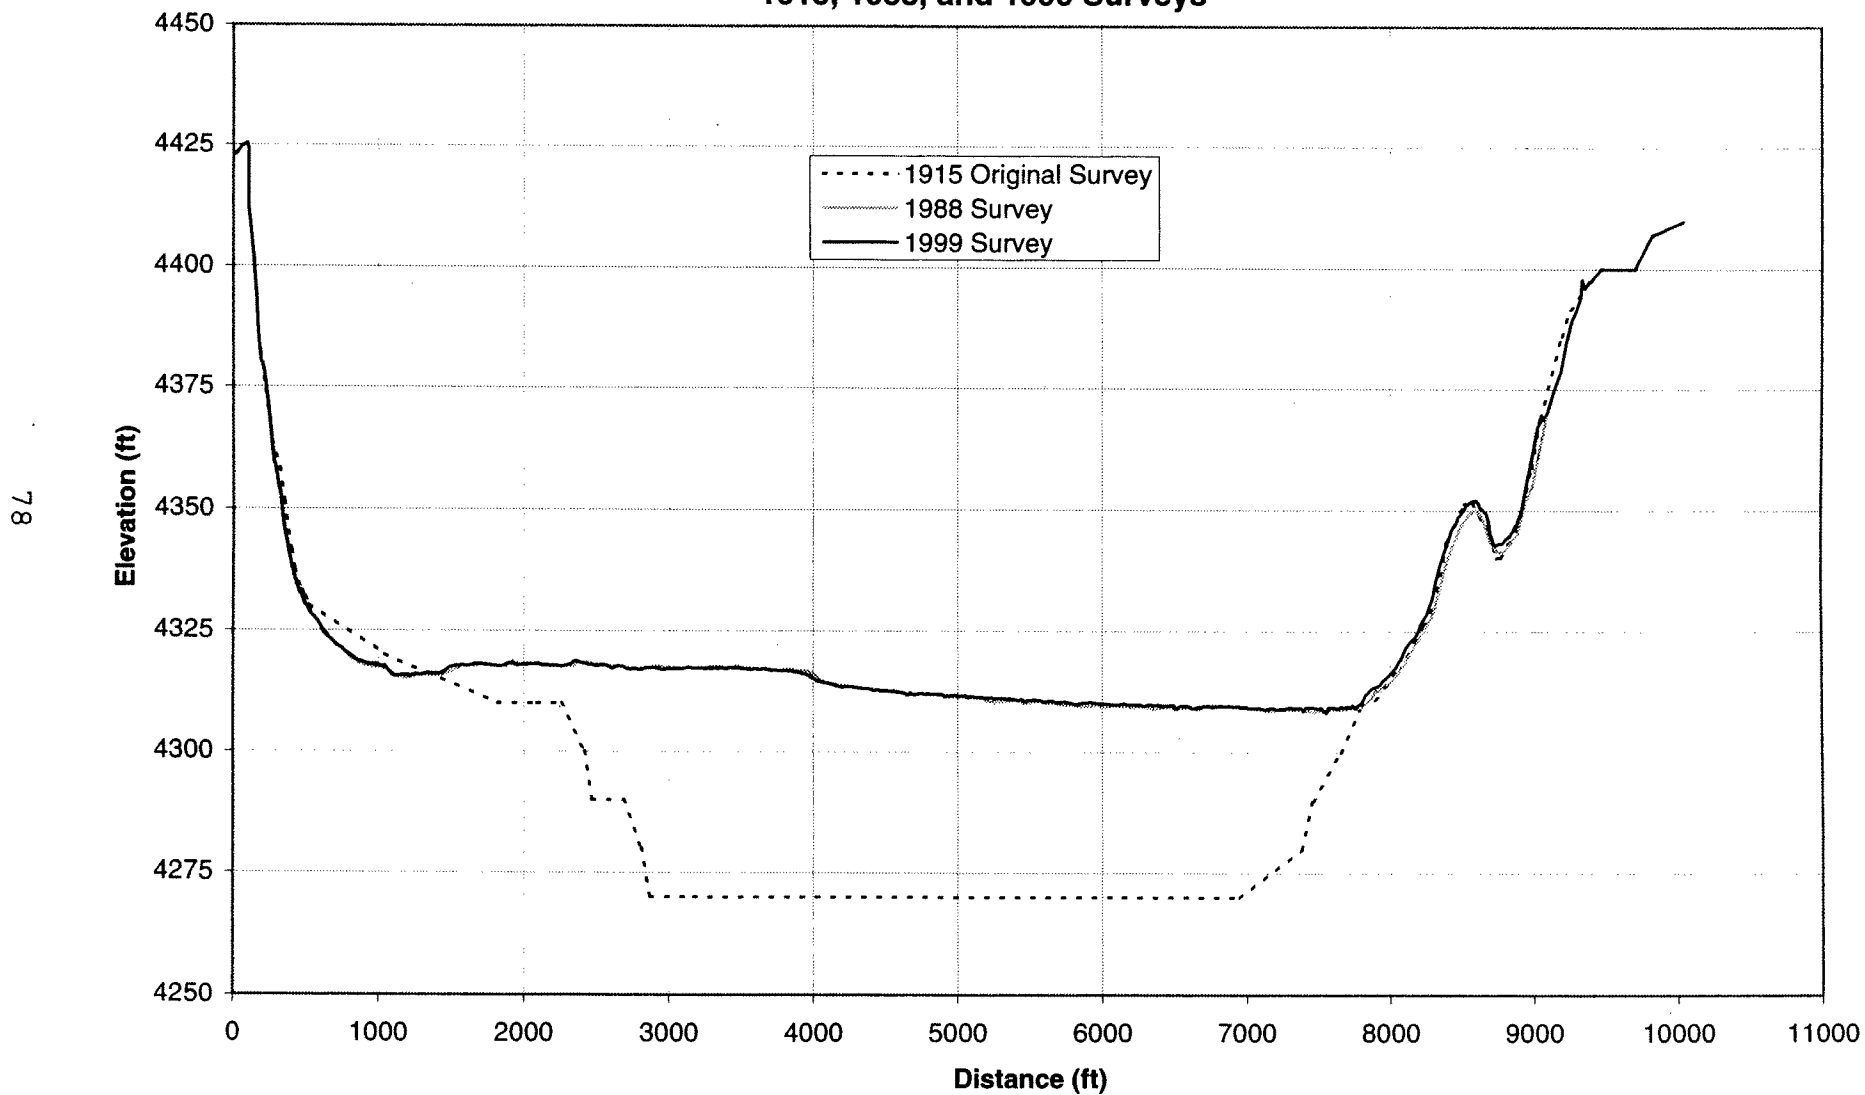
Elephant Butte Sediment Range Profile: Rangeline 66 1915, 1988, and 1999 Surveys

Figure 44. - Sedimentation range profiles for 1915, 1988, and 1999, range 66.

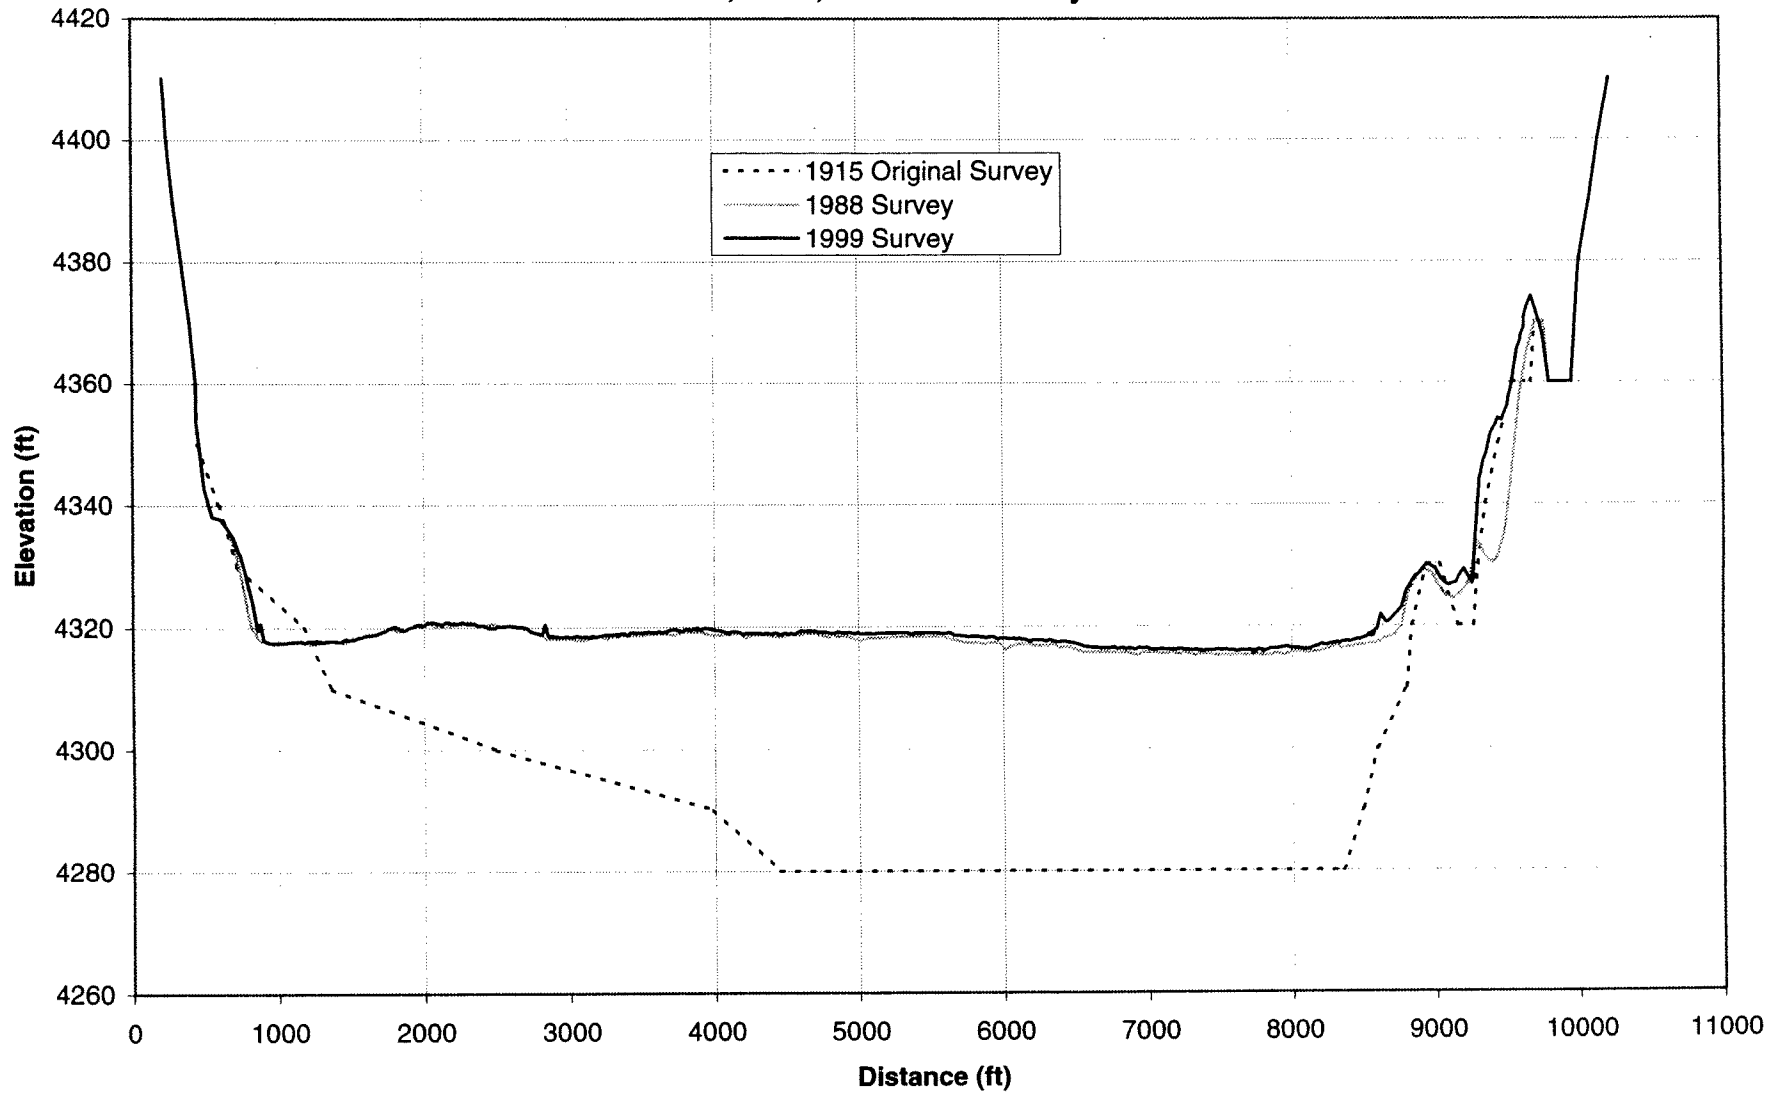
**Elephant Butte Sediment Range Profile: Rangeline 65
1915, 1988, and 1999 Surveys**

Figure 45. - Sedimentation range profiles for 1915, 1988, and 1999, range 65.

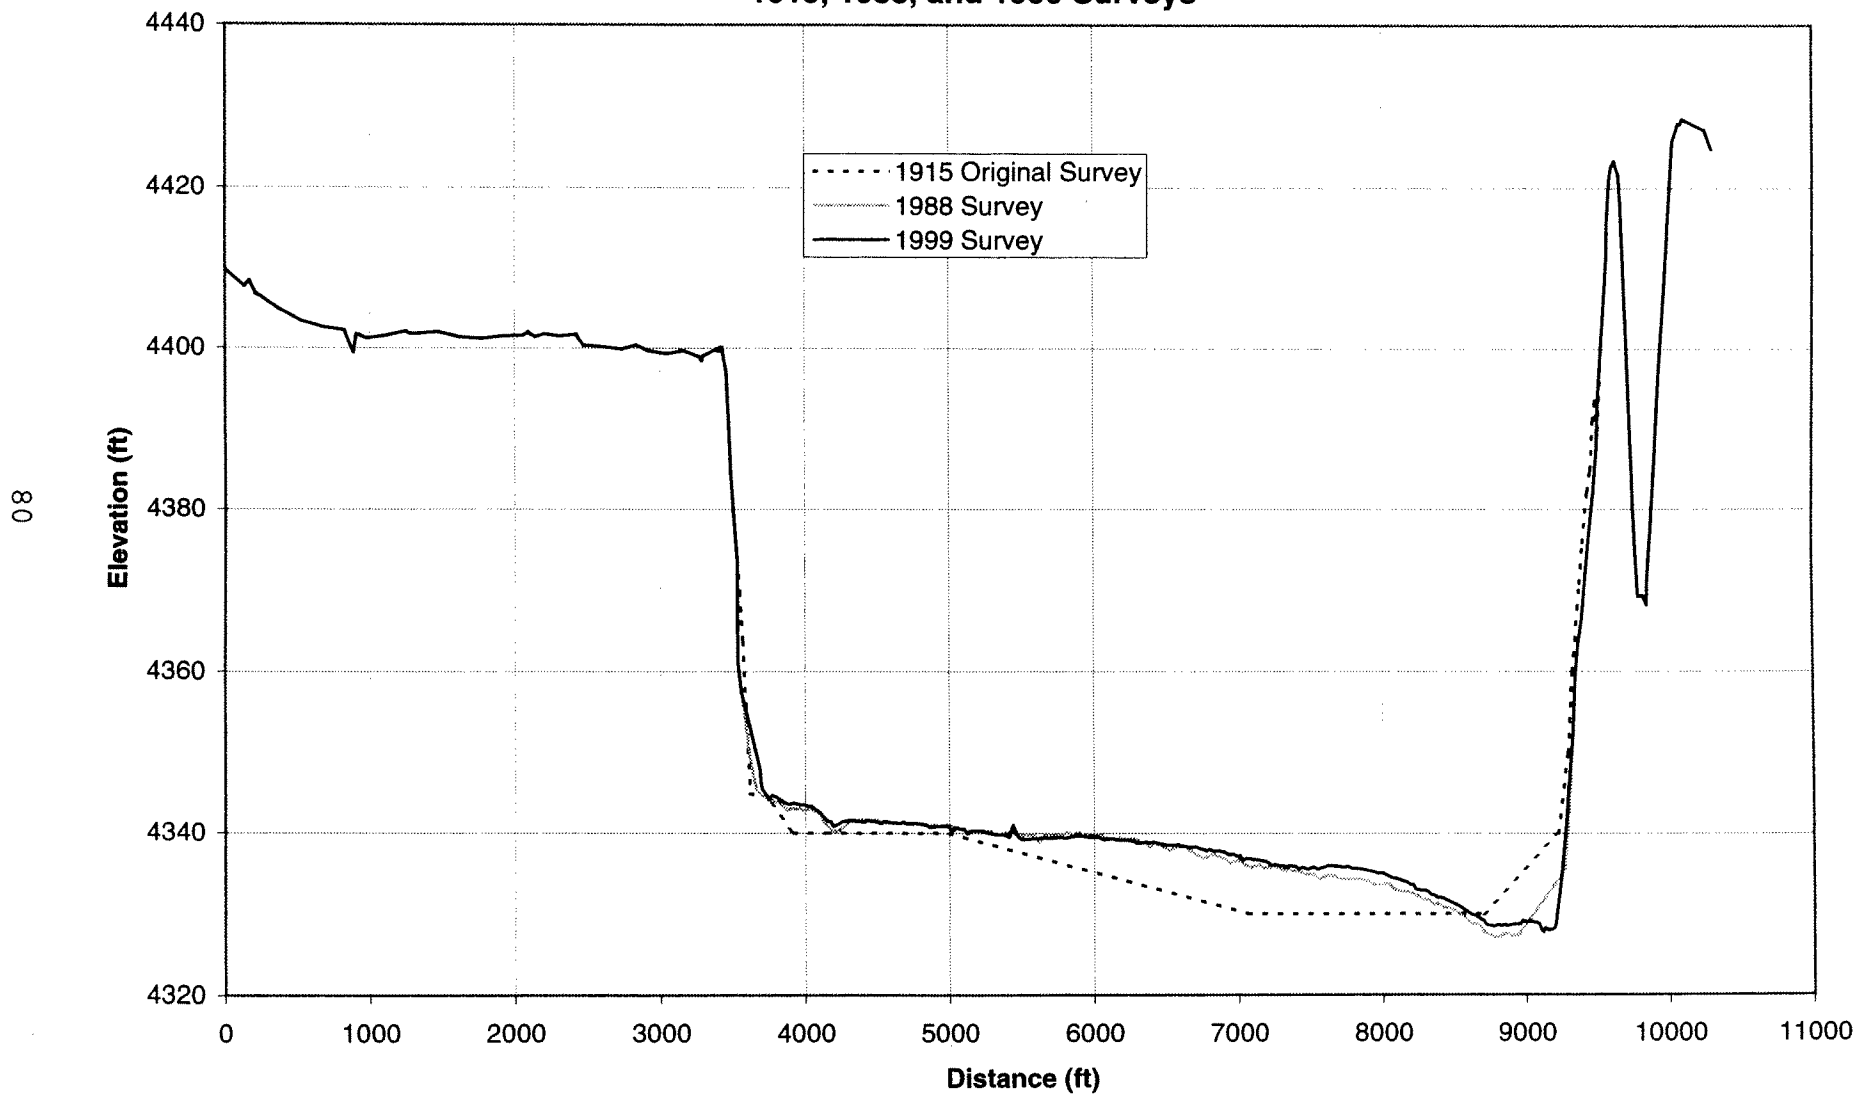
Elephant Butte Sediment Range Profile: Rangeline 64 1915, 1988, and 1999 Surveys

Figure 46. - Sedimentation range profiles for 1915, 1988, and 1999, range 64.

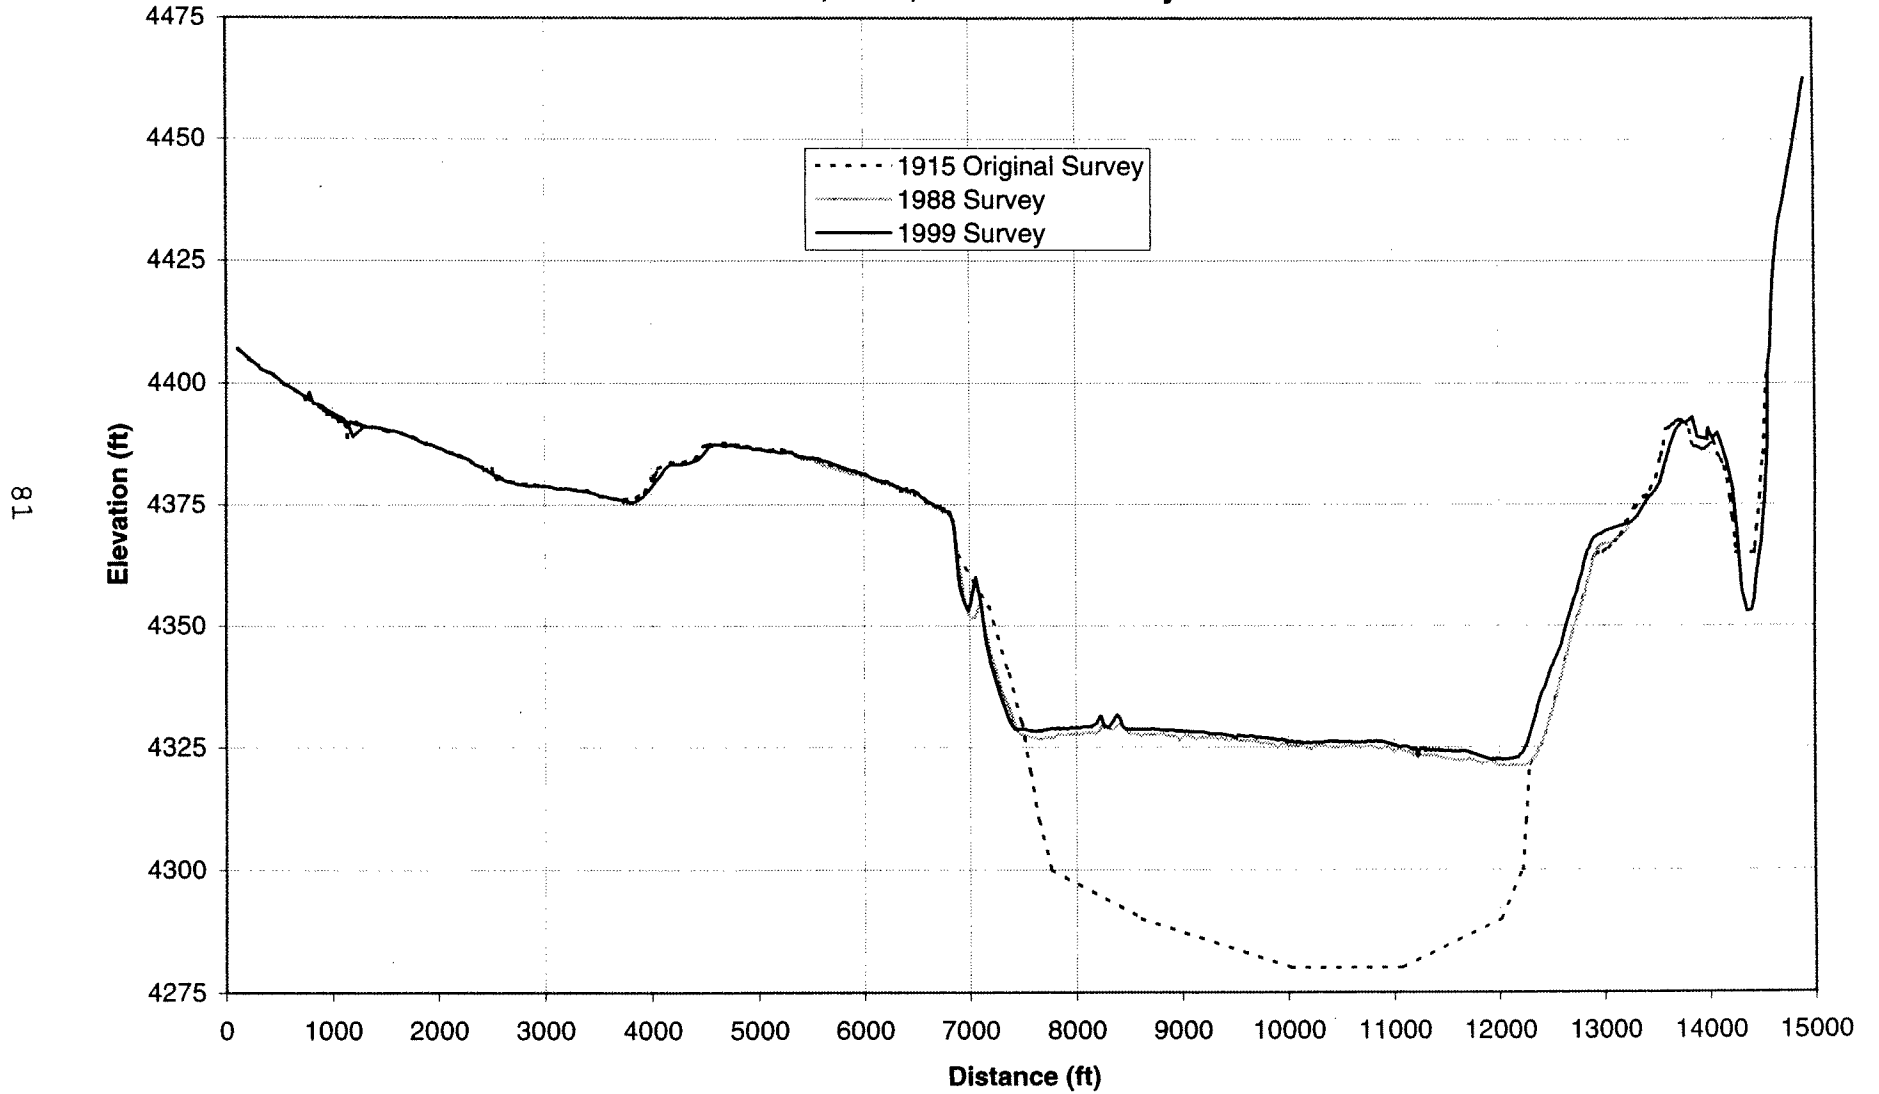
**Elephant Butte Sediment Range Profile: Rangeline 63
1915, 1988, and 1999 Surveys**

Figure 47. - Sedimentation range profiles for 1915, 1988, and 1999, range 63.

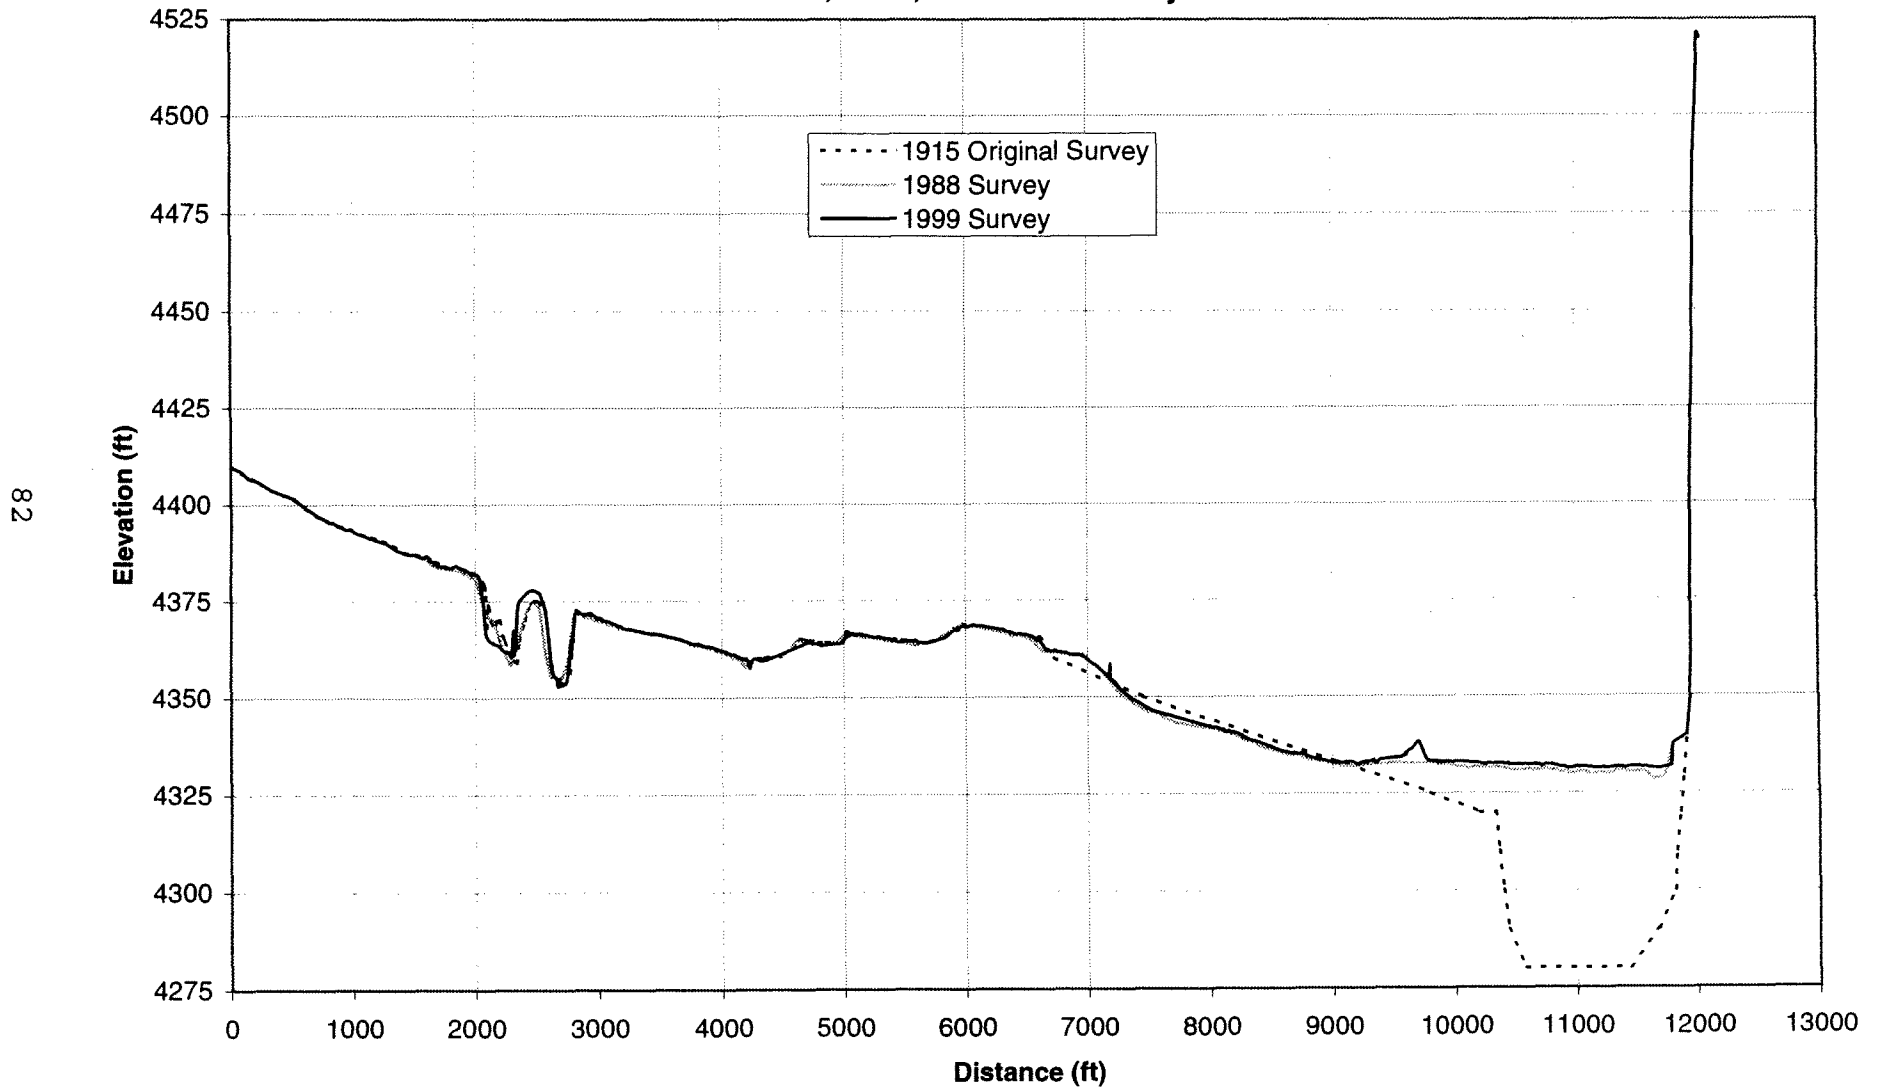
Elephant Butte Sediment Range Profile: Rangeline 62 1915, 1988, and 1999 Surveys

Figure 48. - Sedimentation range profiles for 1915, 1988, and 1999, range 62.

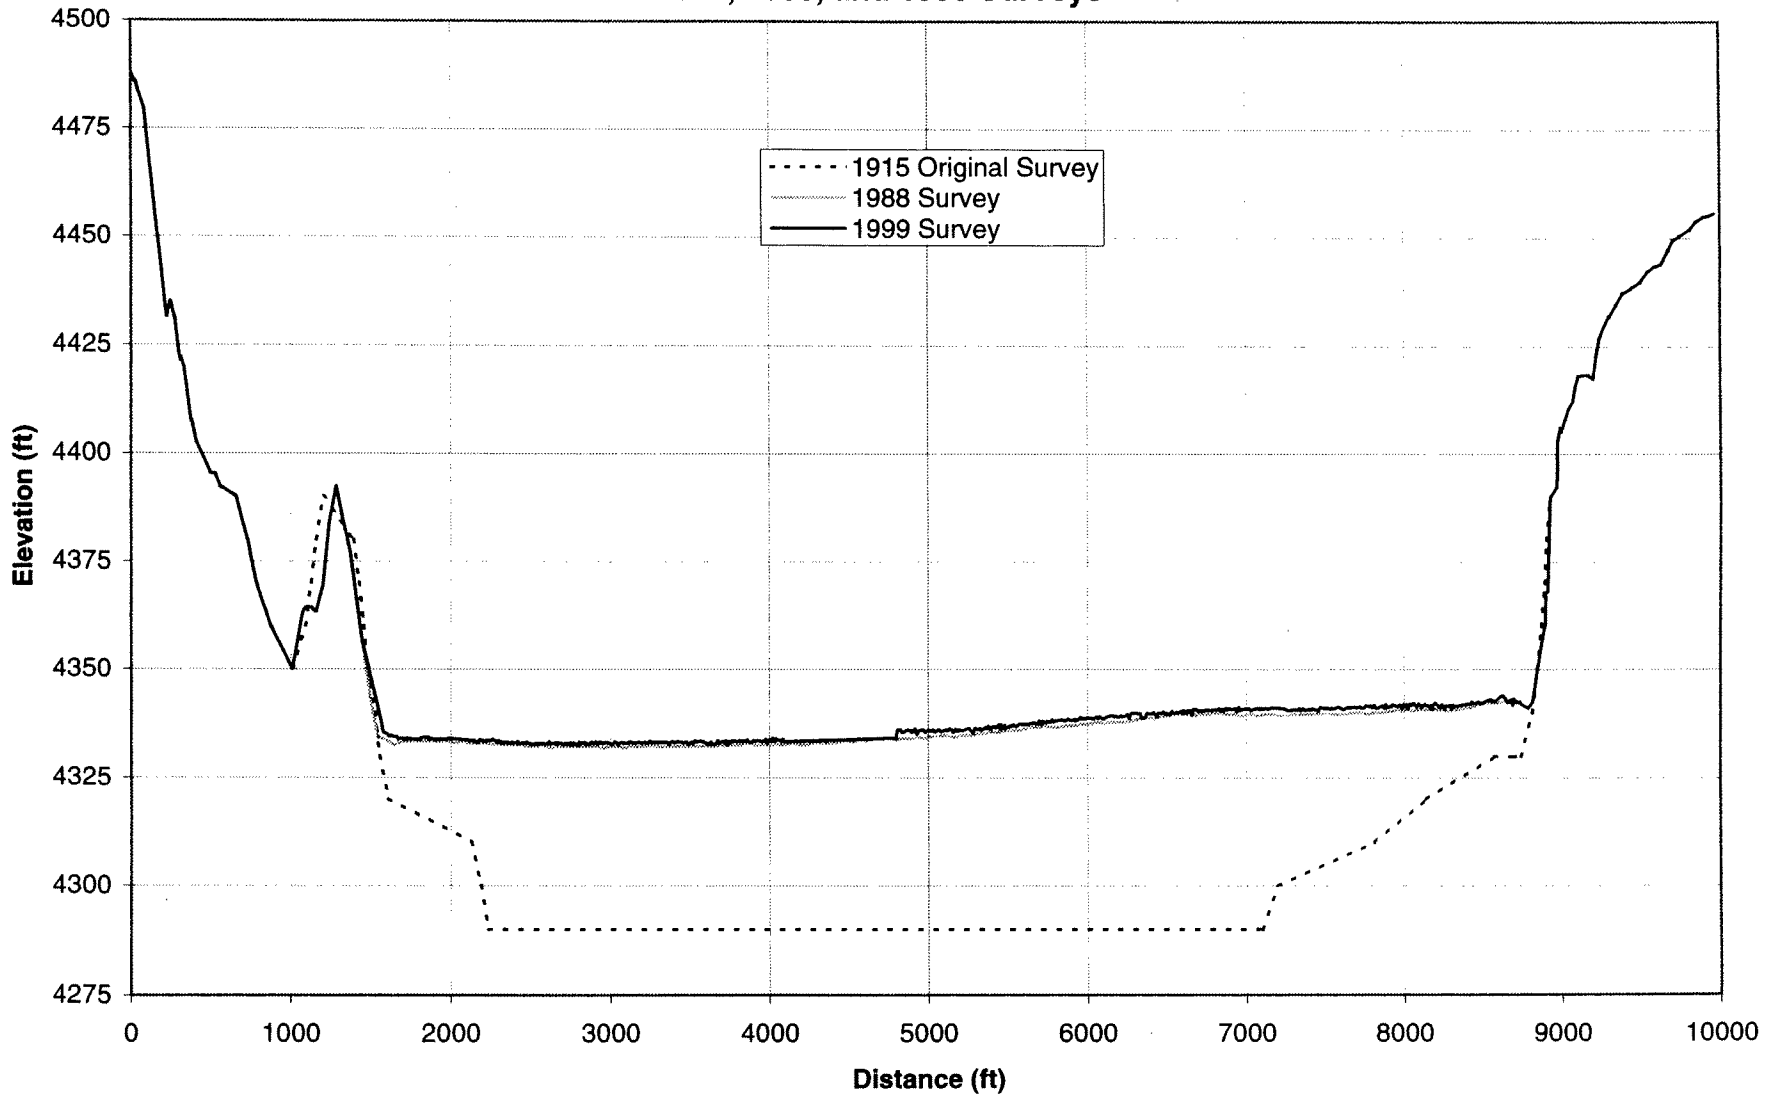
Elephant Butte Sediment Range Profile: Rangeline 61 1915, 1988, and 1999 Surveys

Figure 49. - Sedimentation range profiles for 1915, 1988, and 1999, range 61.

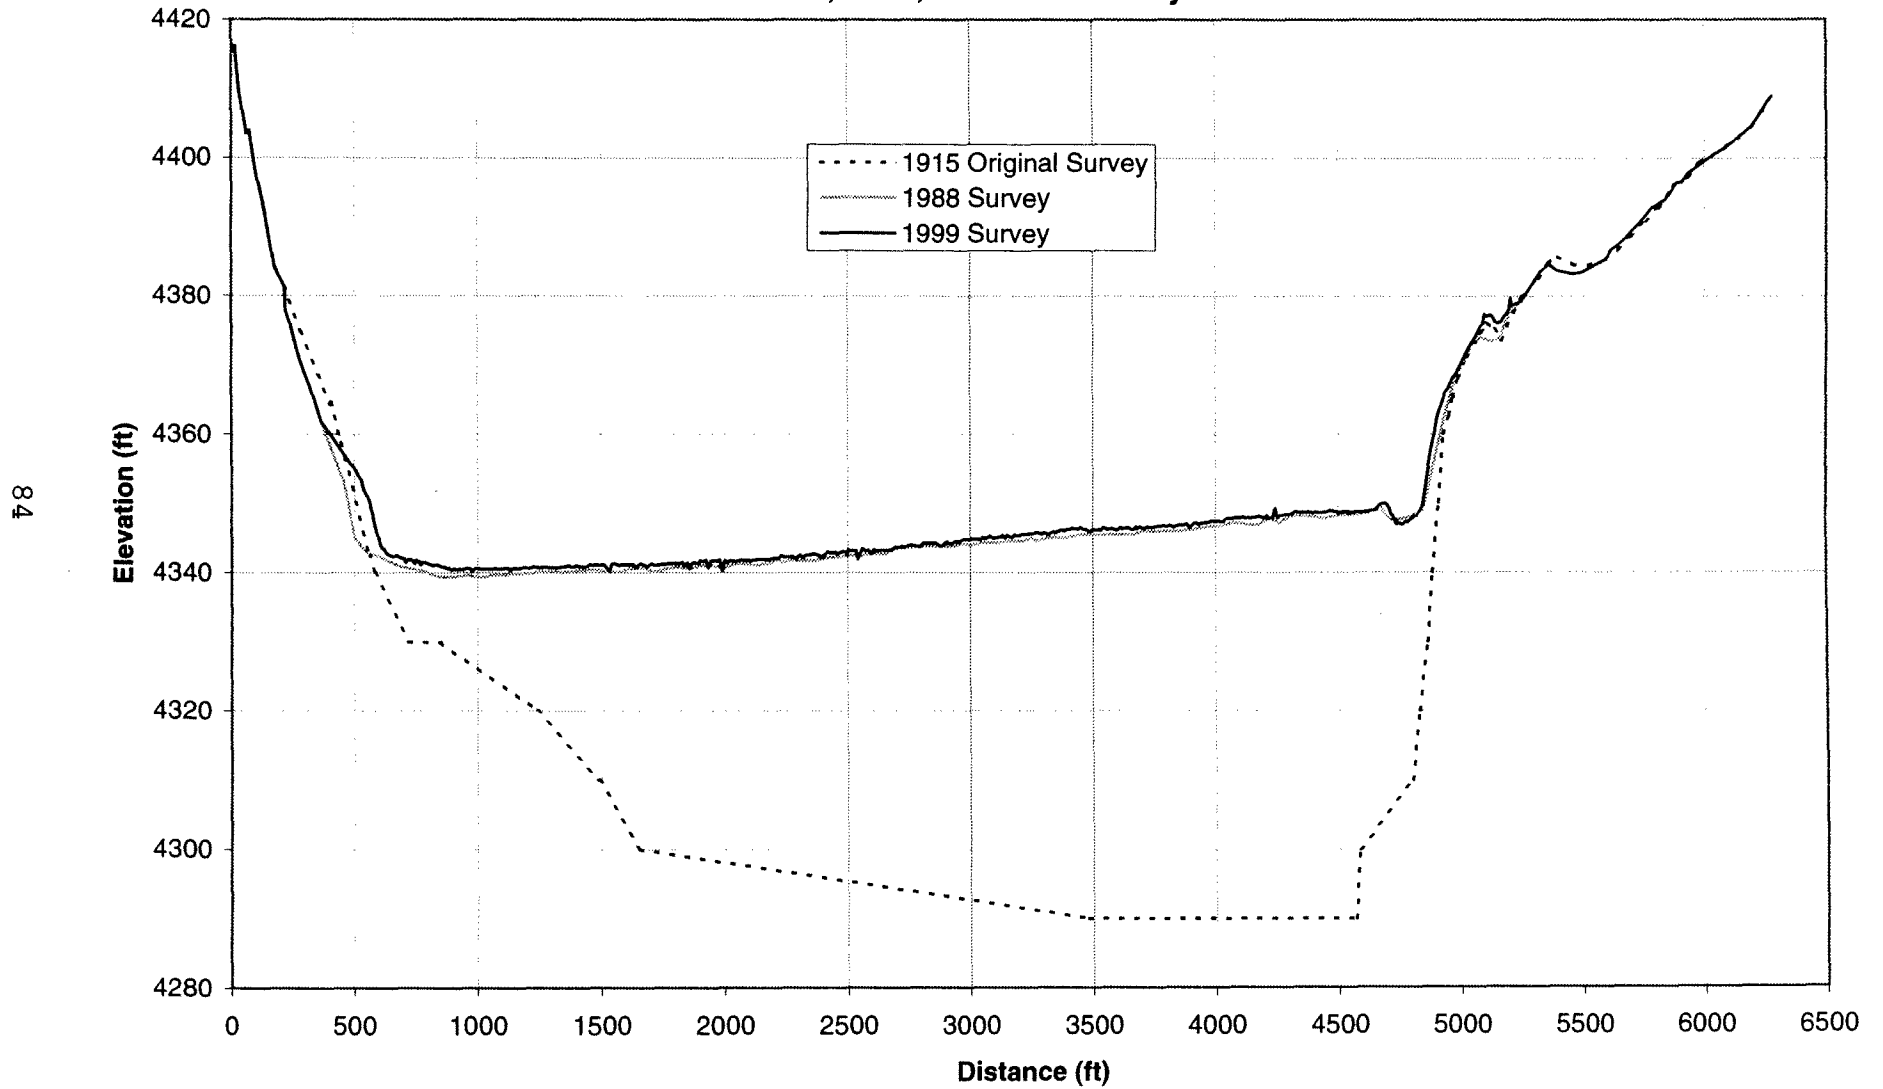
Elephant Butte Sediment Range Profile: Rangeline 60 1915, 1988, and 1999 Surveys

Figure 50. - Sedimentation range profiles for 1915, 1988, and 1999, range 60.

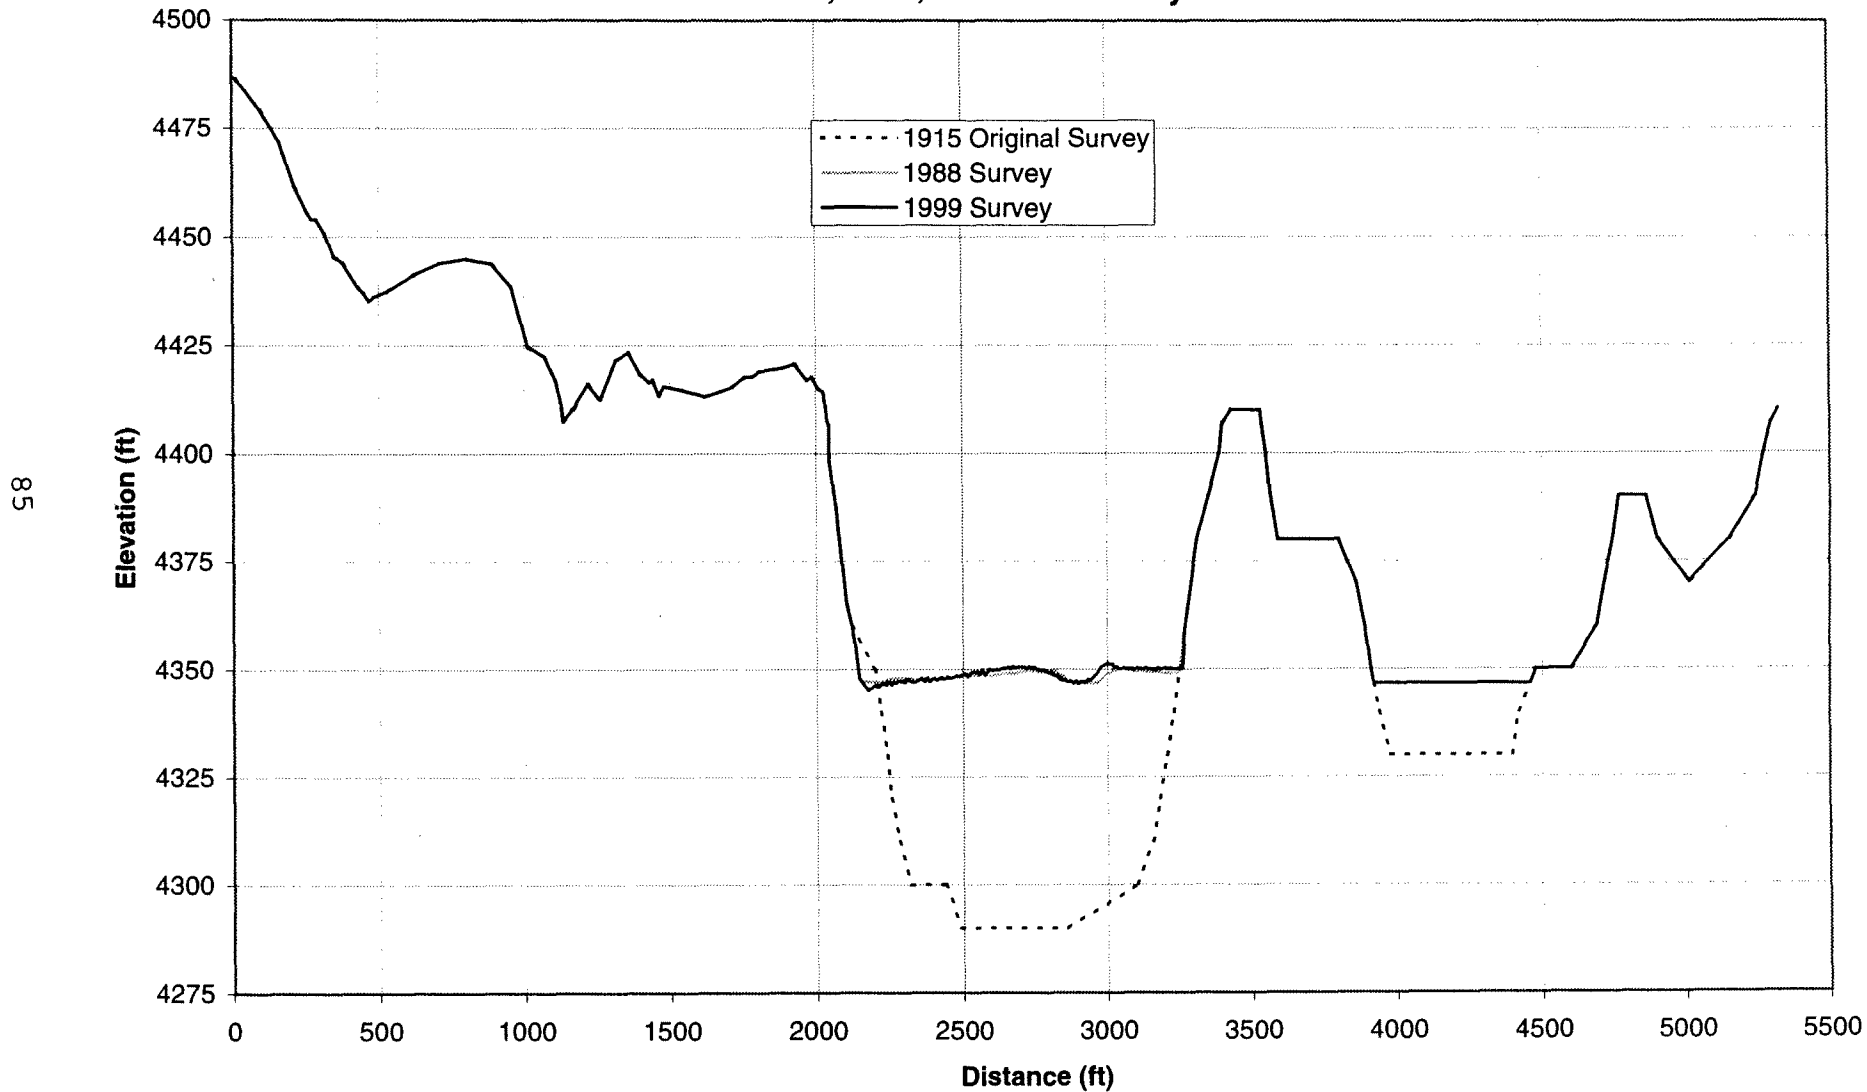
Elephant Butte Sediment Range Profile: Rangeline 59 1915, 1988, and 1999 Surveys

Figure 51. - Sedimentation range profiles for 1915, 1988, and 1999, range 59.

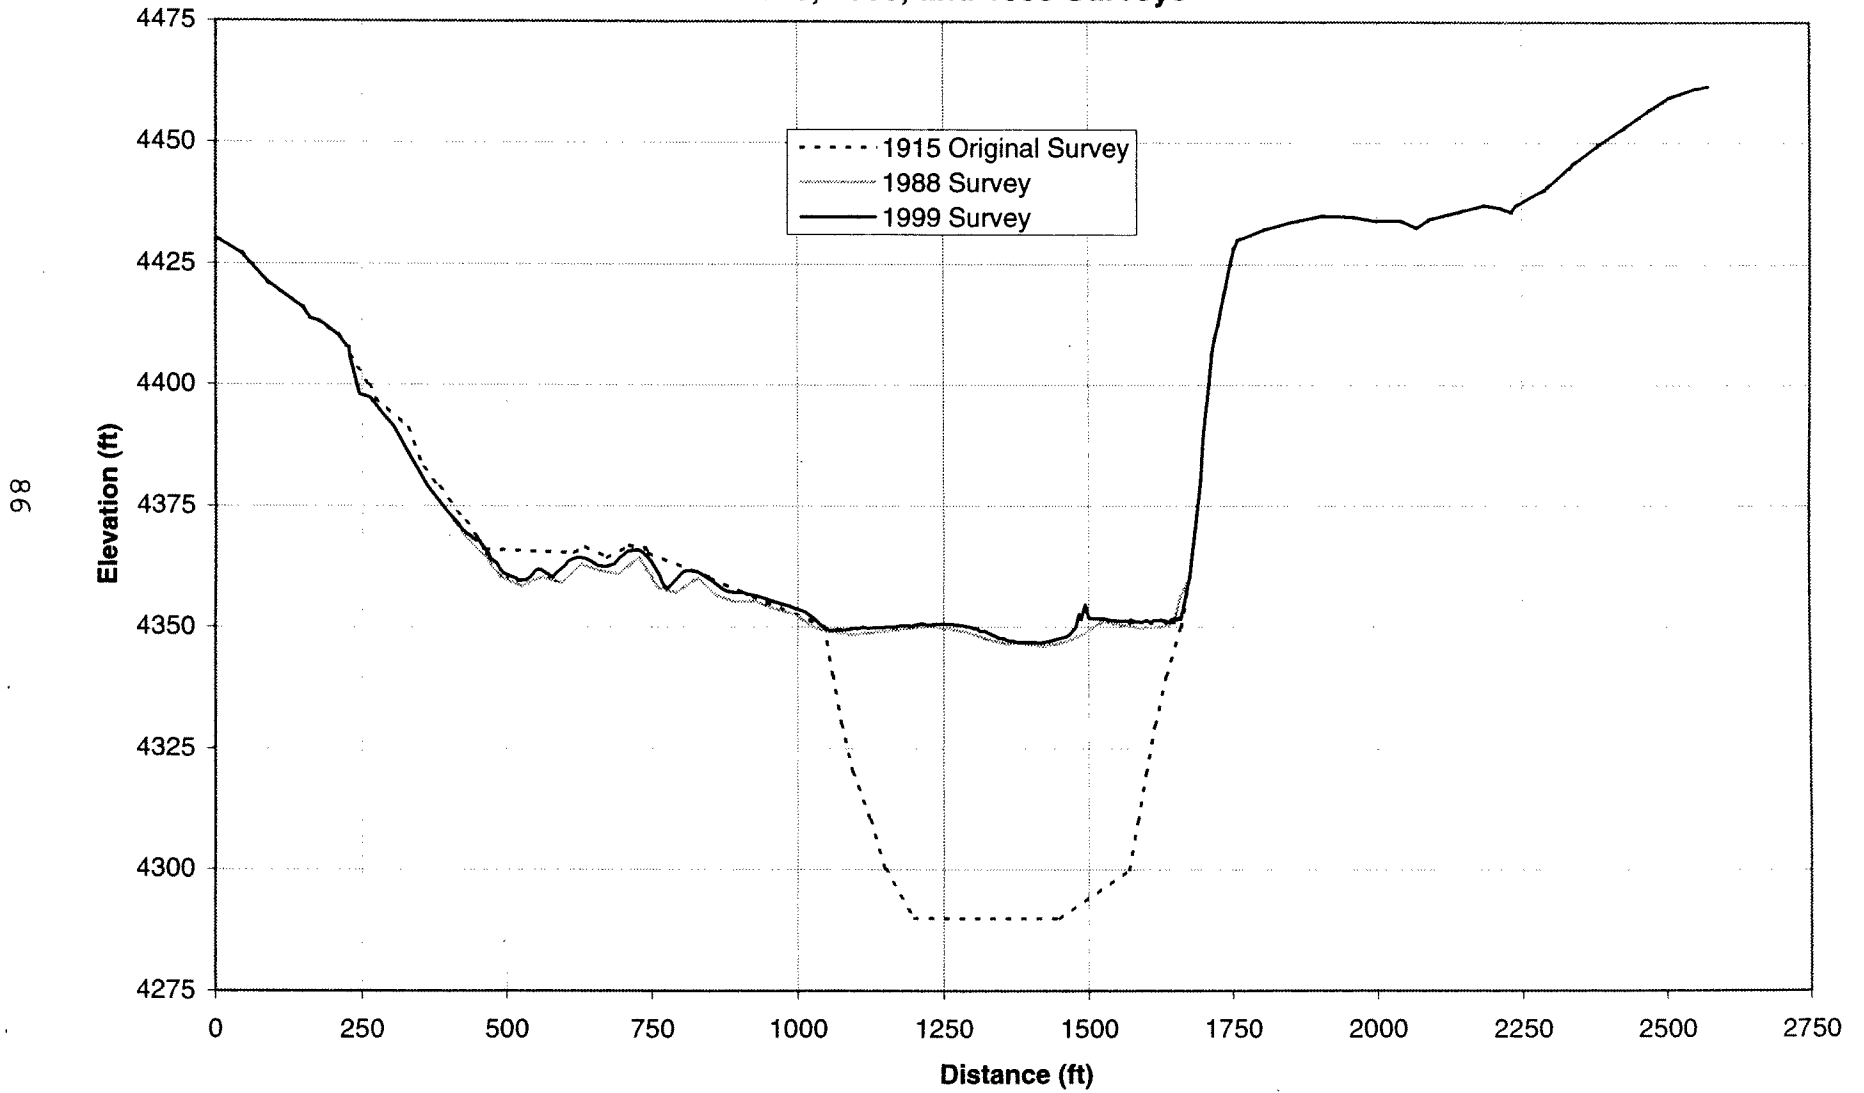
**Elephant Butte Sediment Range Profile: Rangeline 58
1915, 1988, and 1999 Surveys**

Figure 52. - Sedimentation range profiles for 1915, 1988, and 1999, range 58.

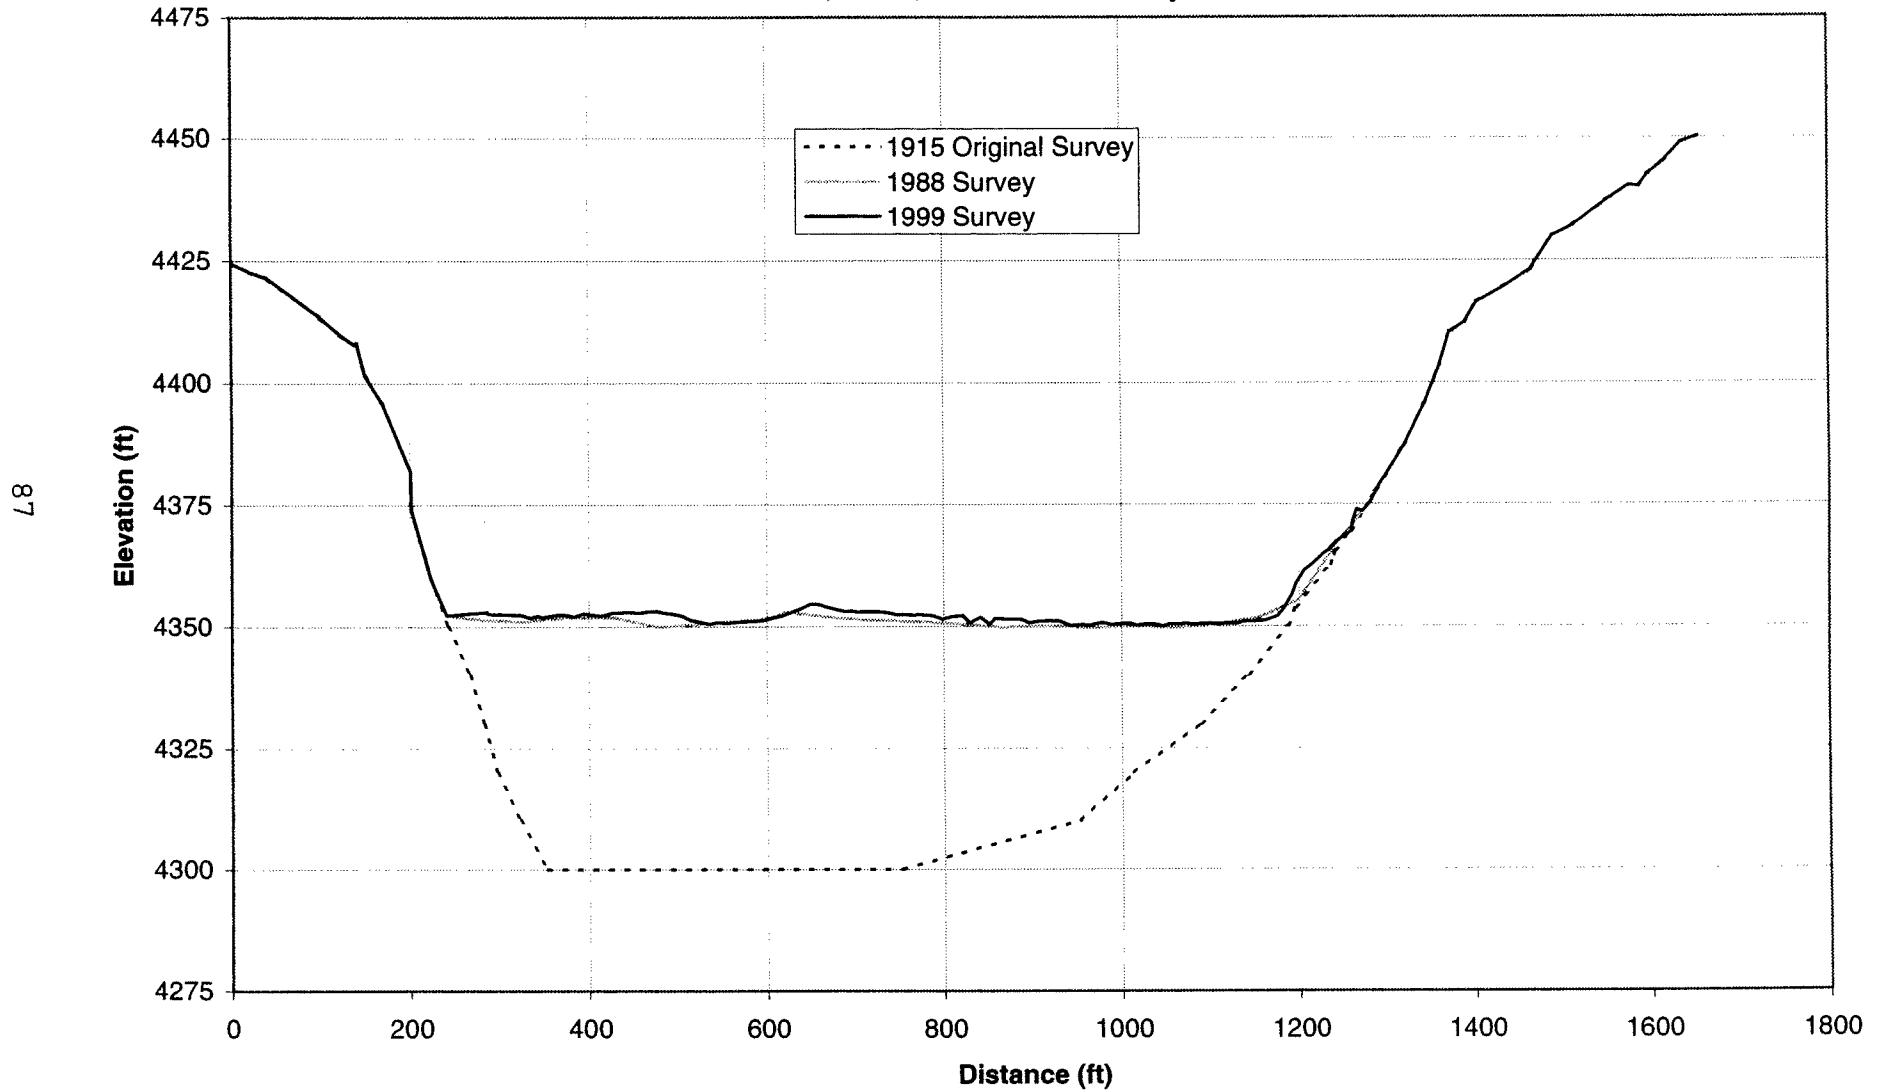
Elephant Butte Sediment Range Profile: Rangeline 57 1915, 1988, and 1999 Surveys

Figure 53. - Sedimentation range profiles for 1915, 1988, and 1999, range 57.
