ELEPHANT BUTTE RESERVOIR

1999 RESERVOIR SURVEY

U.S. Department of the Interior
Bureau of Reclamation

**Sedimentation and River Hydraulics Group
Water Resources Services
Technical Service Center
Denver, Colorado**

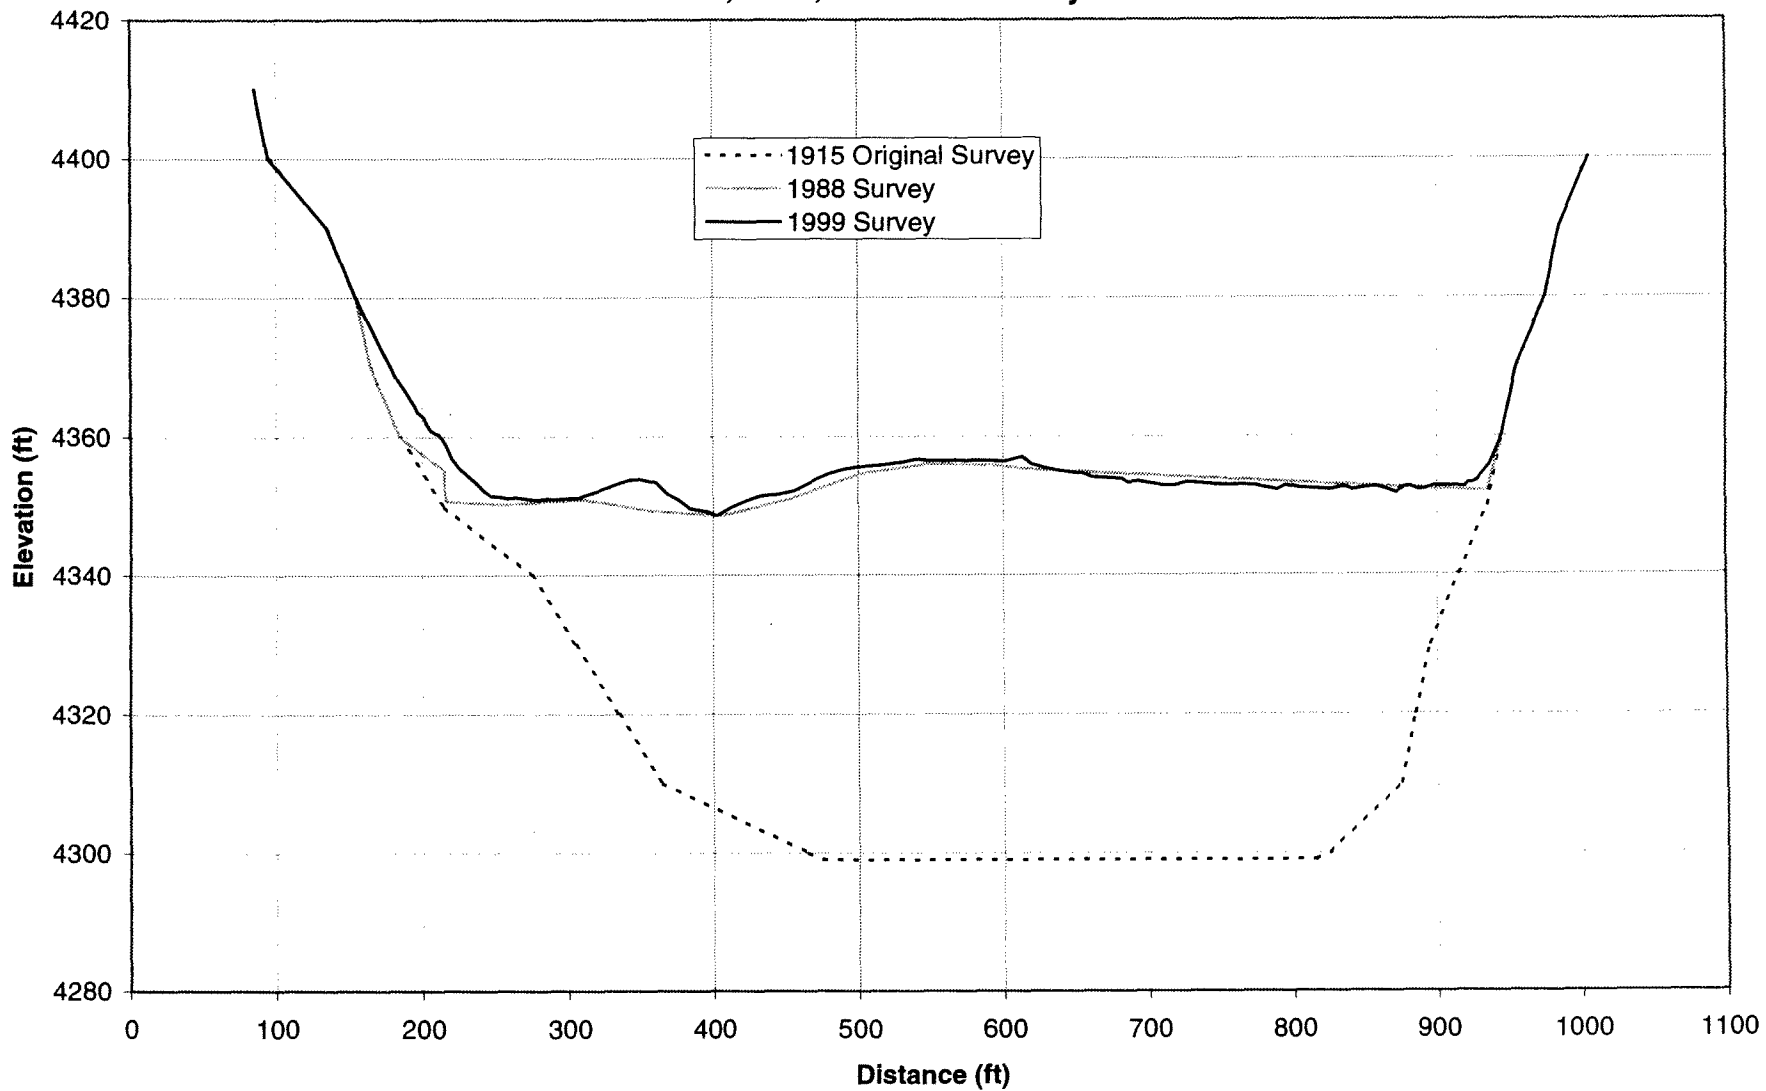
Elephant Butte Sediment Range Profile: Rangeline 56 1915, 1988, and 1999 Surveys

Figure 54. - Sedimentation range profiles for 1915, 1988, and 1999, range 56.

Ground profiles of the 82 reservoir sedimentation ranges are shown on figures 20 through 101. These profiles illustrate the general lateral distribution of sediments in the reservoir. Plots are from left to right looking upstream to be consistent with previous survey reports. The plots illustrate the survey results from the original, 1988, and 1999 surveys. The original and other profiles do not fully agree in the lateral direction for all ranges mainly due to the fact the original profiles were

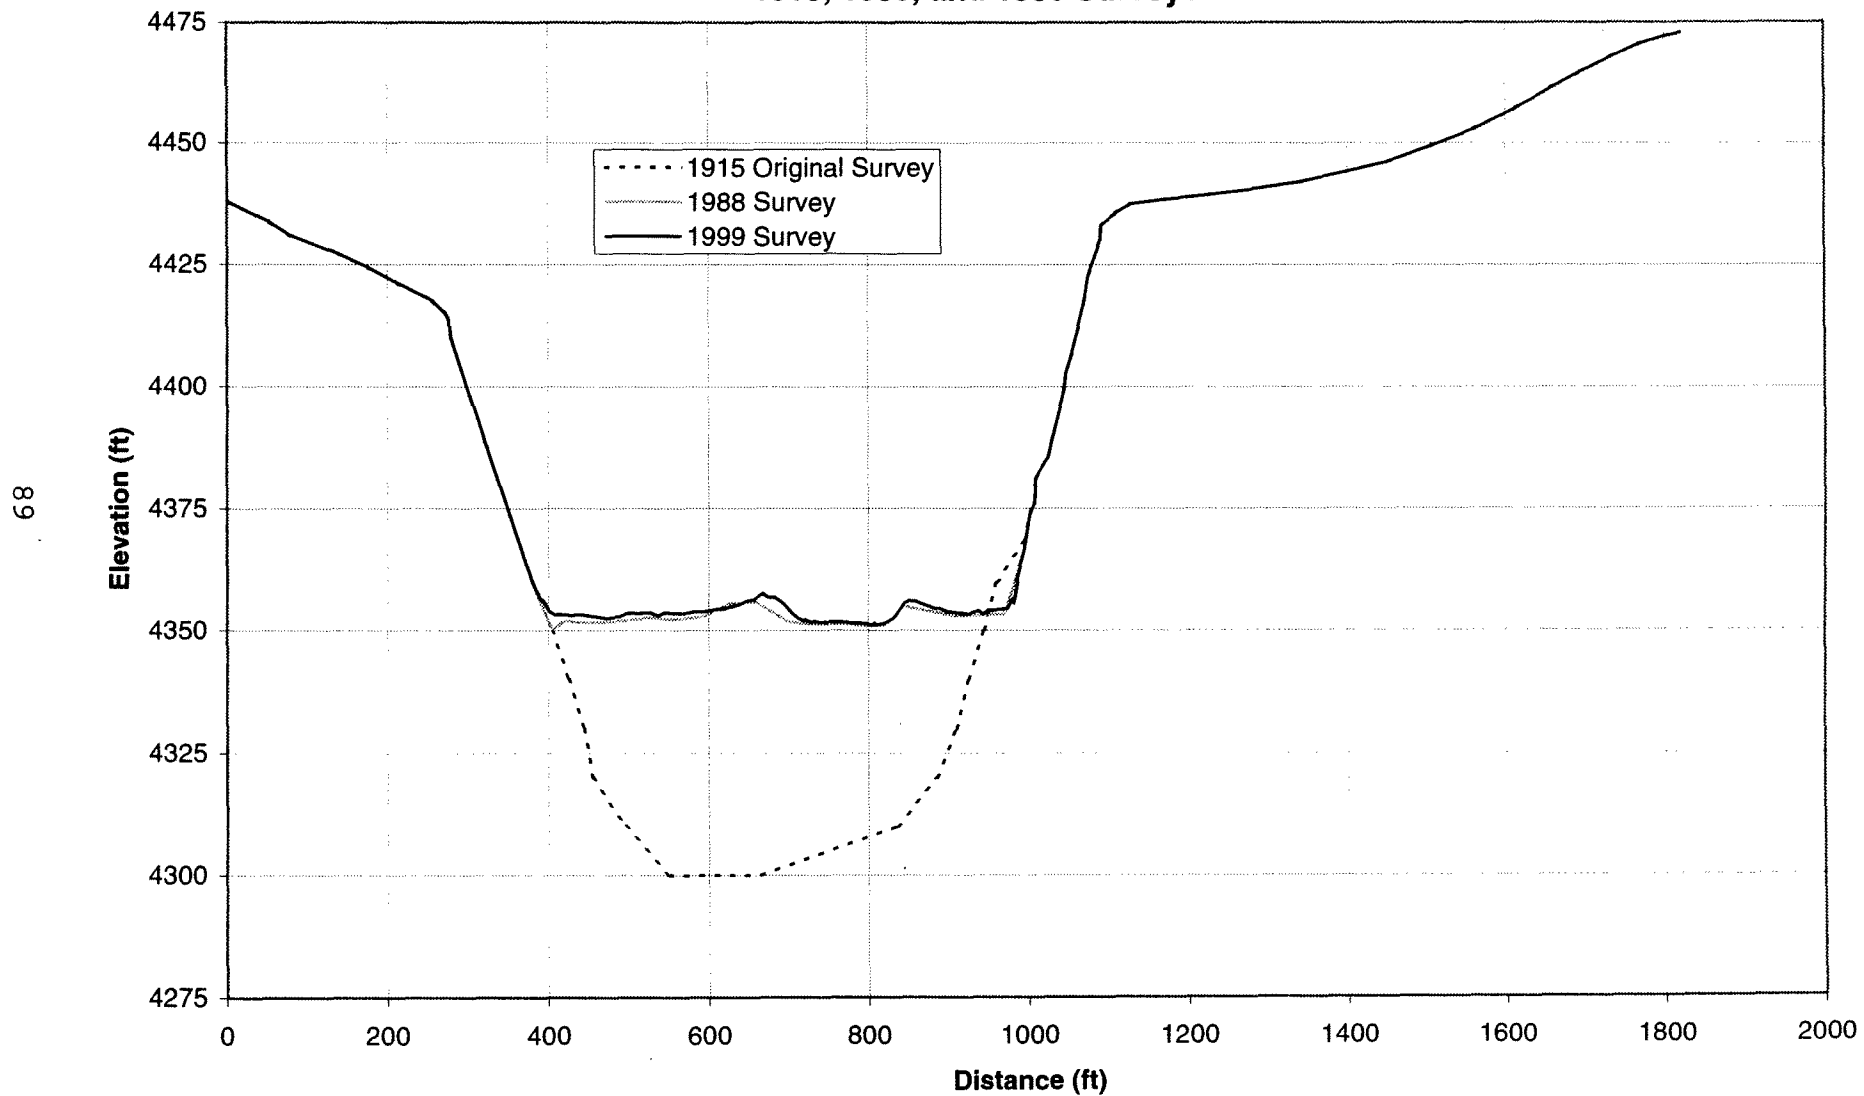
Elephant Butte Sediment Range Profile: Rangeline 55 1915, 1988, and 1999 Surveys

Figure 55. - Sedimentation range profiles for 1915, 1988, and 1999, range 55.

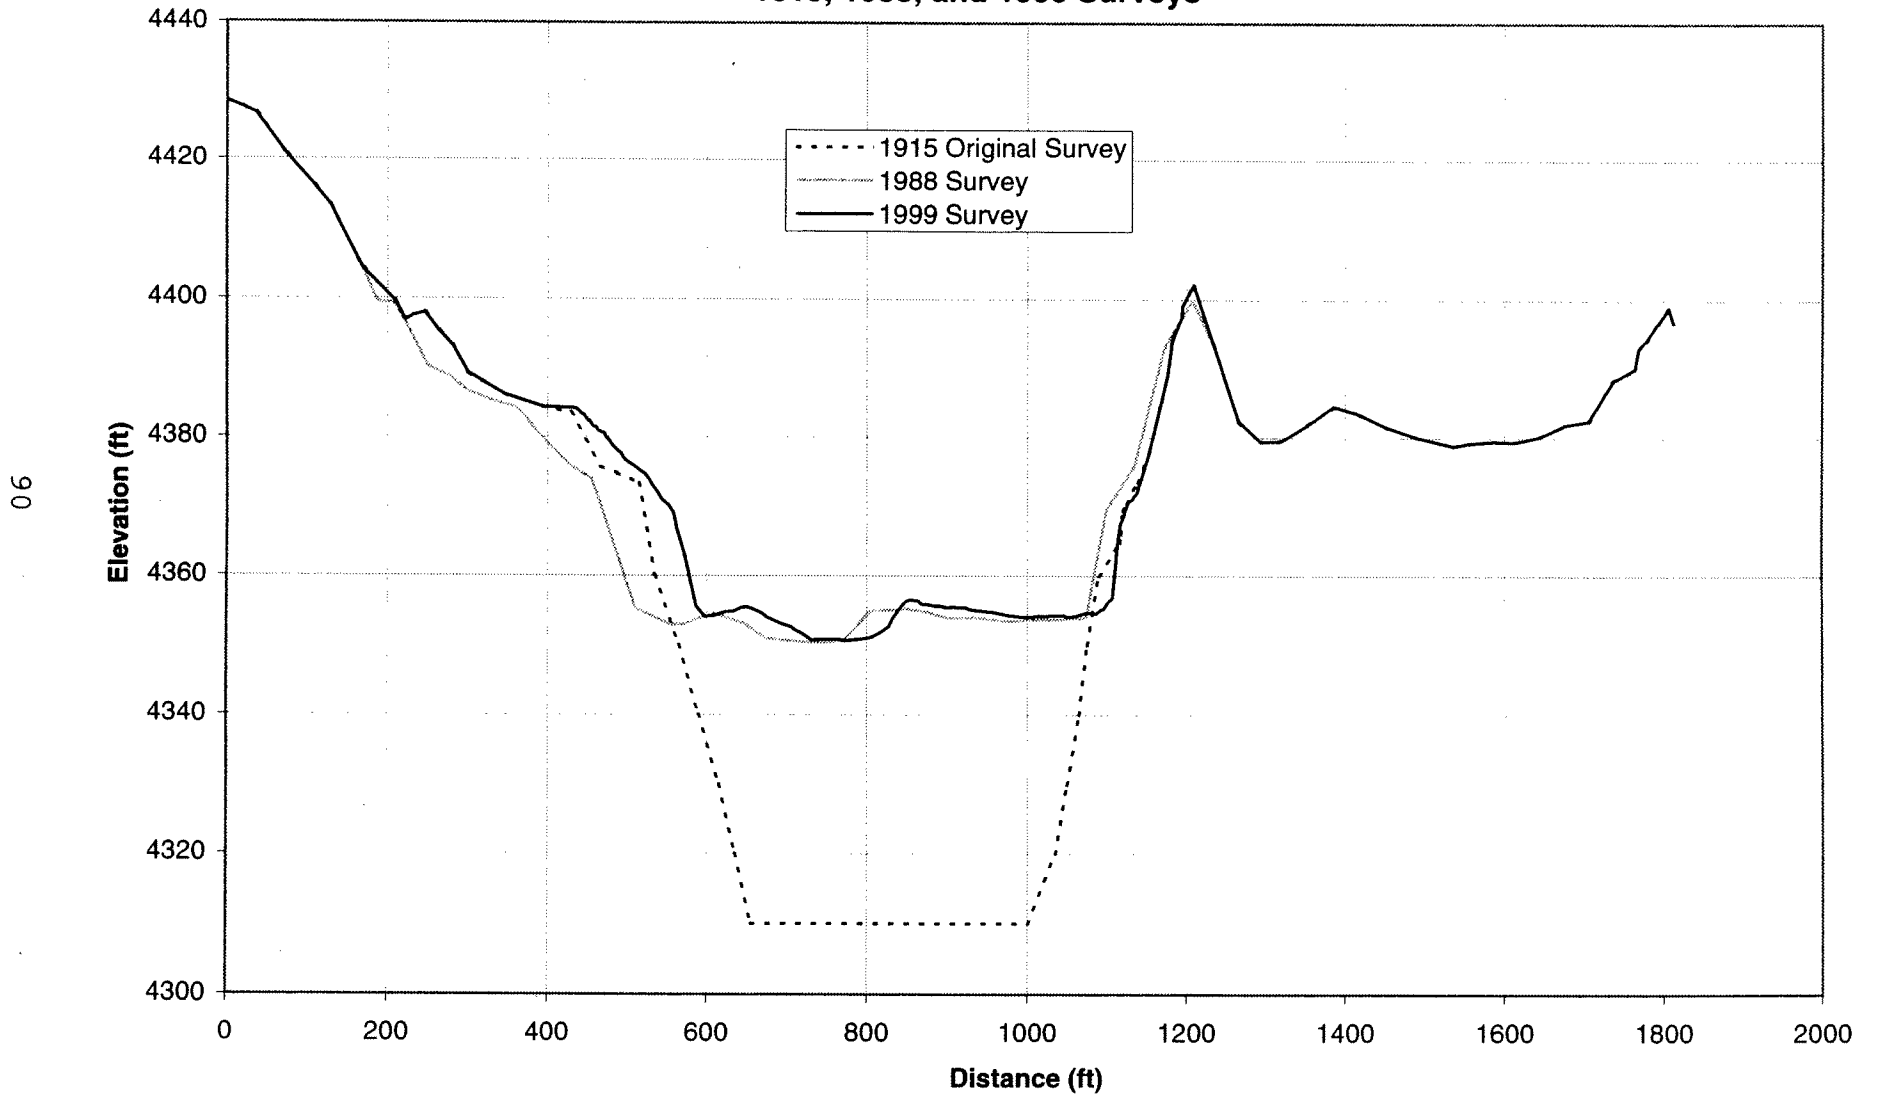
Figure 56. - Sedimentation range profiles for 1915, 1988, and 1999, range 54.

A comparison of the simultaneous plots of original range profiles against the resurveyed range profiles indicates the lateral distribution of the sediment at the measured points. Where these plots indicate changes have occurred on the side slopes of the reservoir, an engineering judgment decision was required to determine whether the change is due to survey inaccuracies or due to actual deposition or erosion. As noted previously the original range line data was scaled from the original 10-foot contour maps.

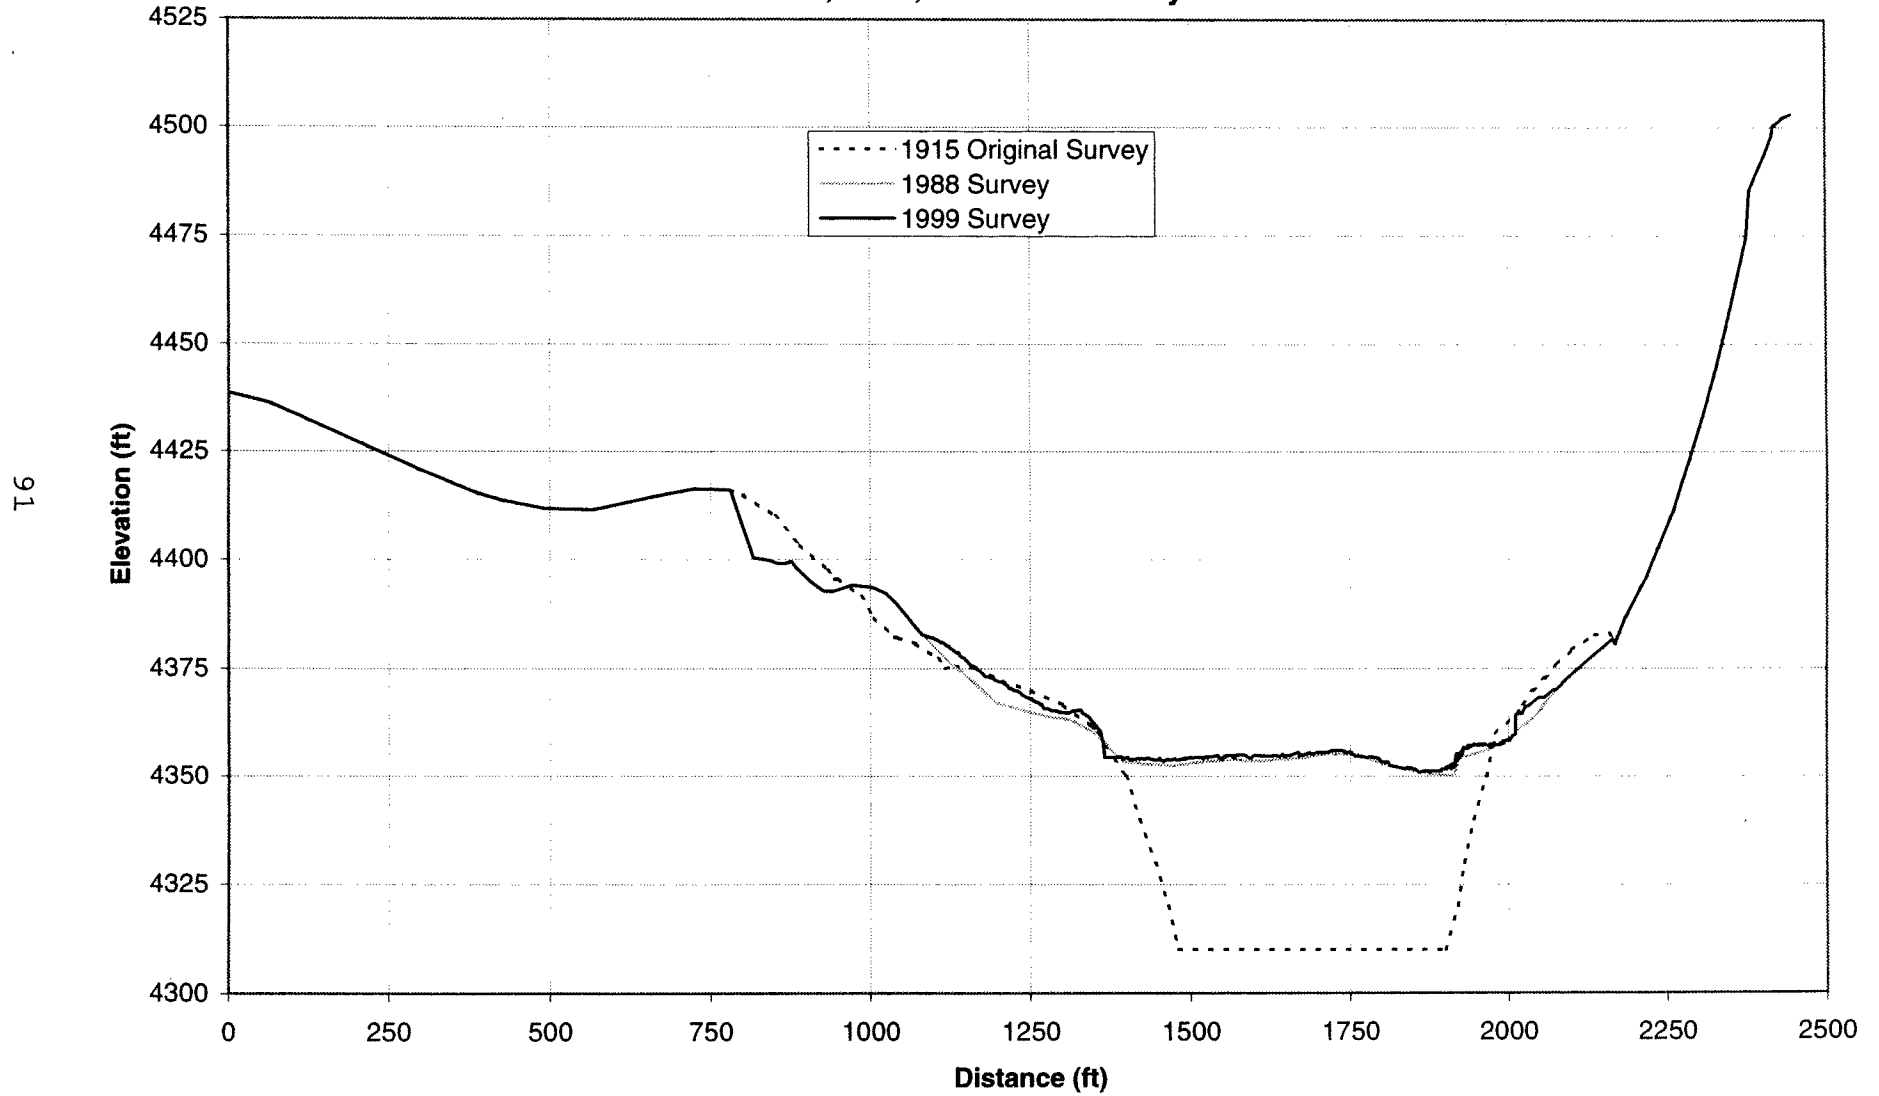
Figure 57. - Sedimentation range profiles for 1915, 1988, and 1999, range 53.

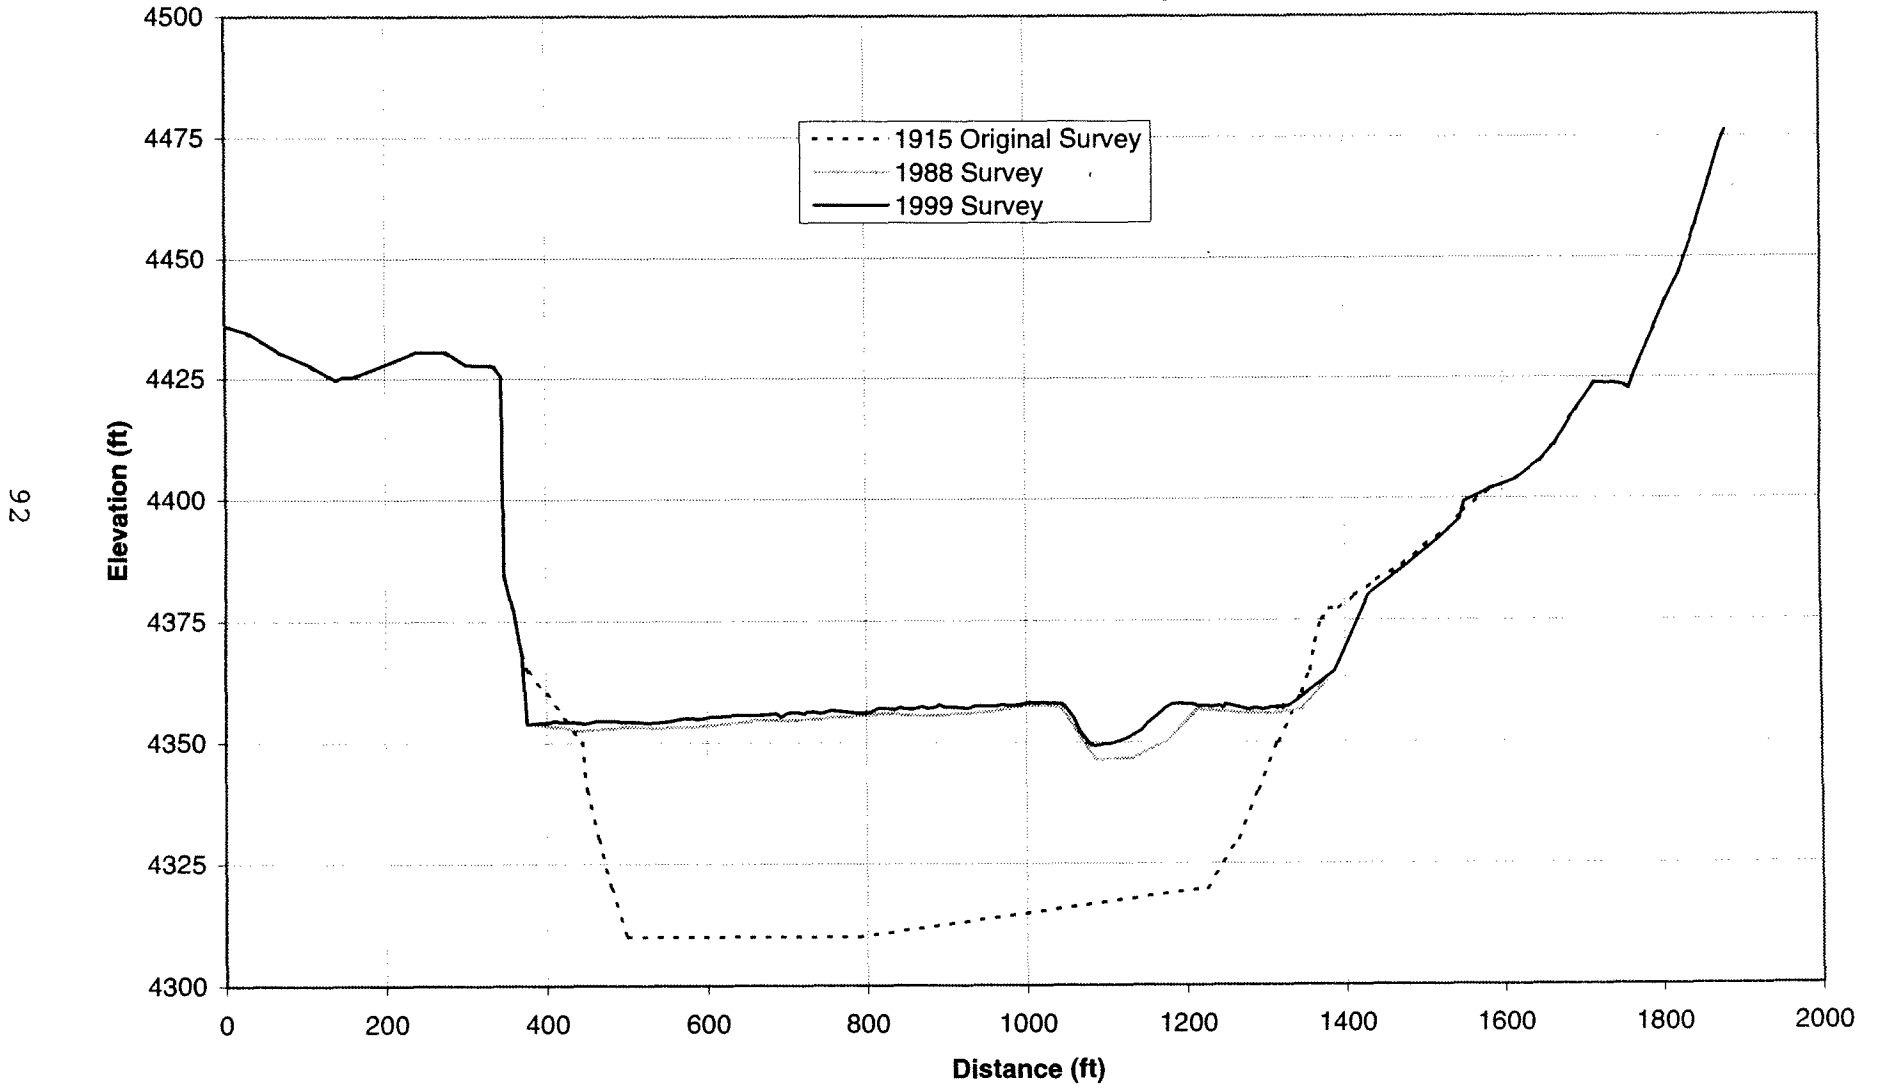
Figure 58. - Sedimentation range profiles for 1915, 1988, and 1999, range 52.

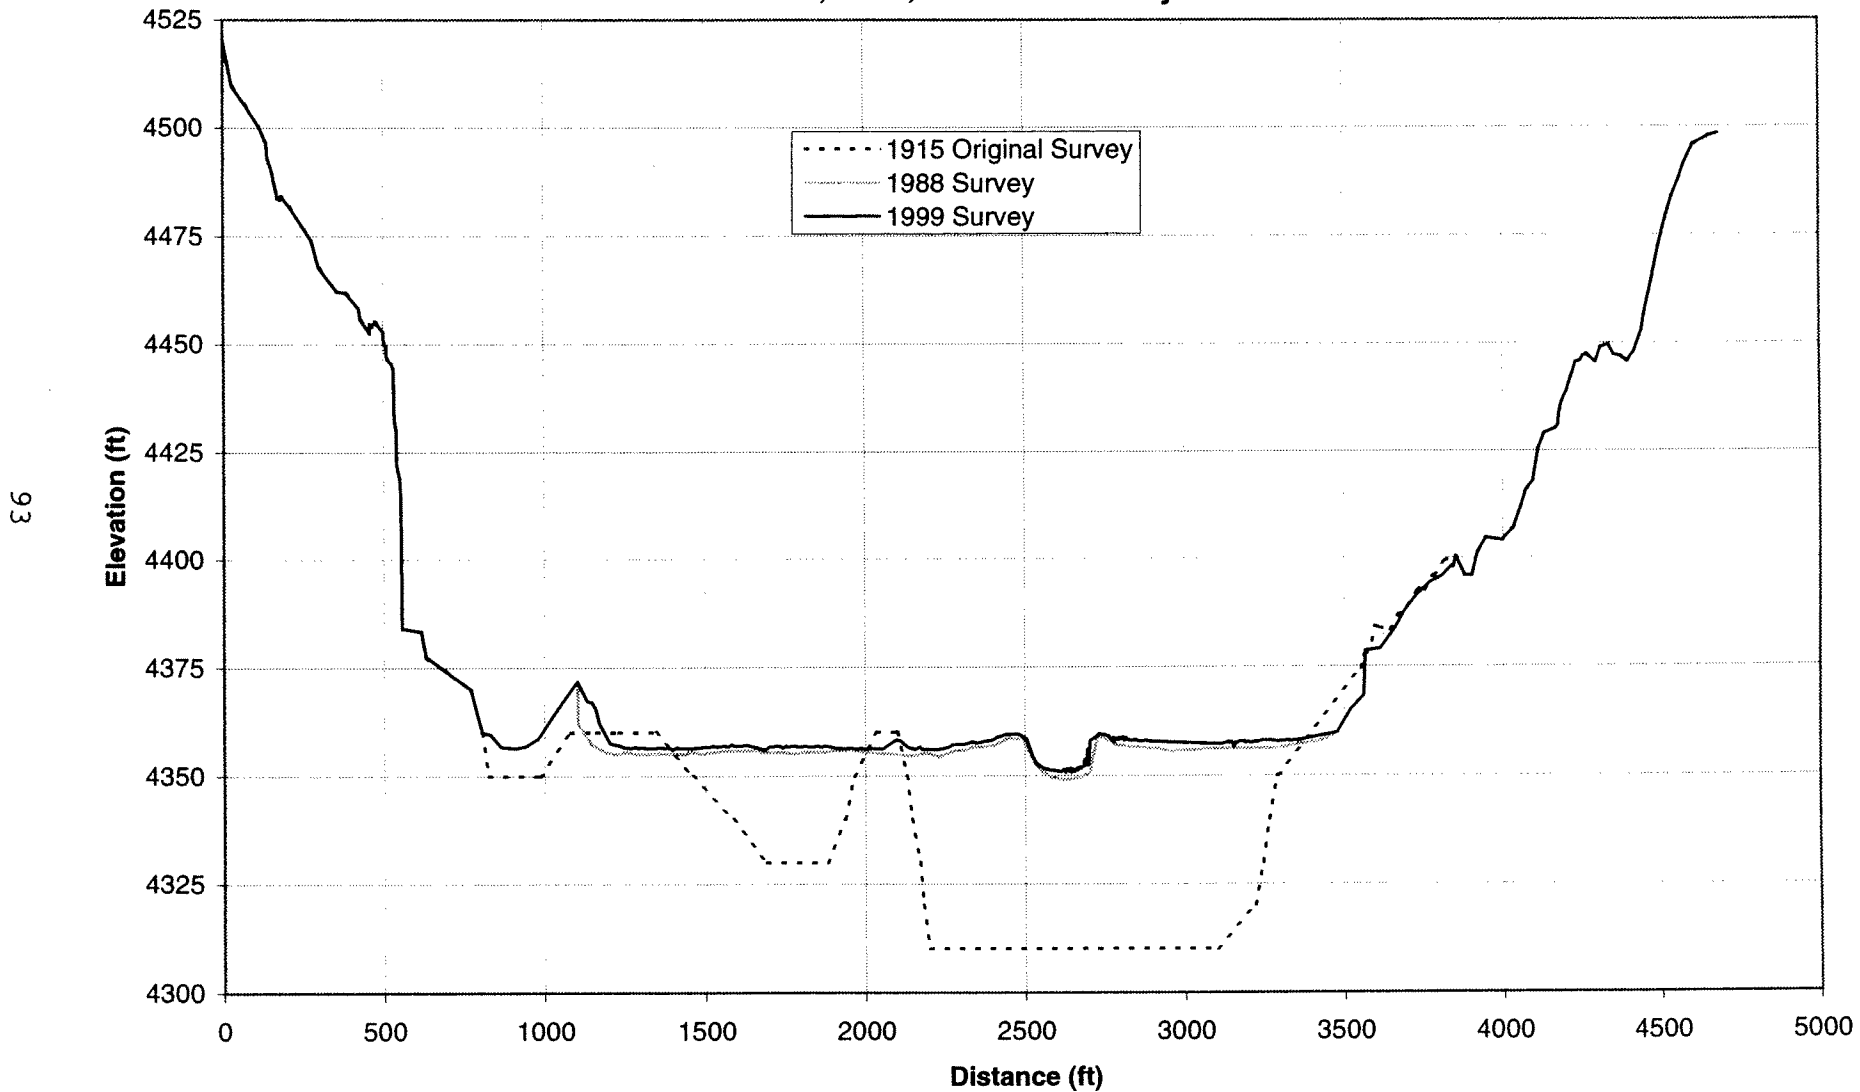
Figure 59. - Sedimentation range profiles for 1915, 1988, and 1999, range 51.

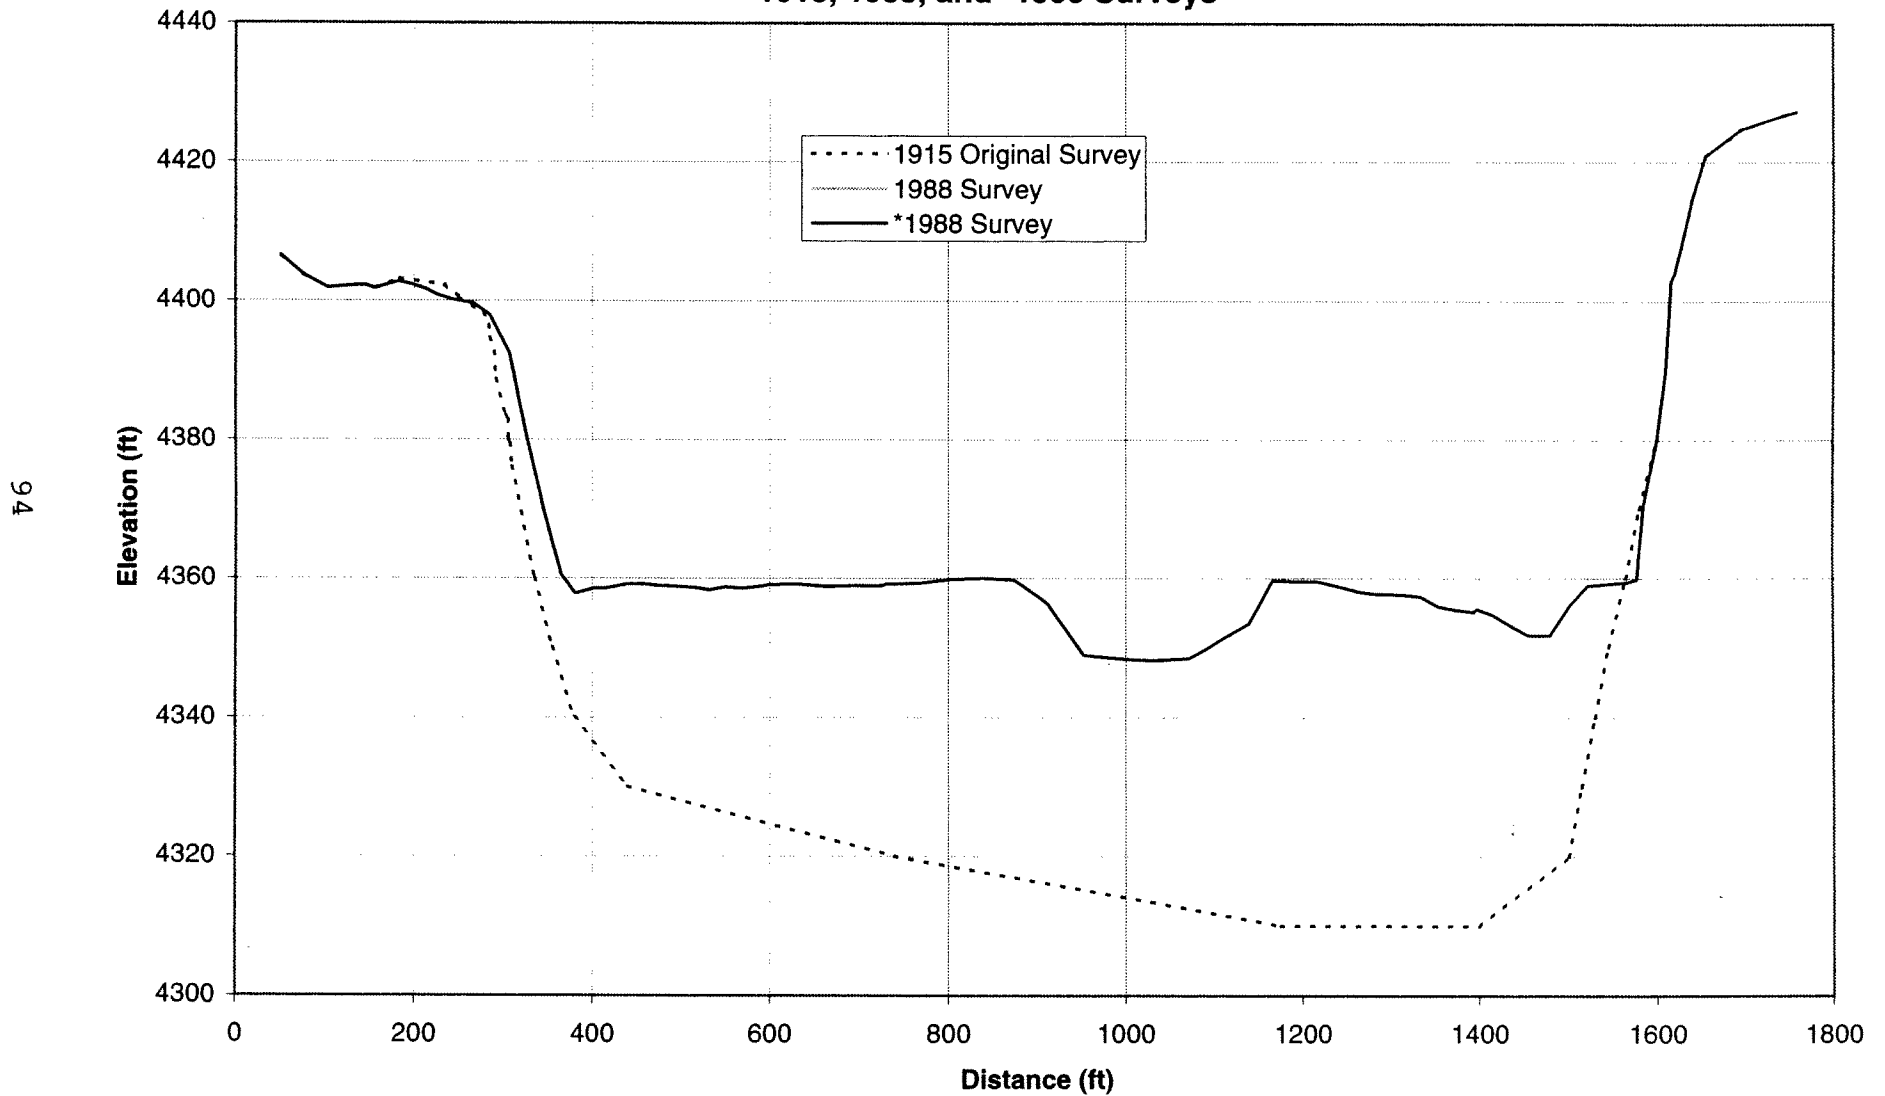
Elephant Butte Sediment Range Profile: Rangeline 50 1915, 1988, and *1999 Surveys

*Rangeline 50 not surveyed in 1999

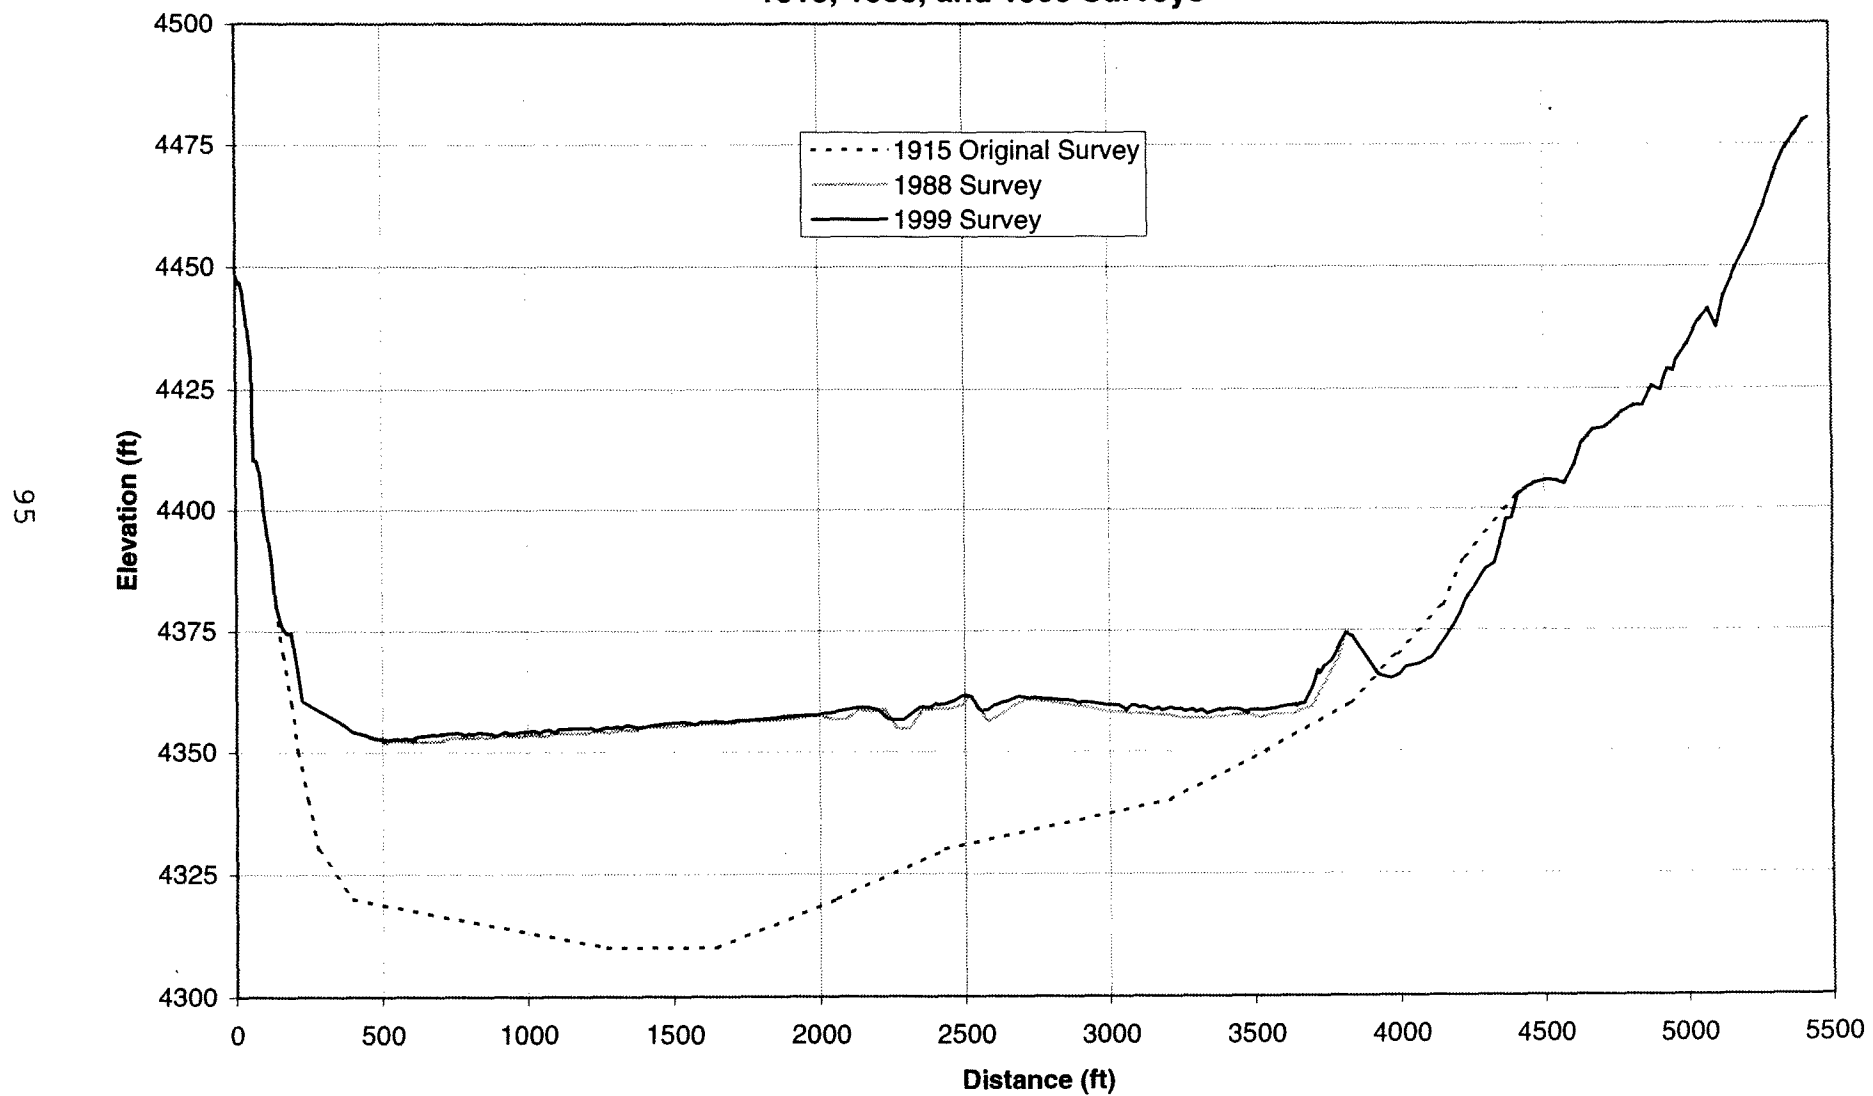
Figure 61. - Sedimentation range profiles for 1915, 1988, and 1999, range 49.

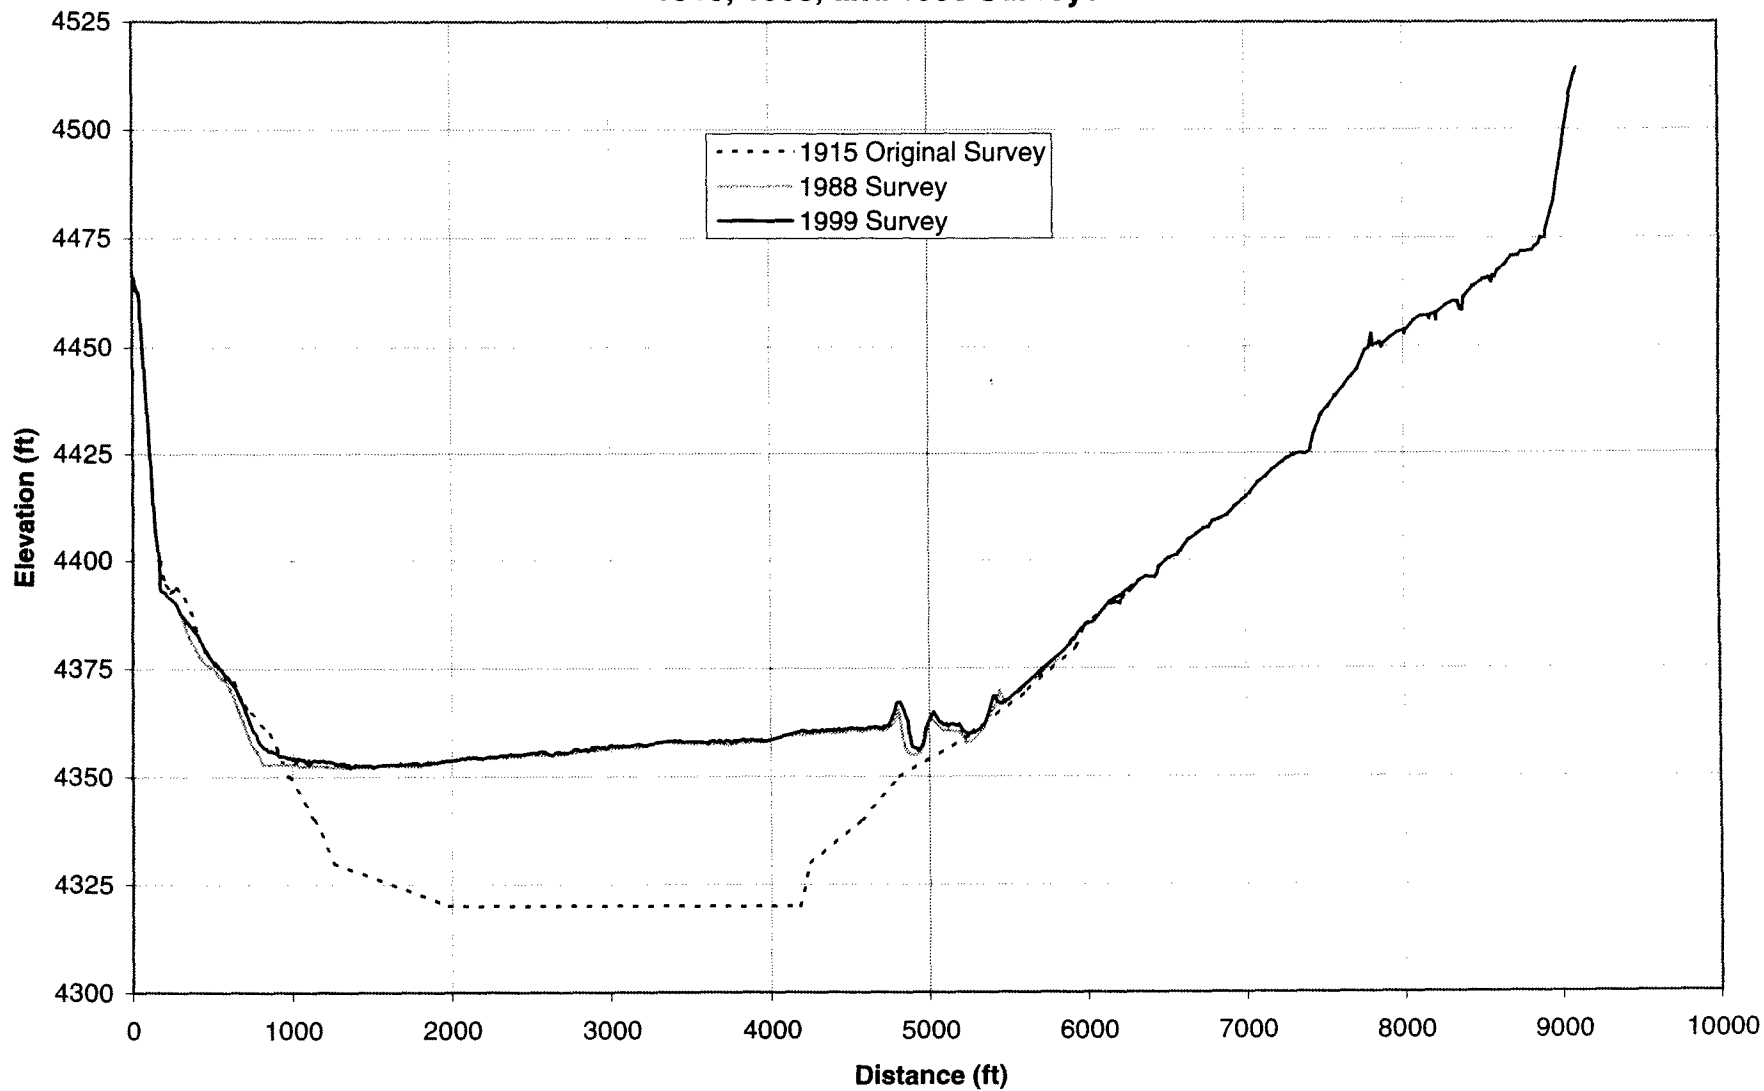
Figure 62. - Sedimentation range profiles for 1915, 1988, and 1999, range 48.

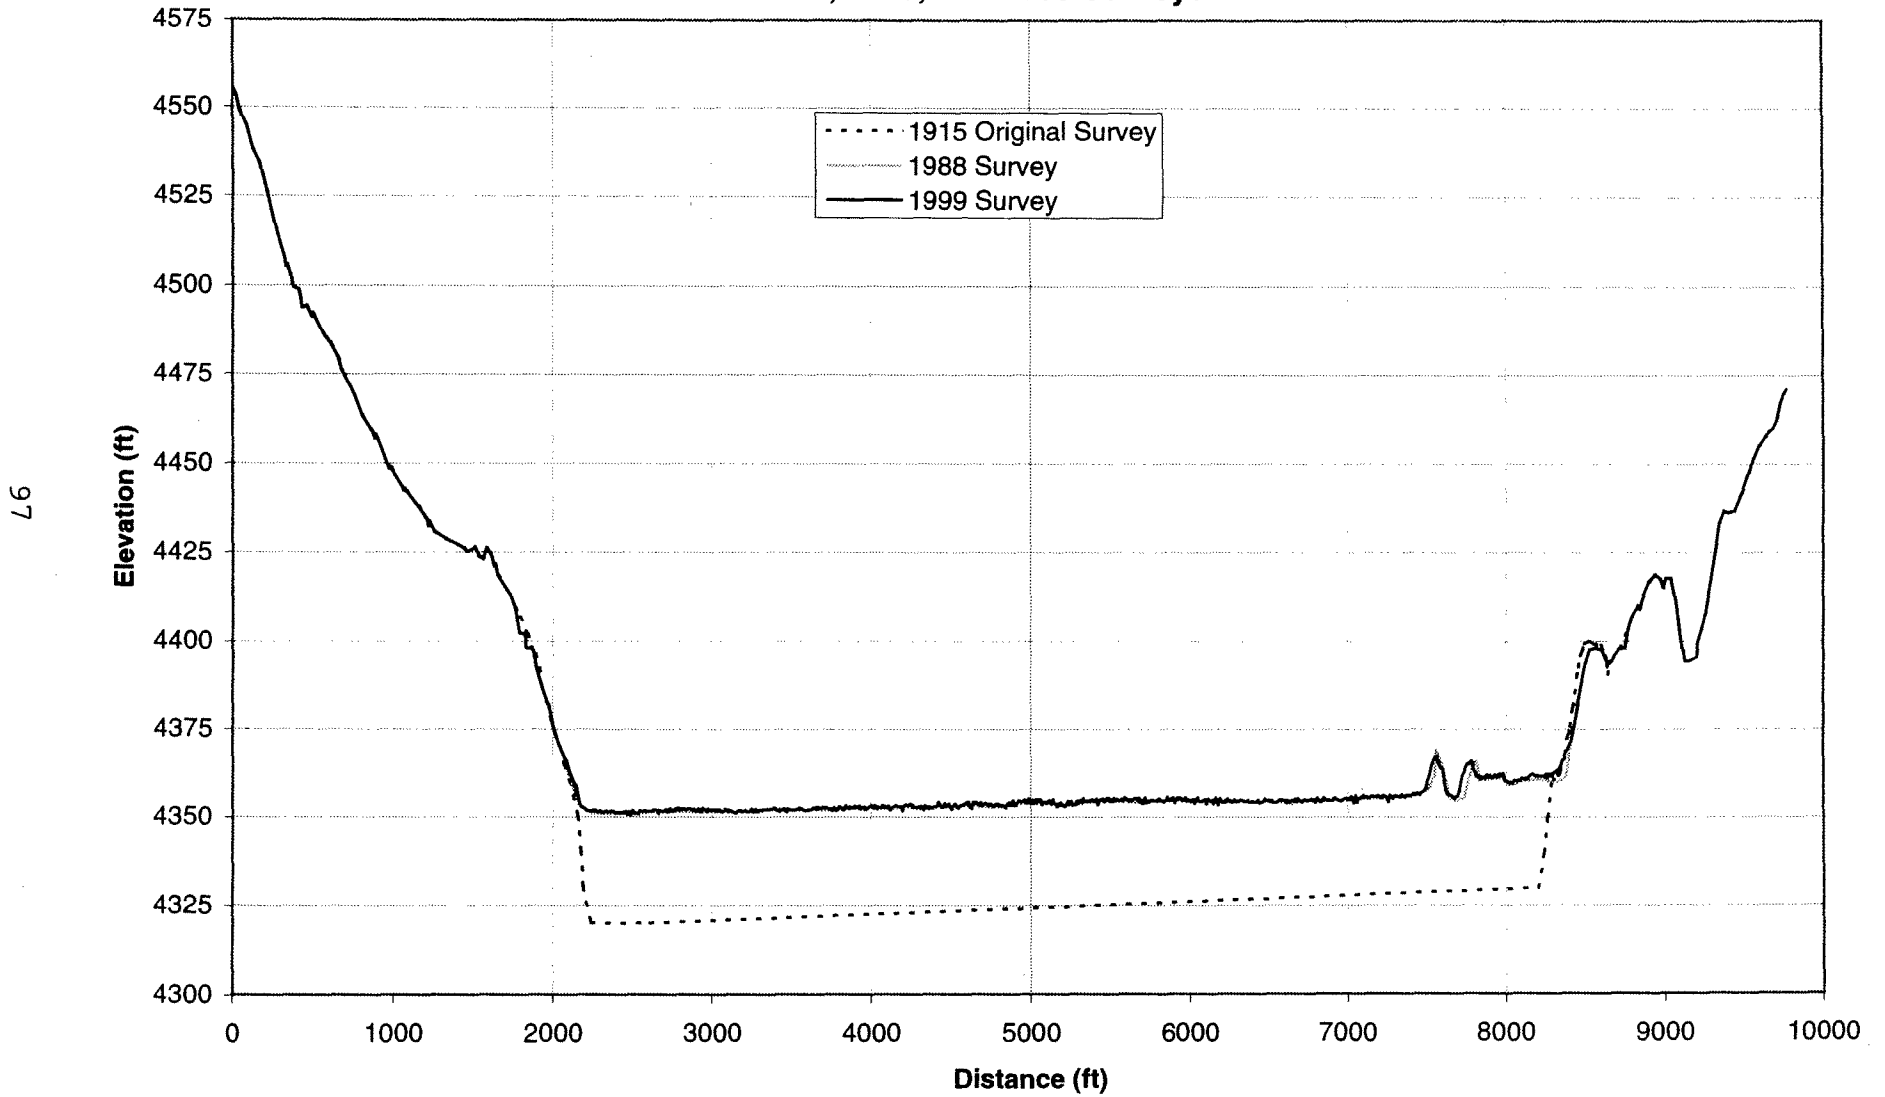
Figure 63. - Sedimentation range profiles for 1915, 1988, and 1999, range 47.

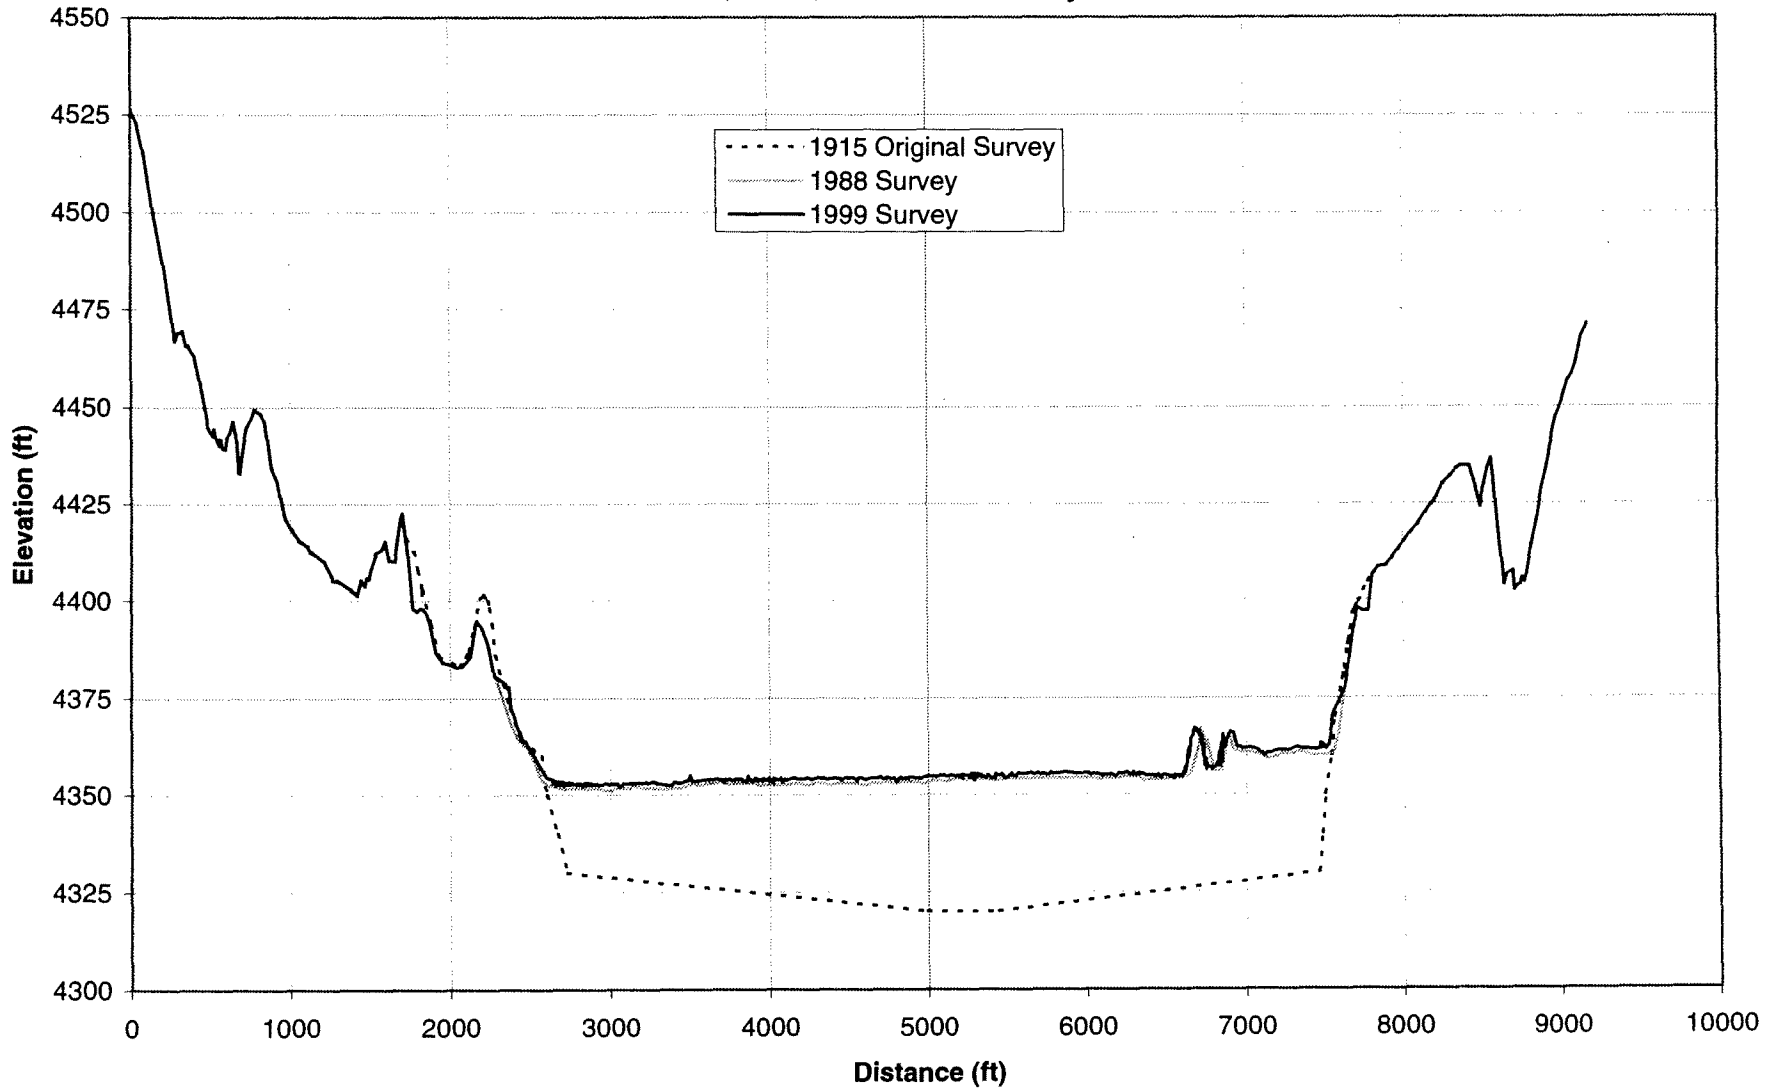
Figure 64. - Sedimentation range profiles for 1915, 1988, and 1999, range 46.
