ELEPHANT BUTTE RESERVOIR

1999 RESERVOIR SURVEY

U.S. Department of the Interior
Bureau of Reclamation

**Sedimentation and River Hydraulics Group
Water Resources Services
Technical Service Center
Denver, Colorado**

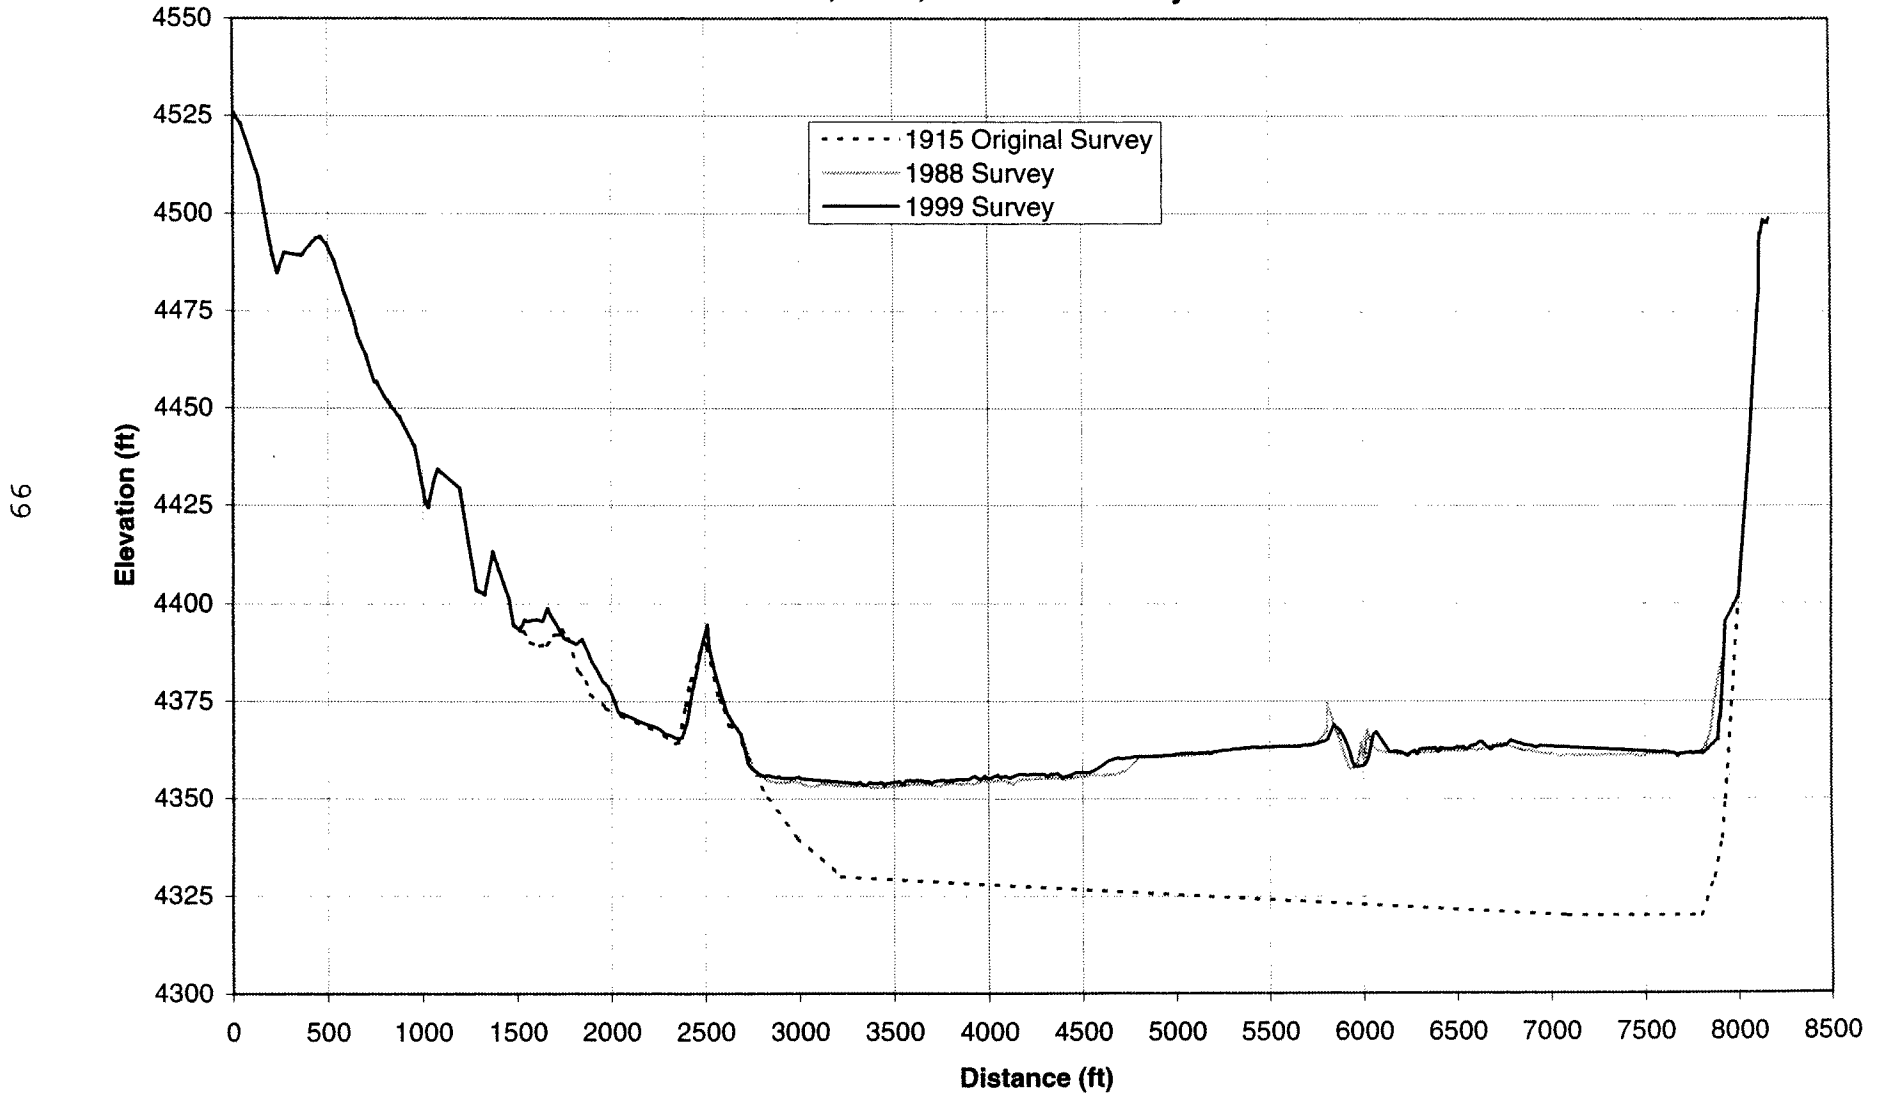
Figure 65. - Sedimentation range profiles for 1915, 1988, and 1999, range 45.

A comparison of the simultaneous plots of original range profiles against the resurveyed range profiles indicates the lateral distribution of the sediment at the measured points. Where these plots indicate changes have occurred on the side slopes of the reservoir, an engineering judgment decision was required to determine whether the change is due to survey inaccuracies or due to actual deposition or erosion. As noted previously the original range line data was scaled from the original 10-foot contour maps.

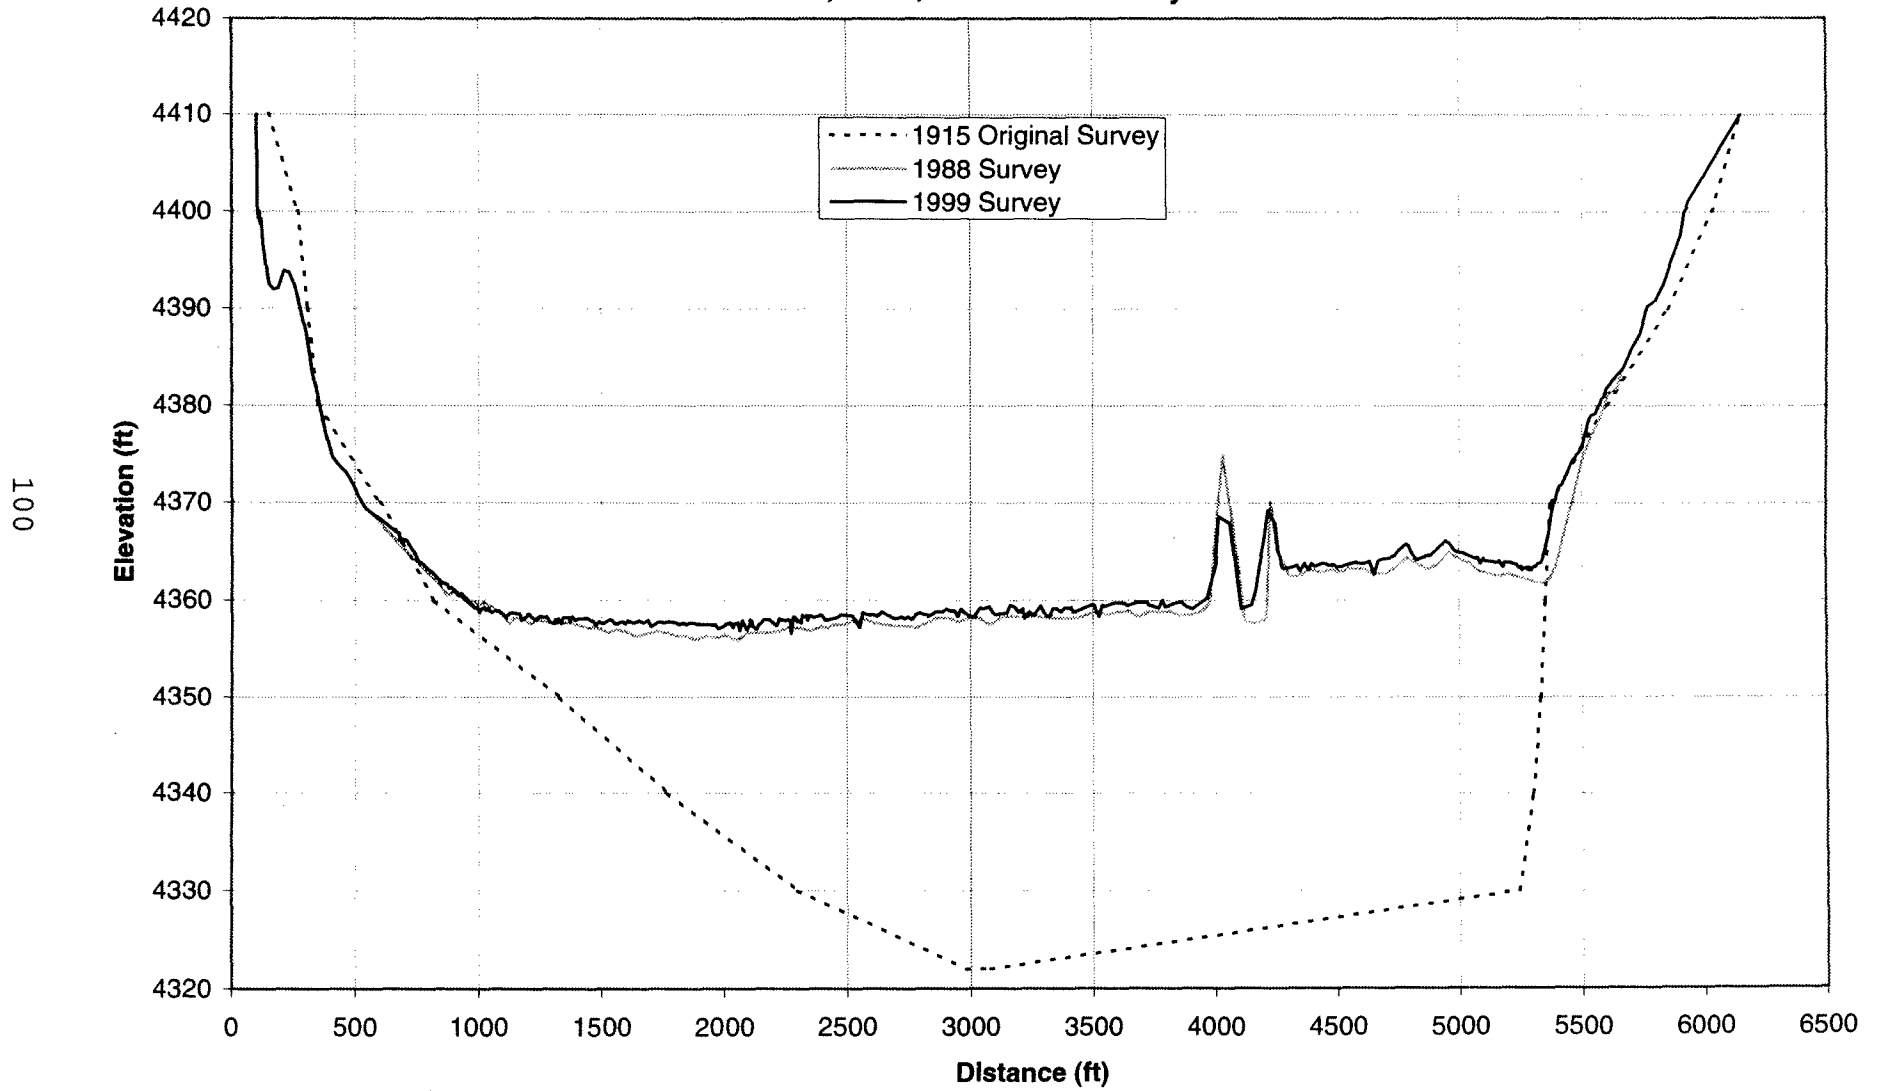
Figure 46. - Sedimentation range profiles for 1915, 1988, and 1999, range 44.

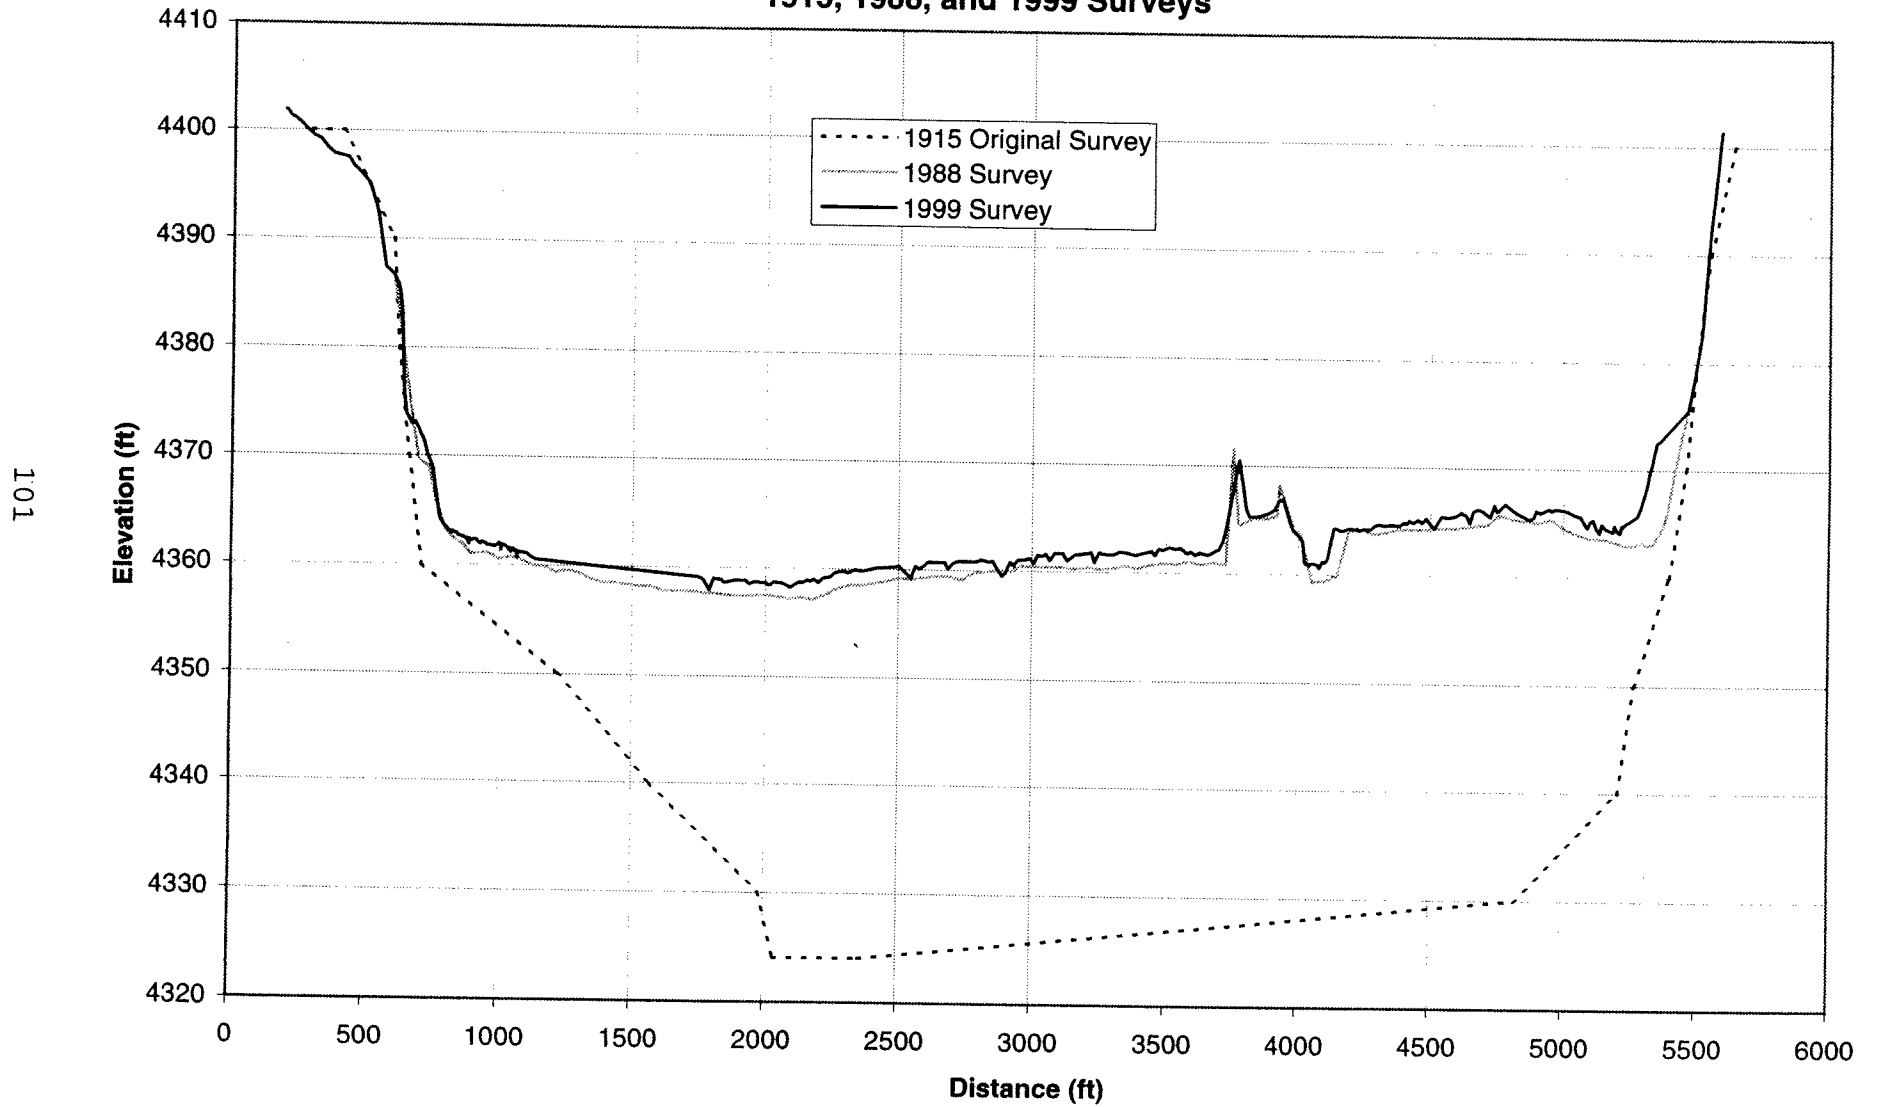
Figure 67. - Sedimentation range profiles for 1915, 1988, and 1999, range 43.

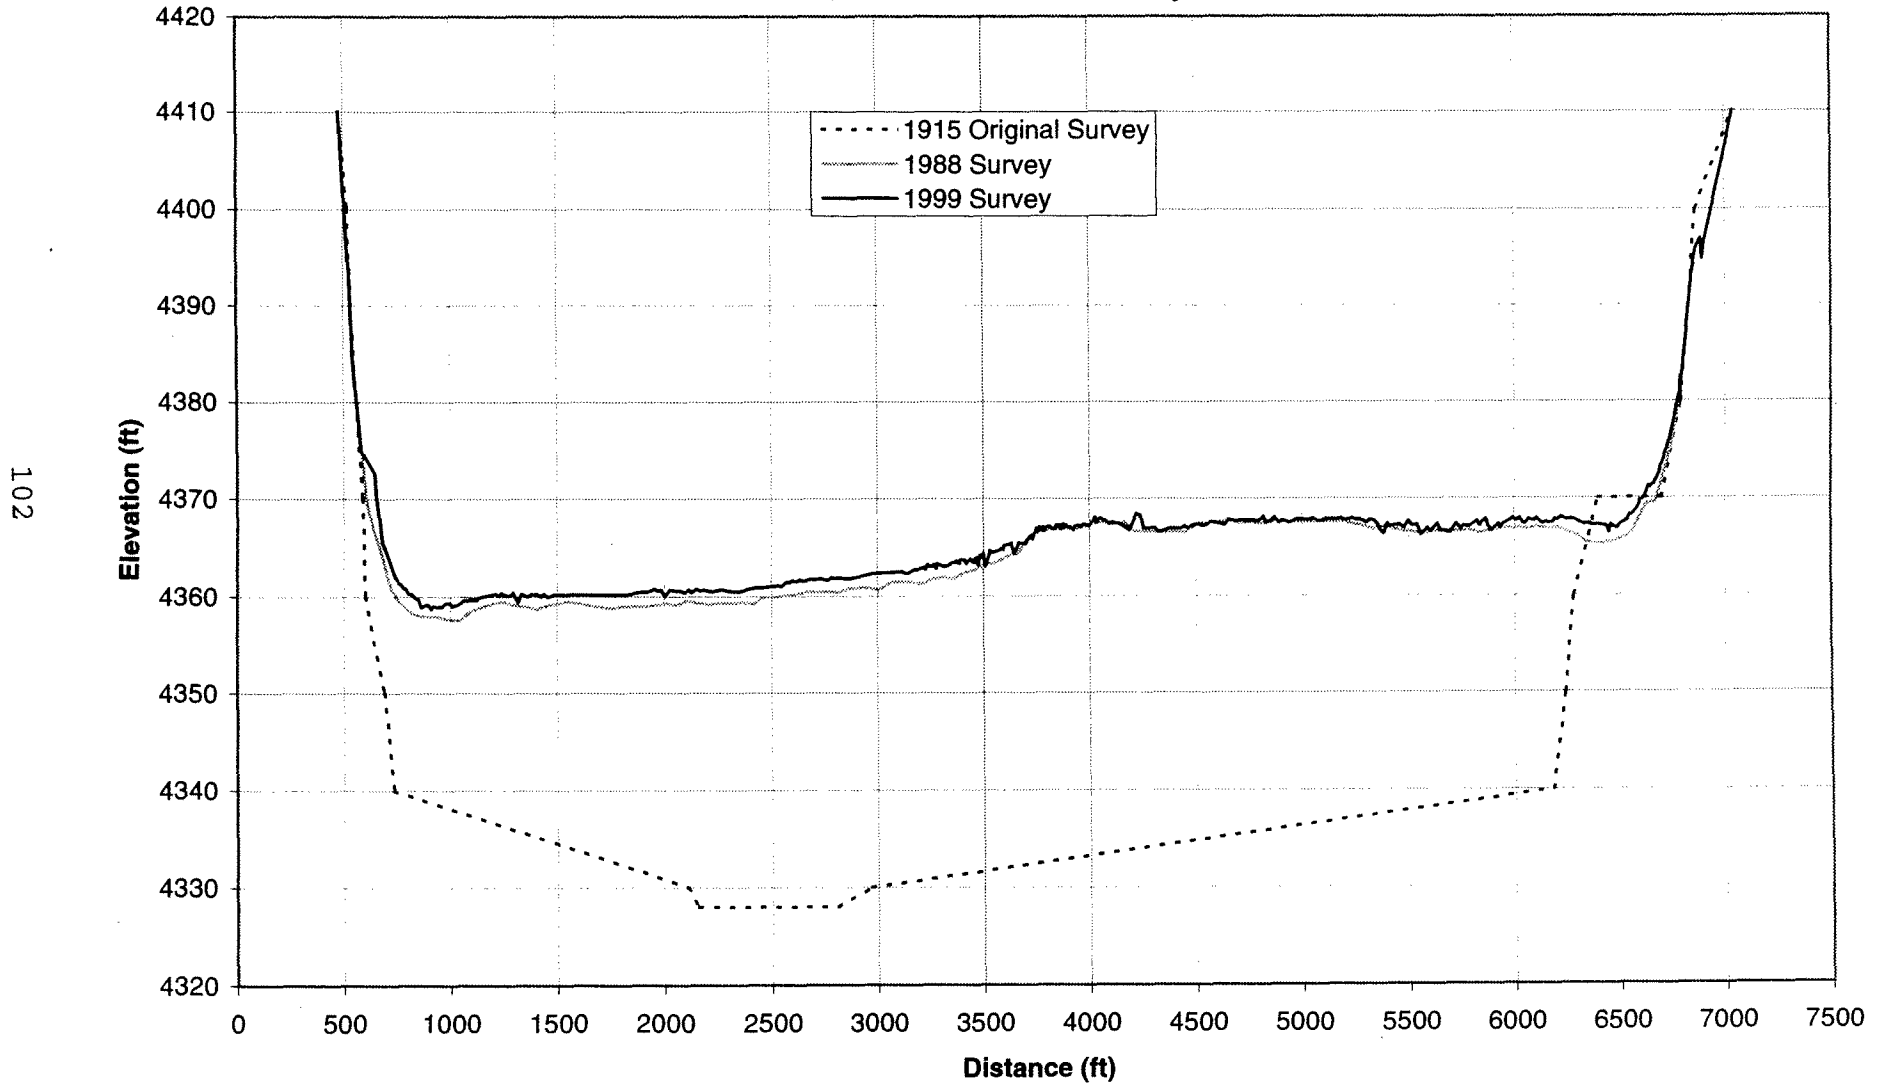
Figure 68. - Sedimentation range profiles for 1915, 1988, and 1999, range 42.

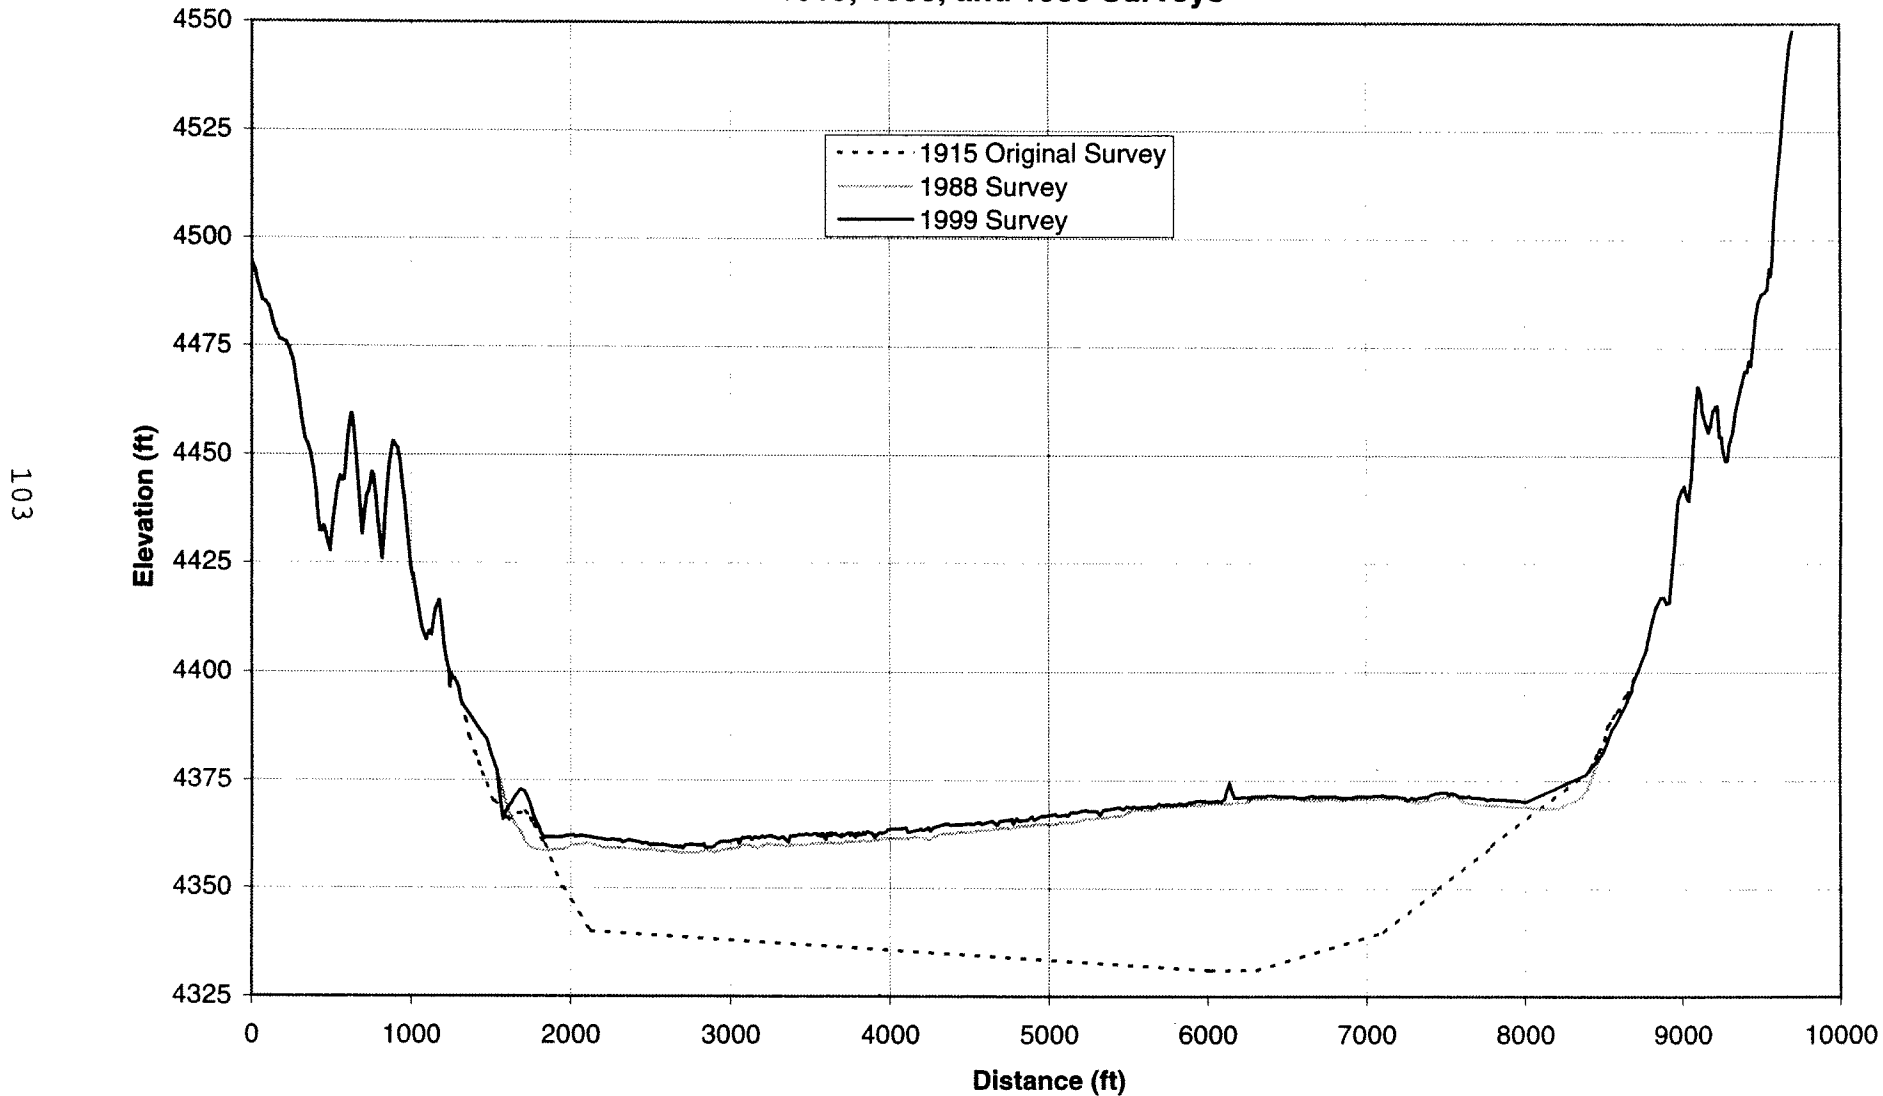
Figure 69. - Sedimentation range profiles for 1915, 1988, and 1999, range 41.

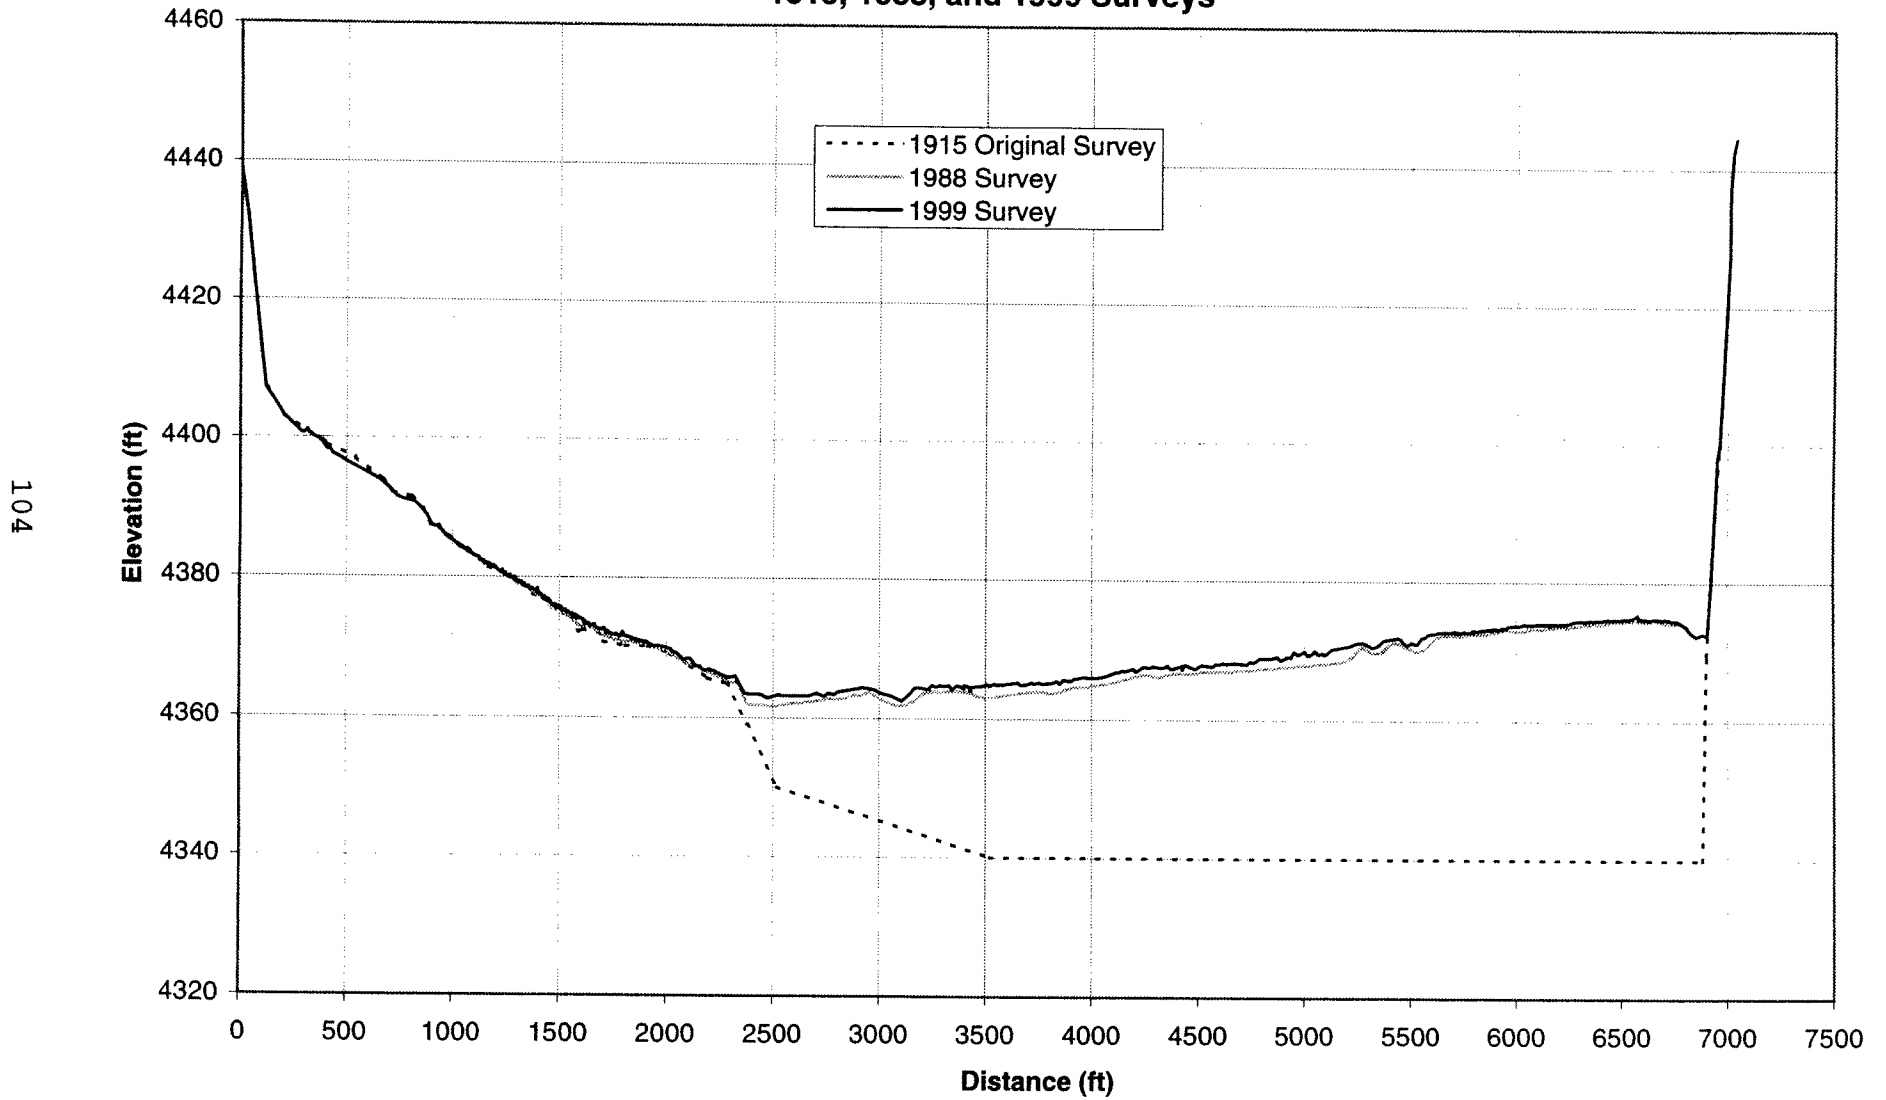
Figure 70. - Sedimentation range profiles for 1915, 1988, and 1999, range 40.

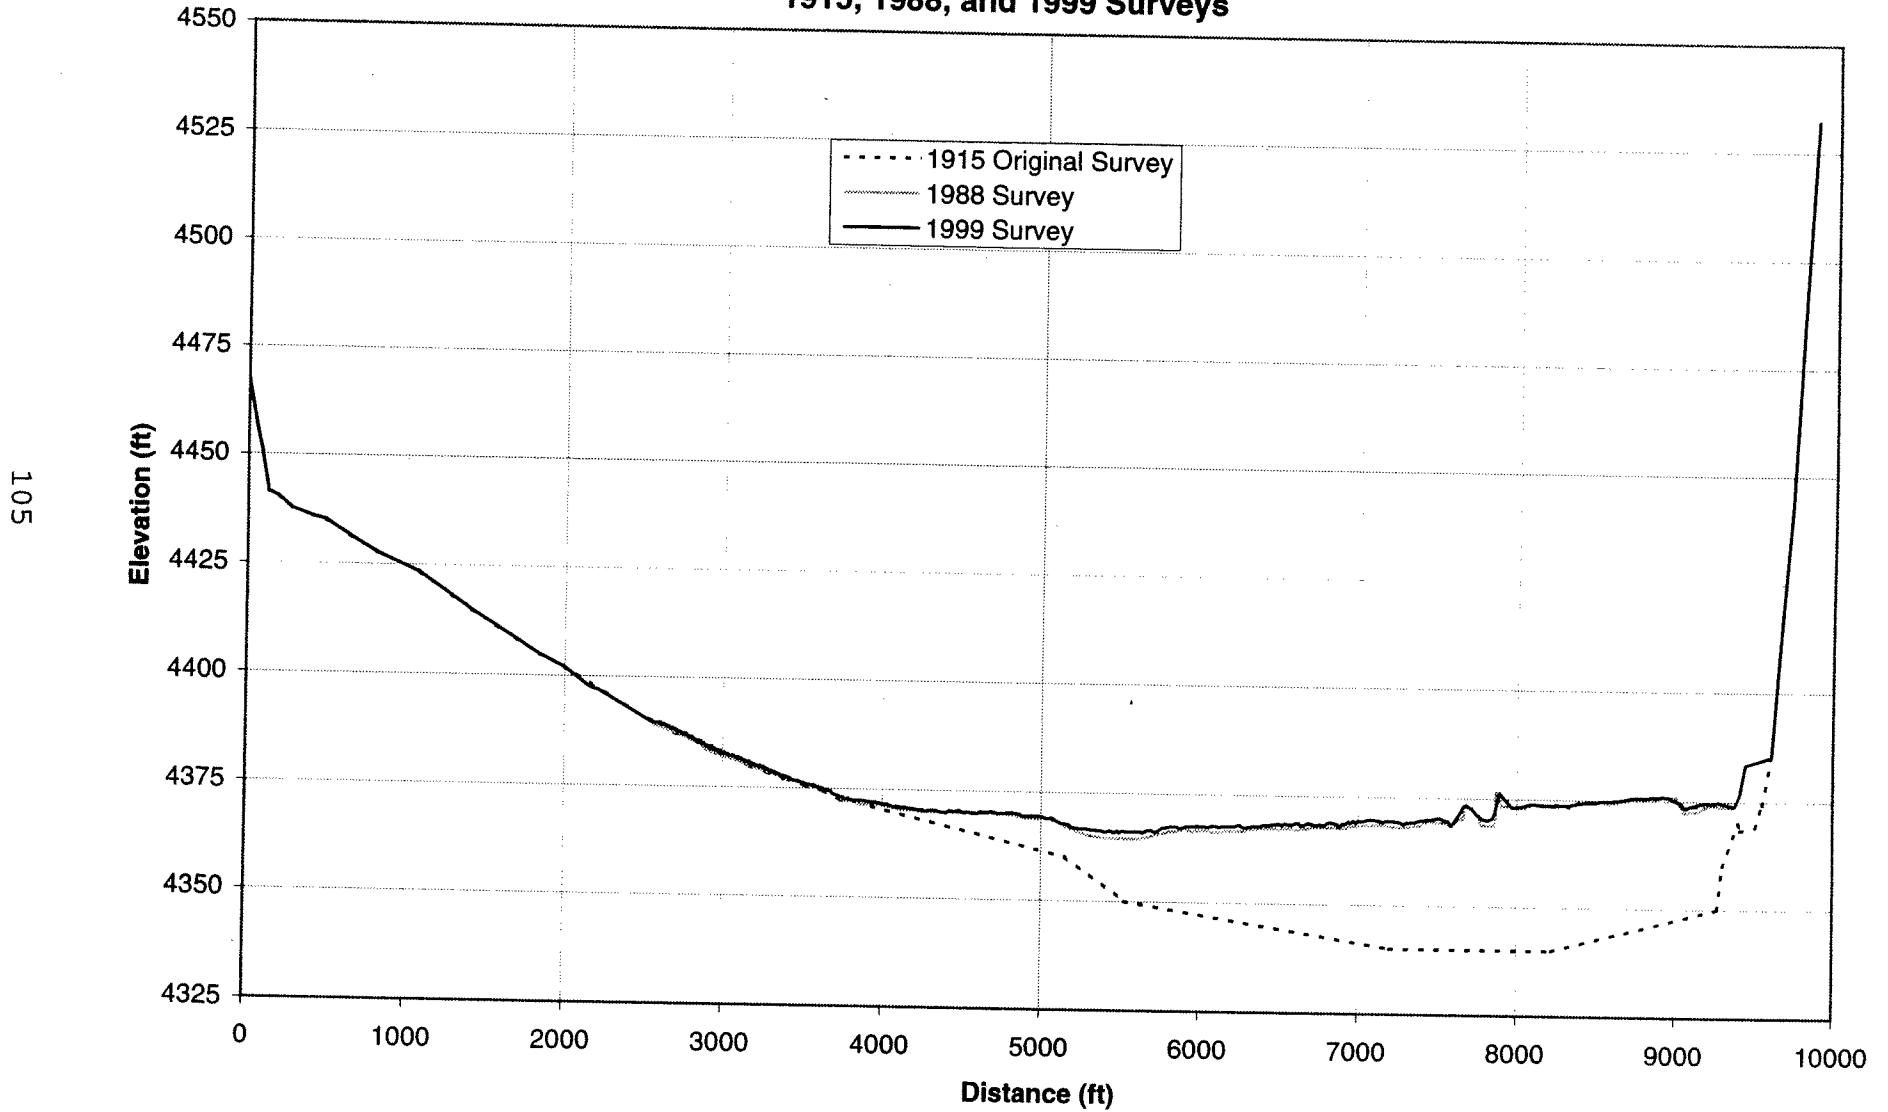
Figure 71. - Sedimentation range profiles for 1915, 1988, and 1999, range 39.

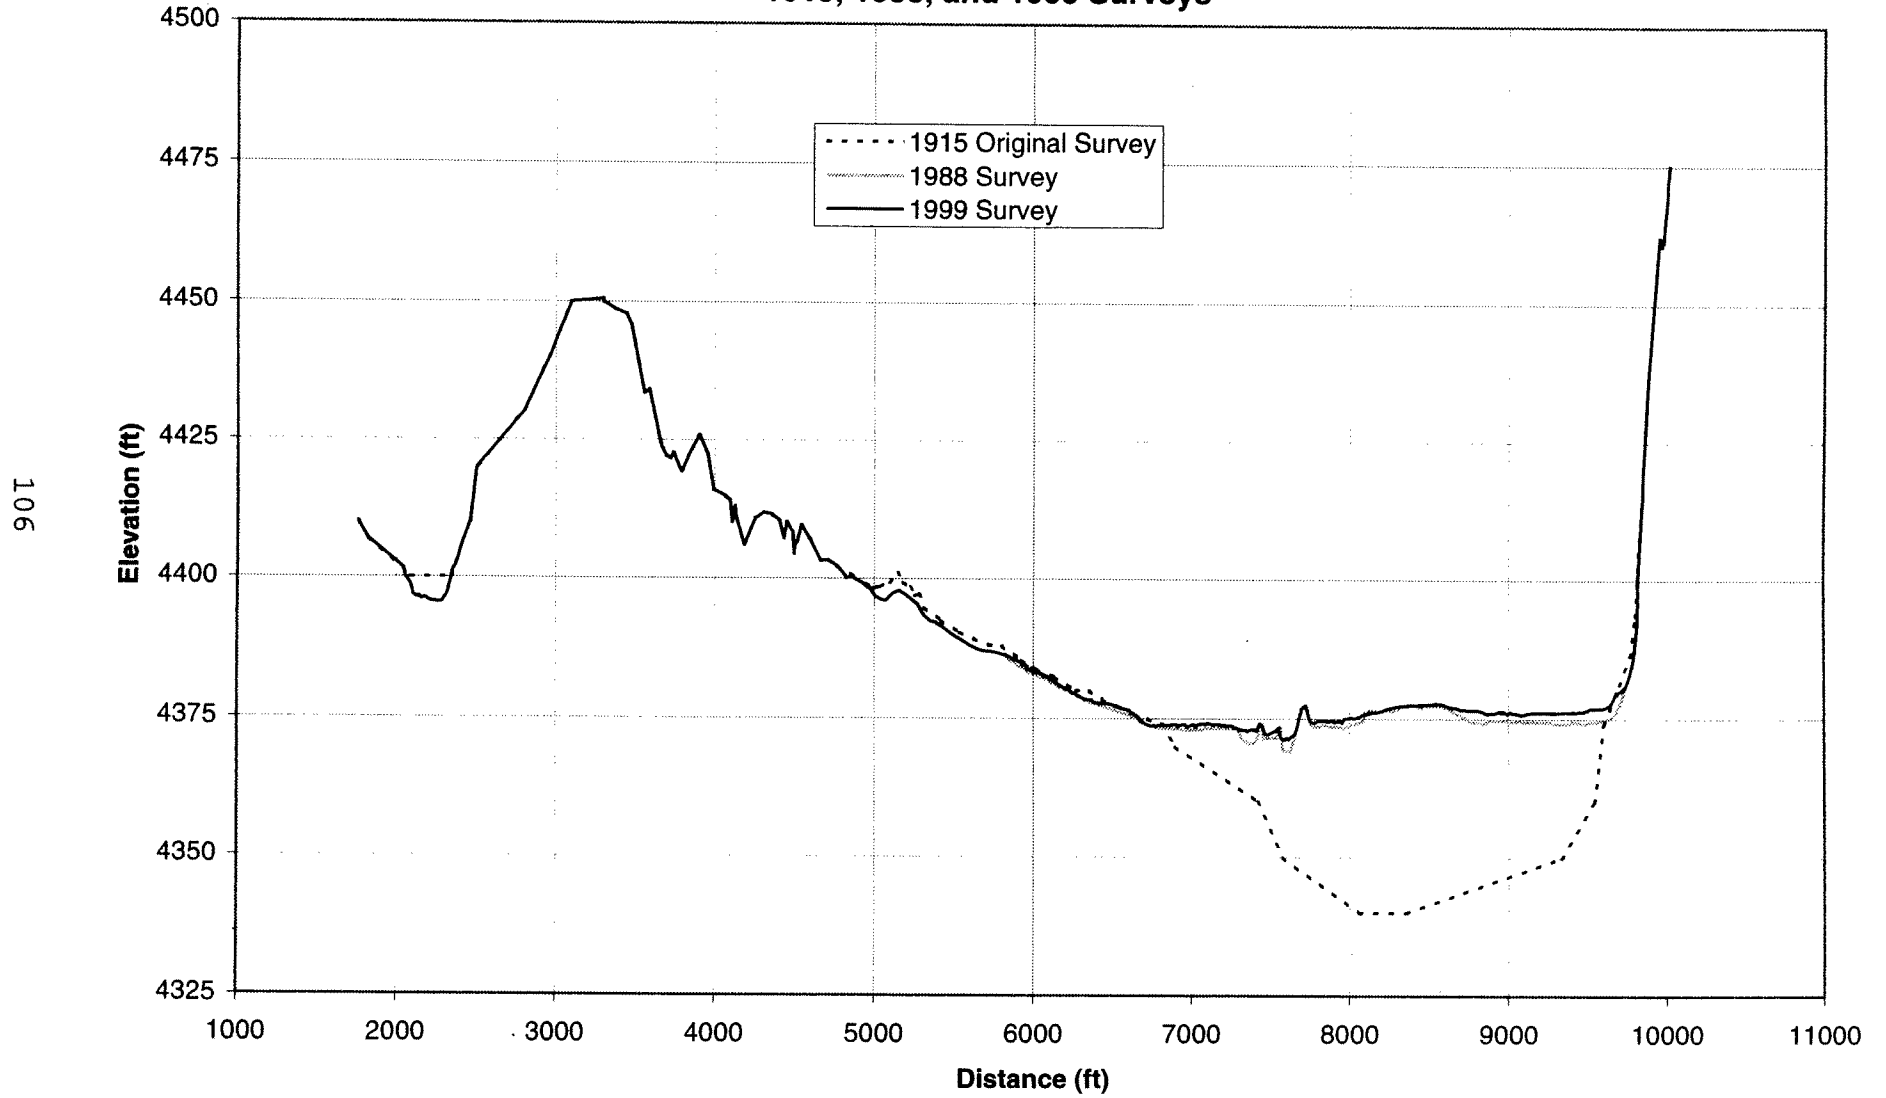
Figure 72. - Sedimentation range profiles for 1915, 1988, and 1999, range 38.

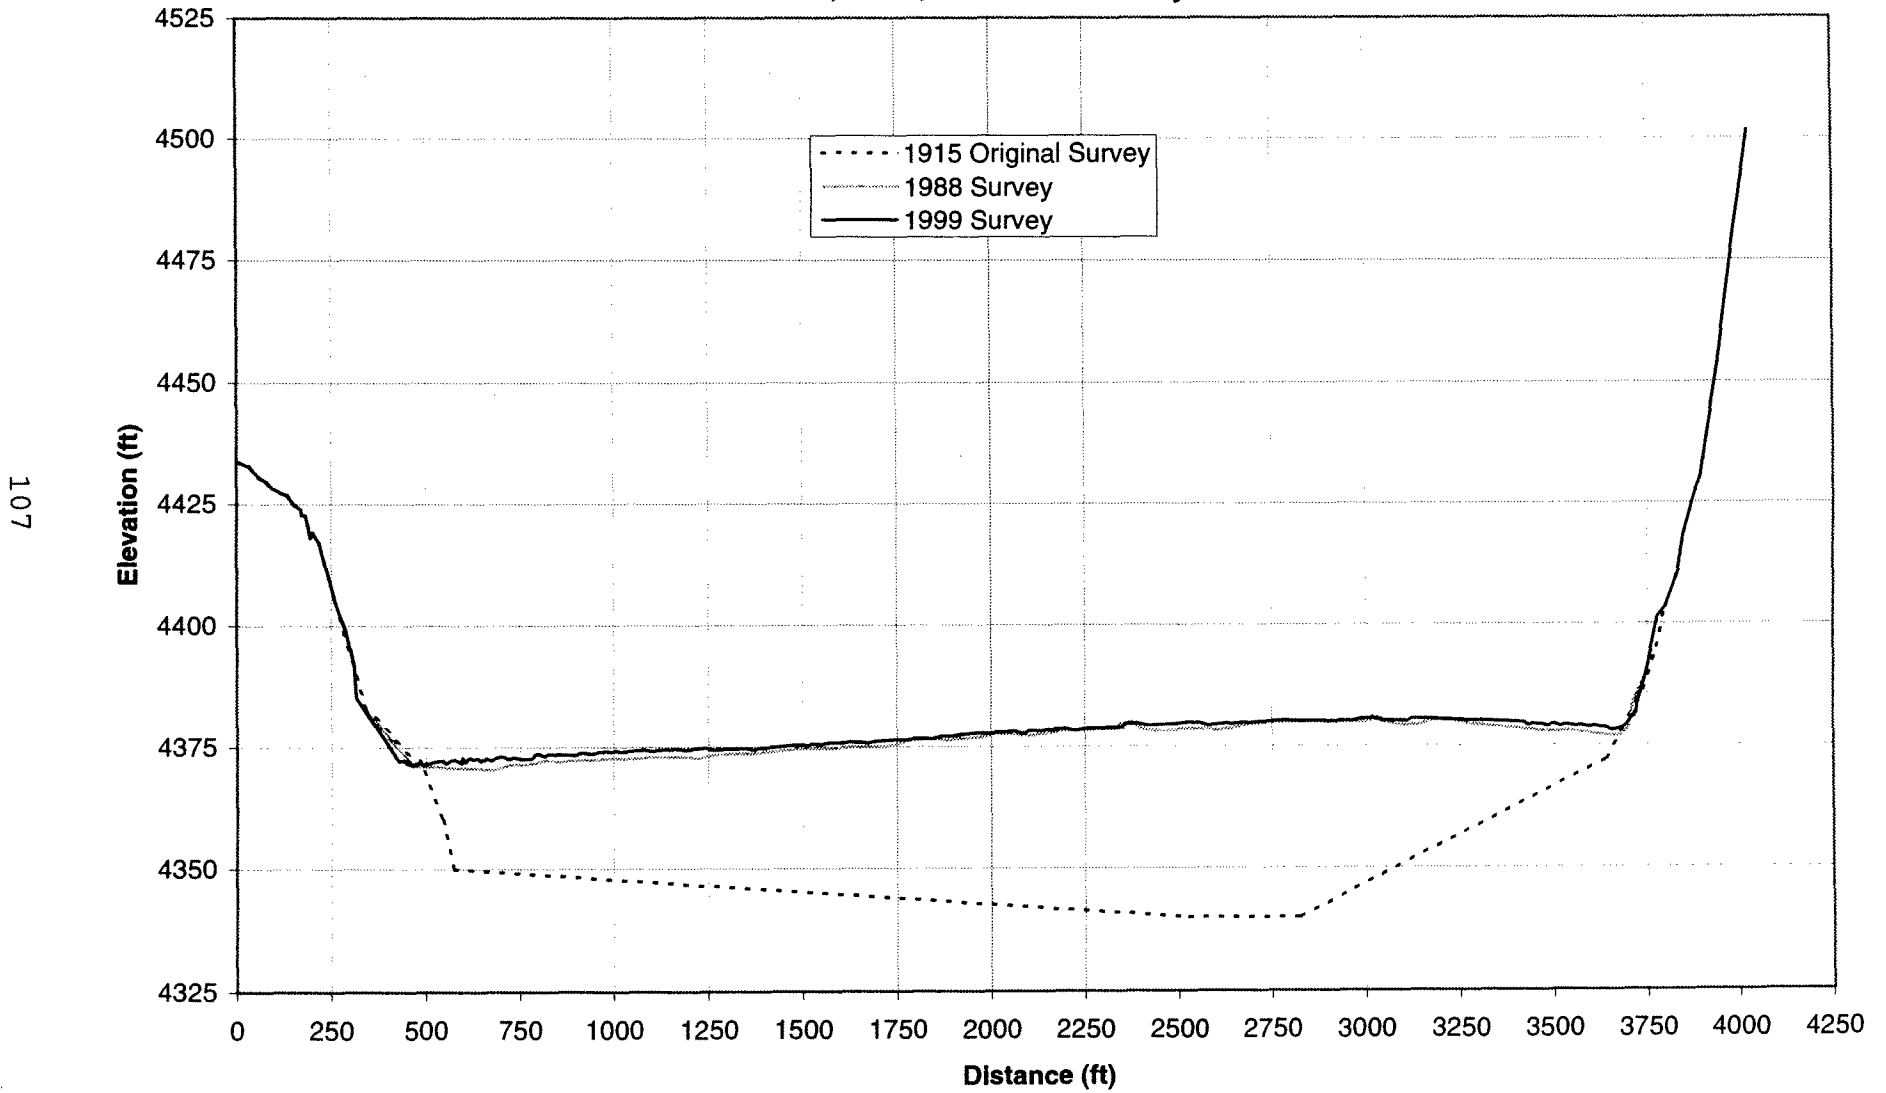
Figure 73. - Sedimentation range profiles for 1915, 1988, and 1999, range 37.

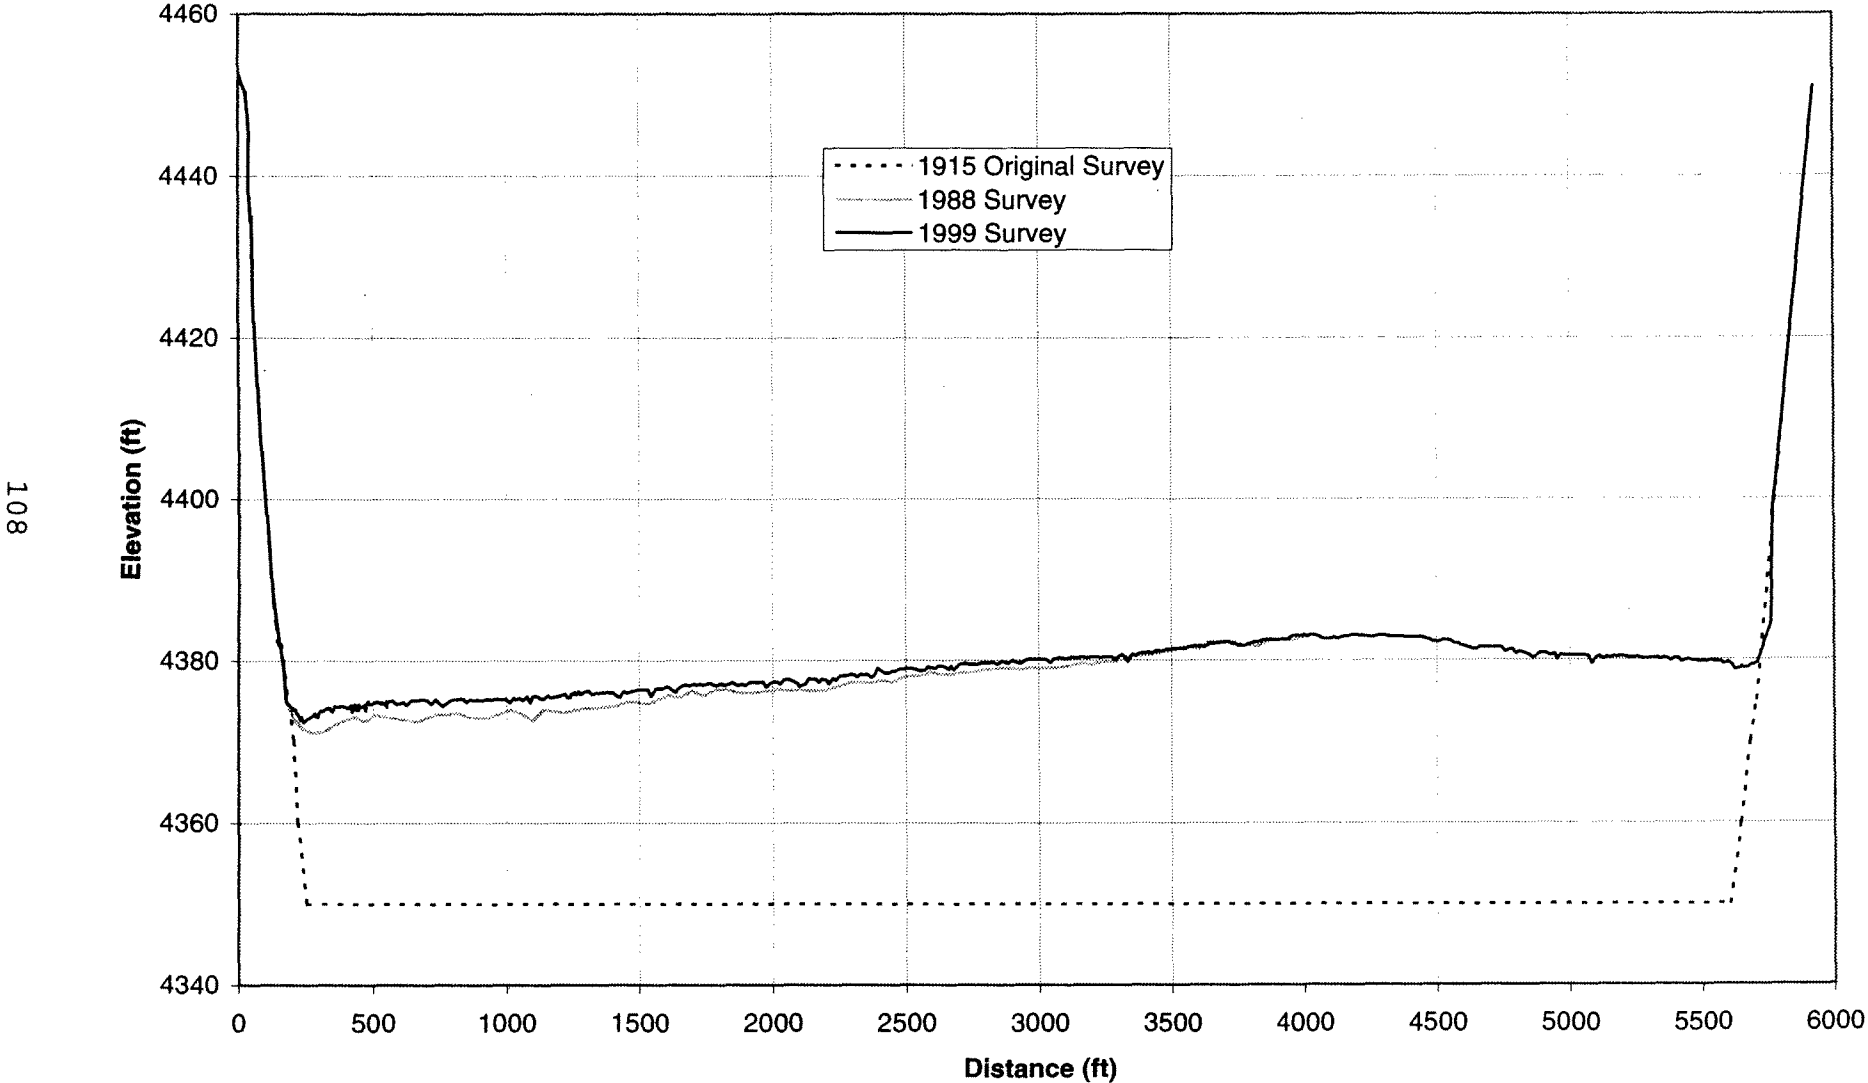
Figure 74. - Sedimentation range profiles for 1915, 1988, and 1999, range 36.

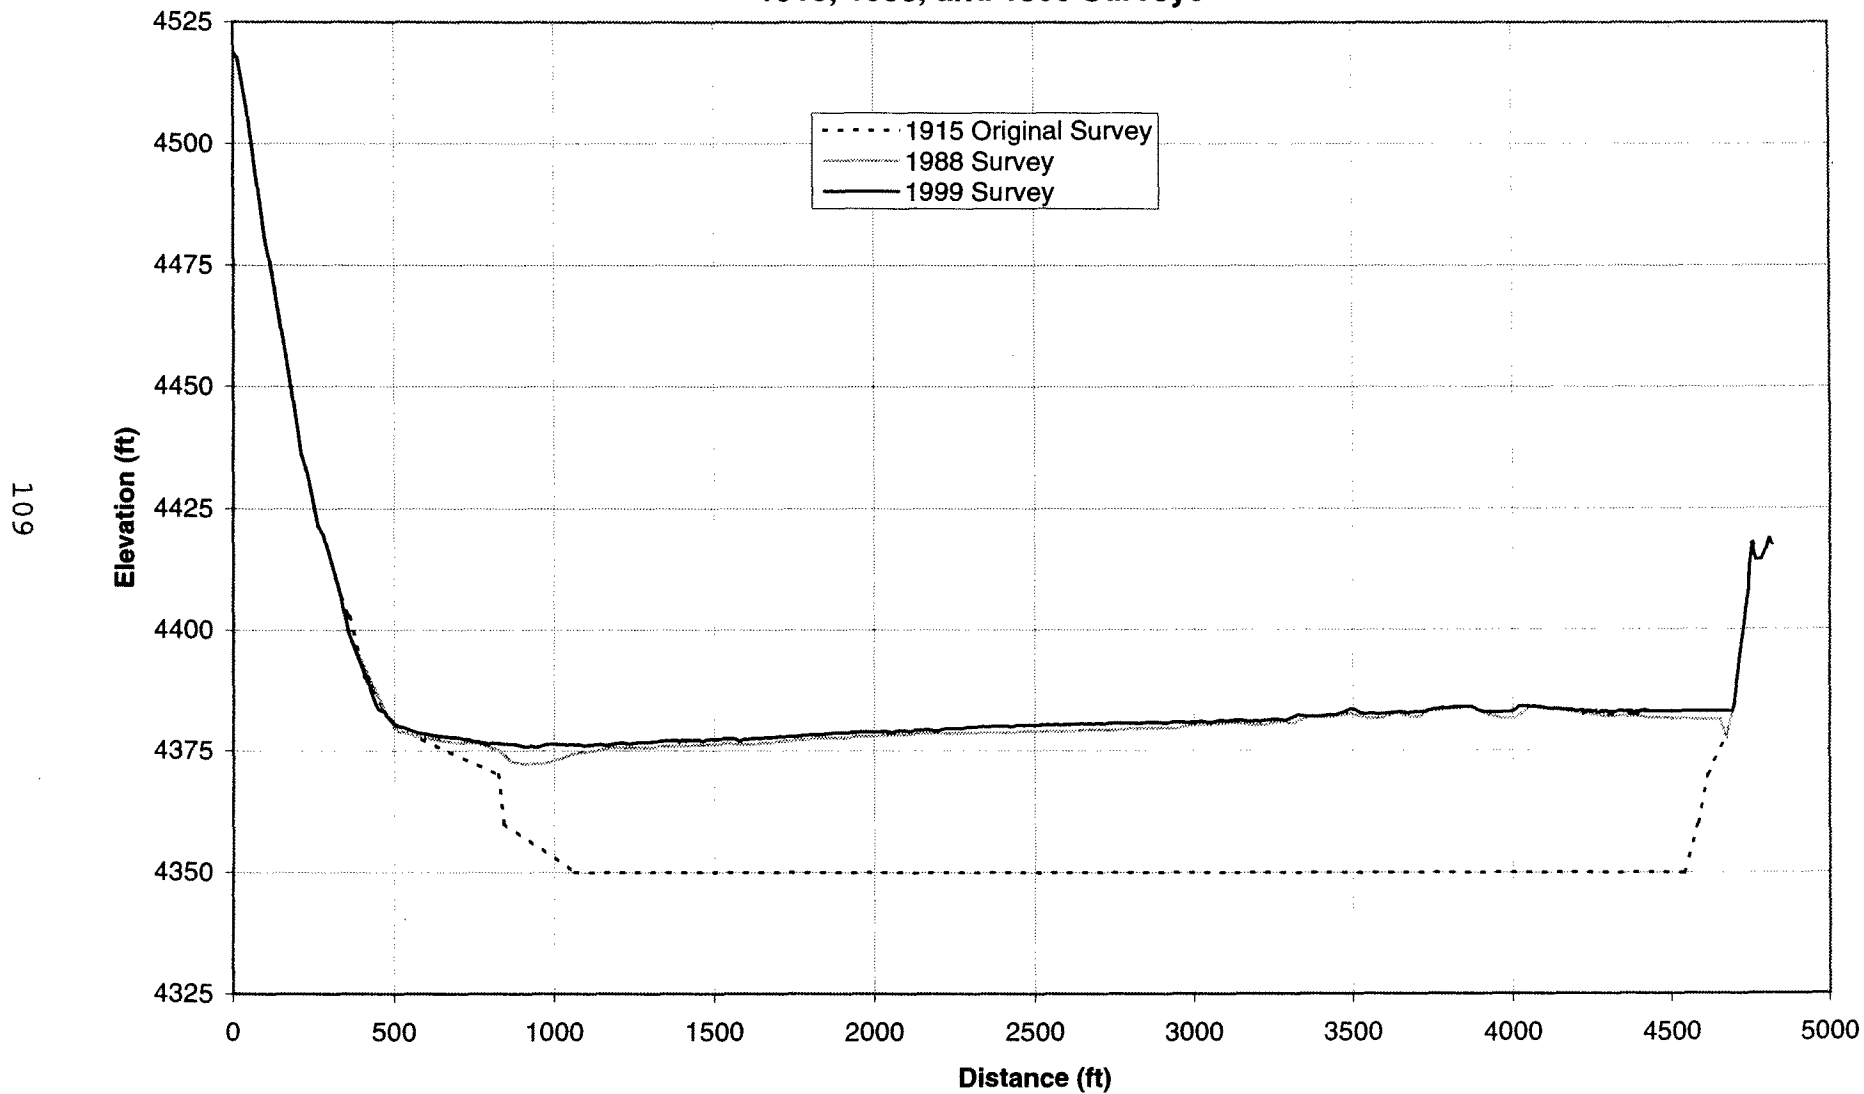
Figure 75. - Sedimentation range profiles for 1915, 1988, and 1999, range 35.
