ELEPHANT BUTTE RESERVOIR

1999 RESERVOIR SURVEY

U.S. Department of the Interior
Bureau of Reclamation

**Sedimentation and River Hydraulics Group
Water Resources Services
Technical Service Center
Denver, Colorado**

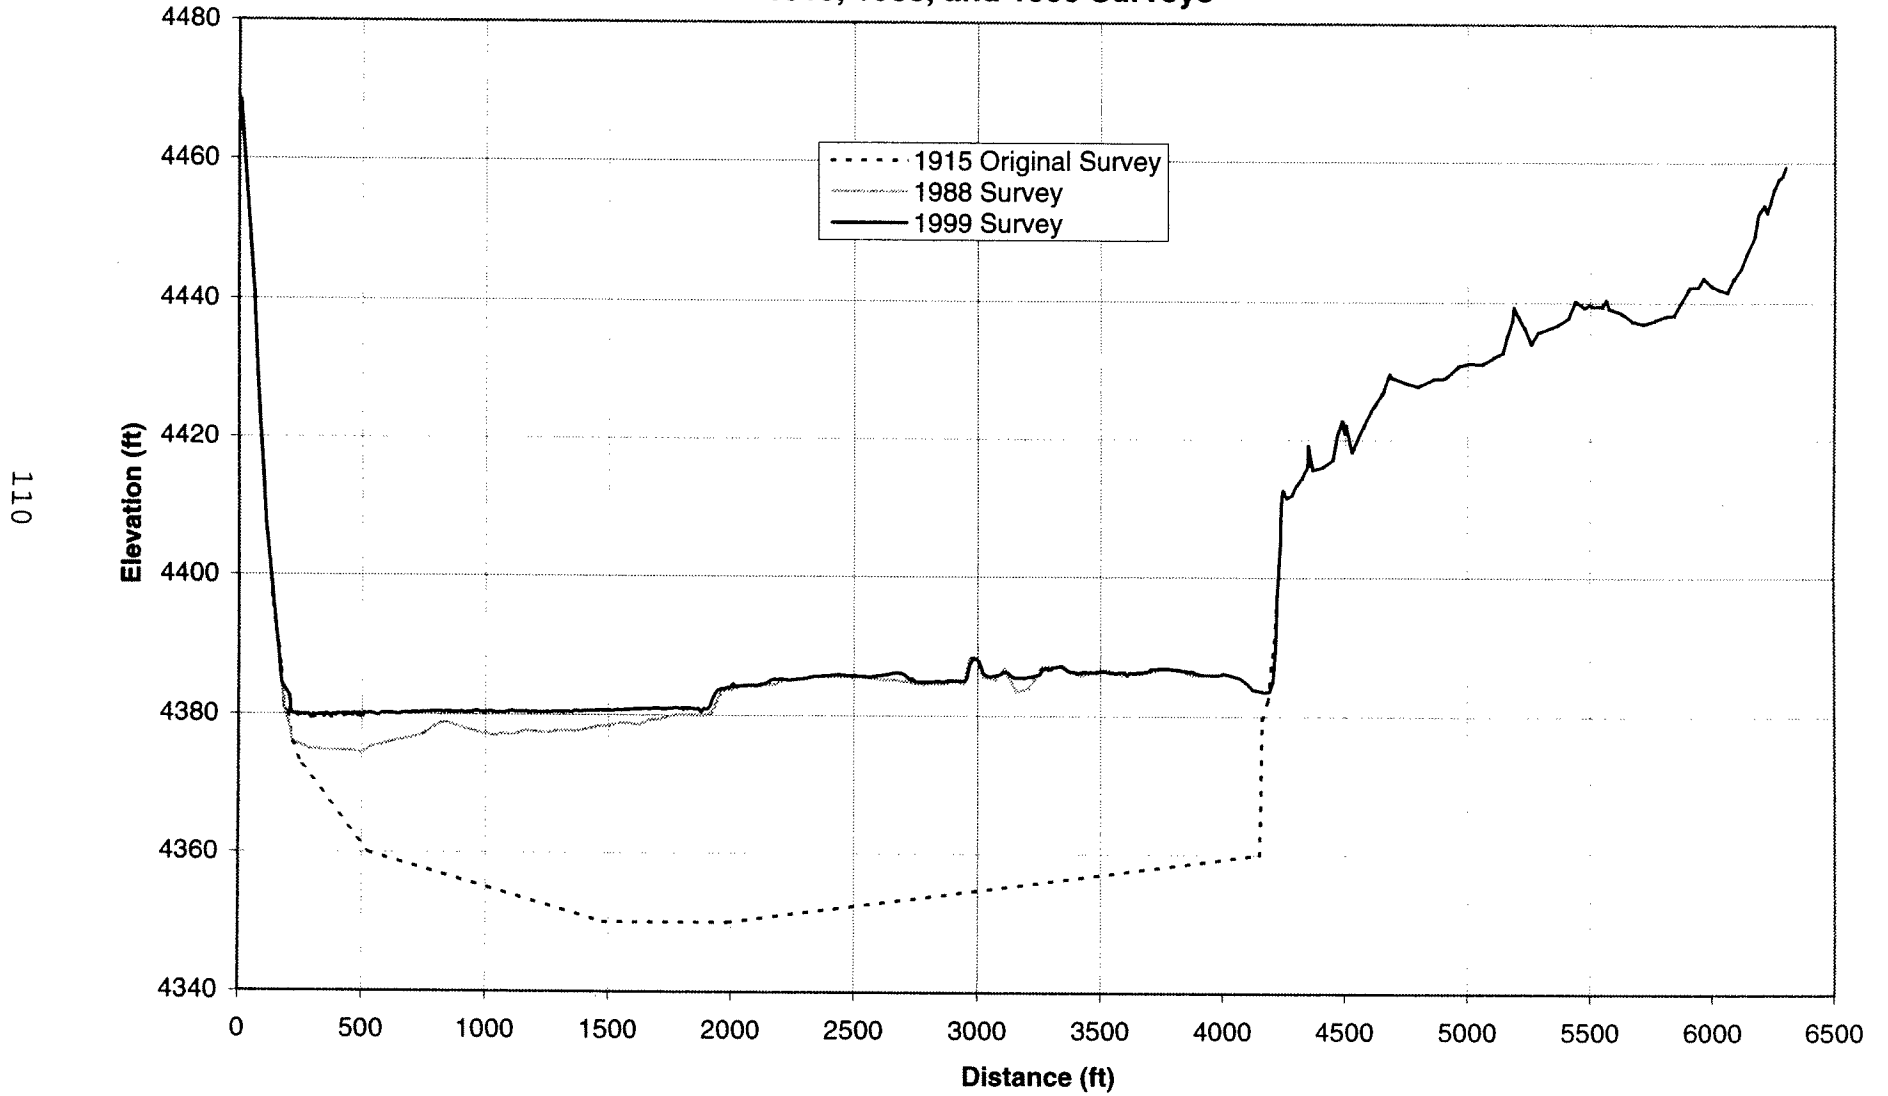
Figure 76. - Sedimentation range profiles for 1915, 1988, and 1999, range 33.

A comparison of the simultaneous plots of original range profiles against the resurveyed range profiles indicates the lateral distribution of the sediment at the measured points. Where these plots indicate changes have occurred on the side slopes of the reservoir, an engineering judgment decision was required to determine whether the change is due to survey inaccuracies or due to actual deposition or erosion. As noted previously the original range line data was scaled from the original 10-foot contour maps.

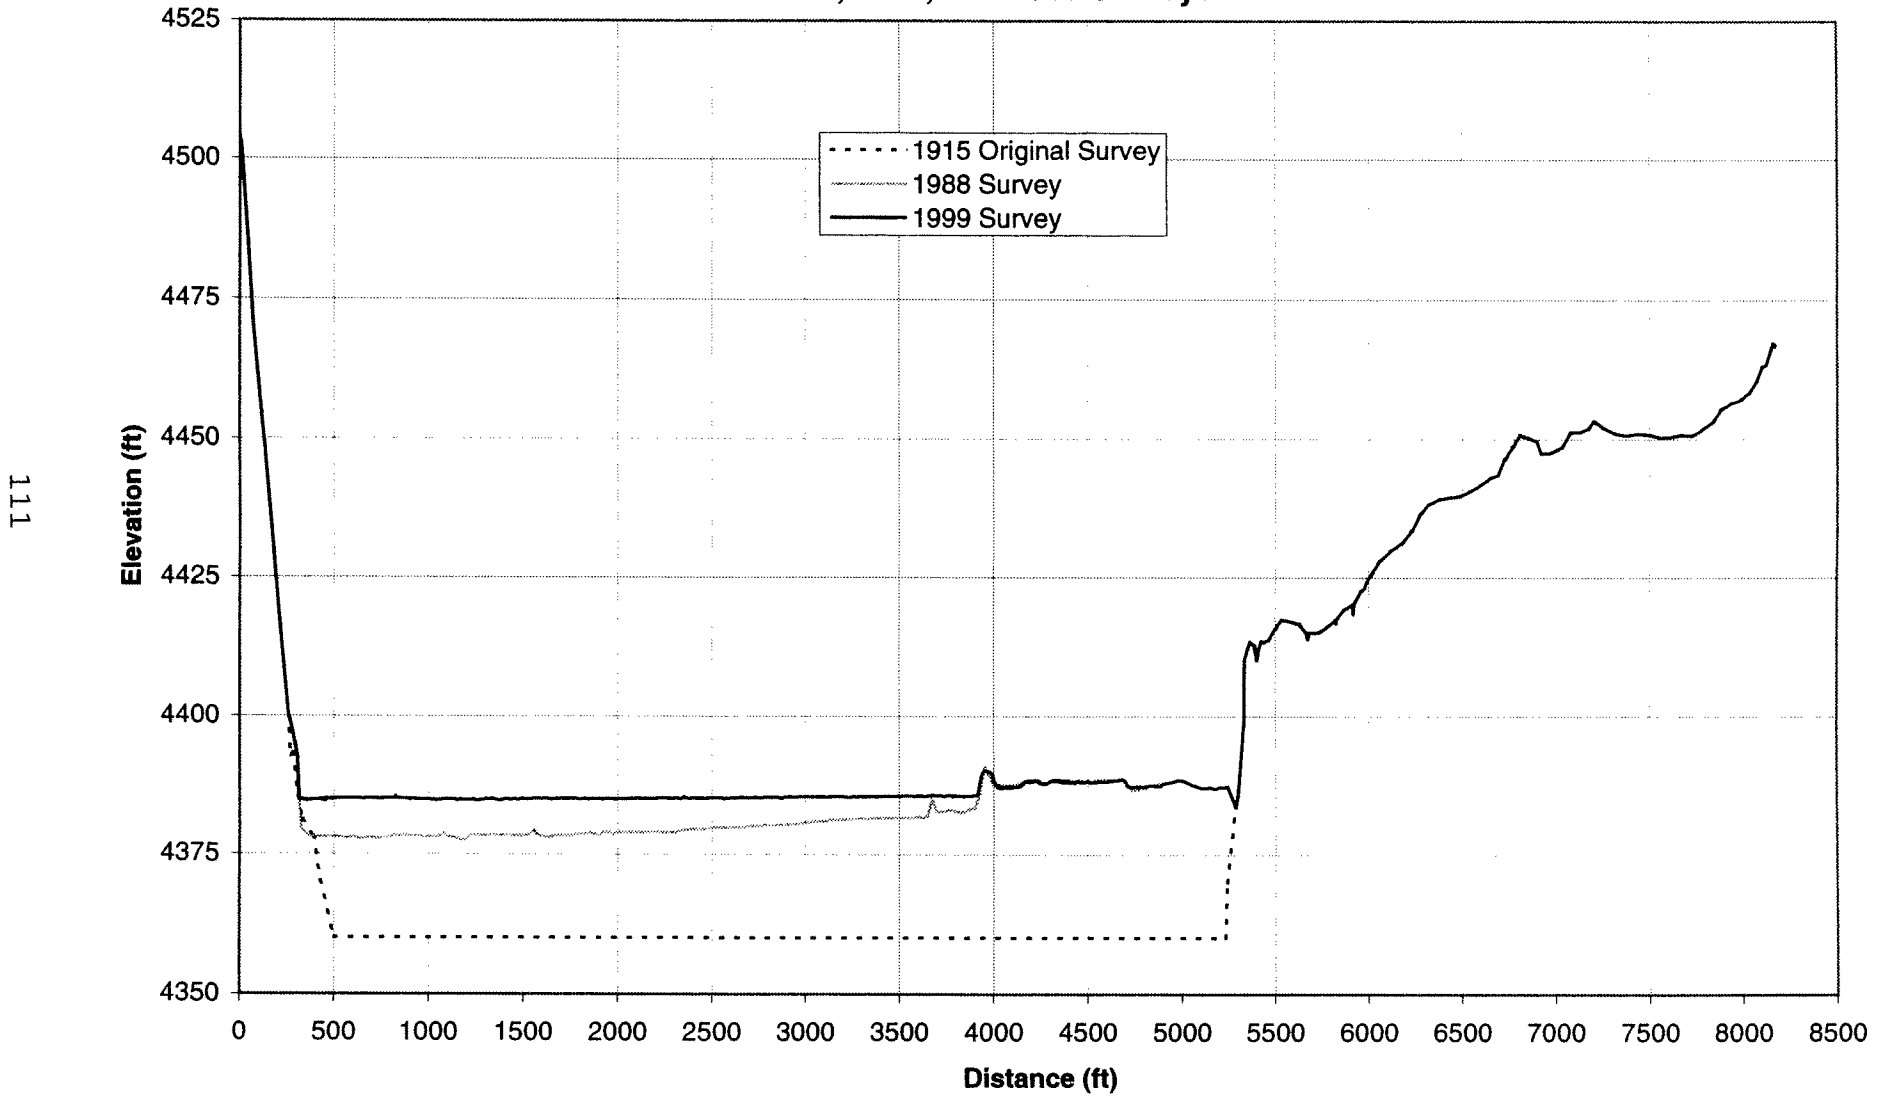
Figure 77. - Sedimentation range profiles for 1915, 1988, and 1999, range 32.

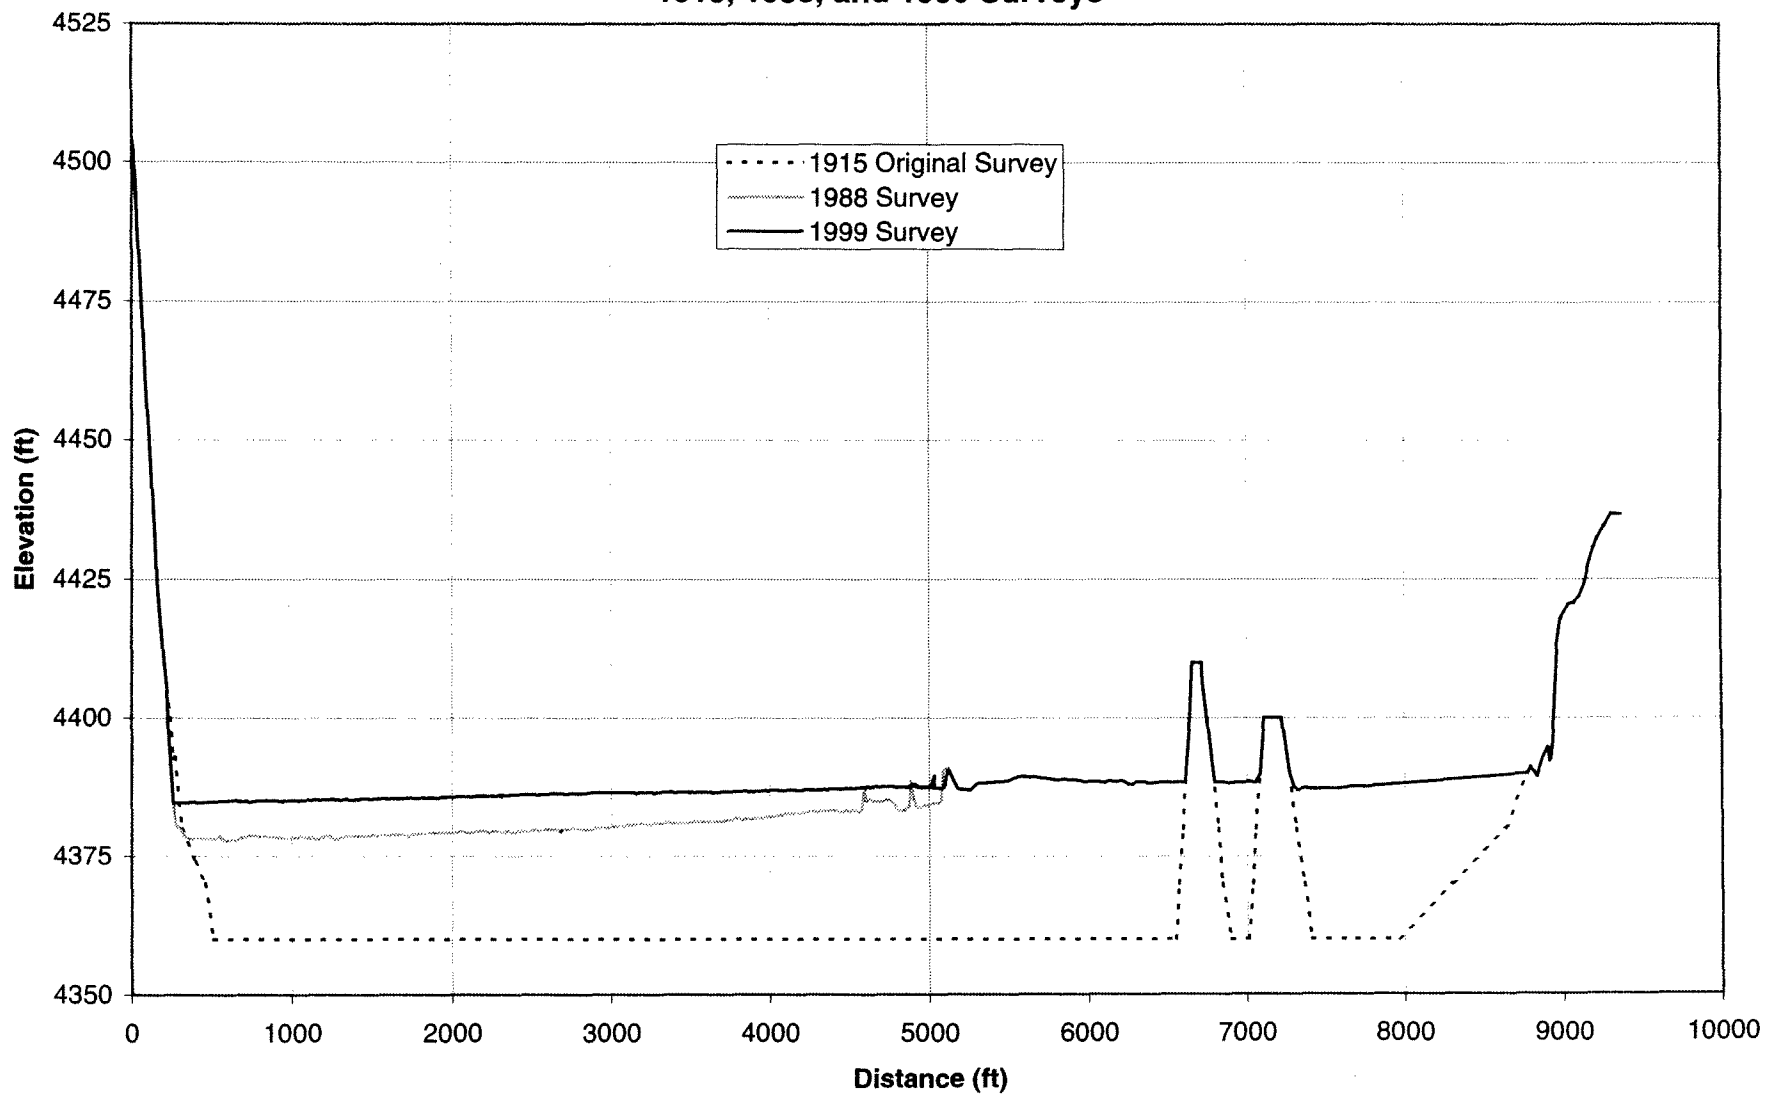
Figure 78. - Sedimentation range profiles for 1915, 1988, and 1999, range 31.

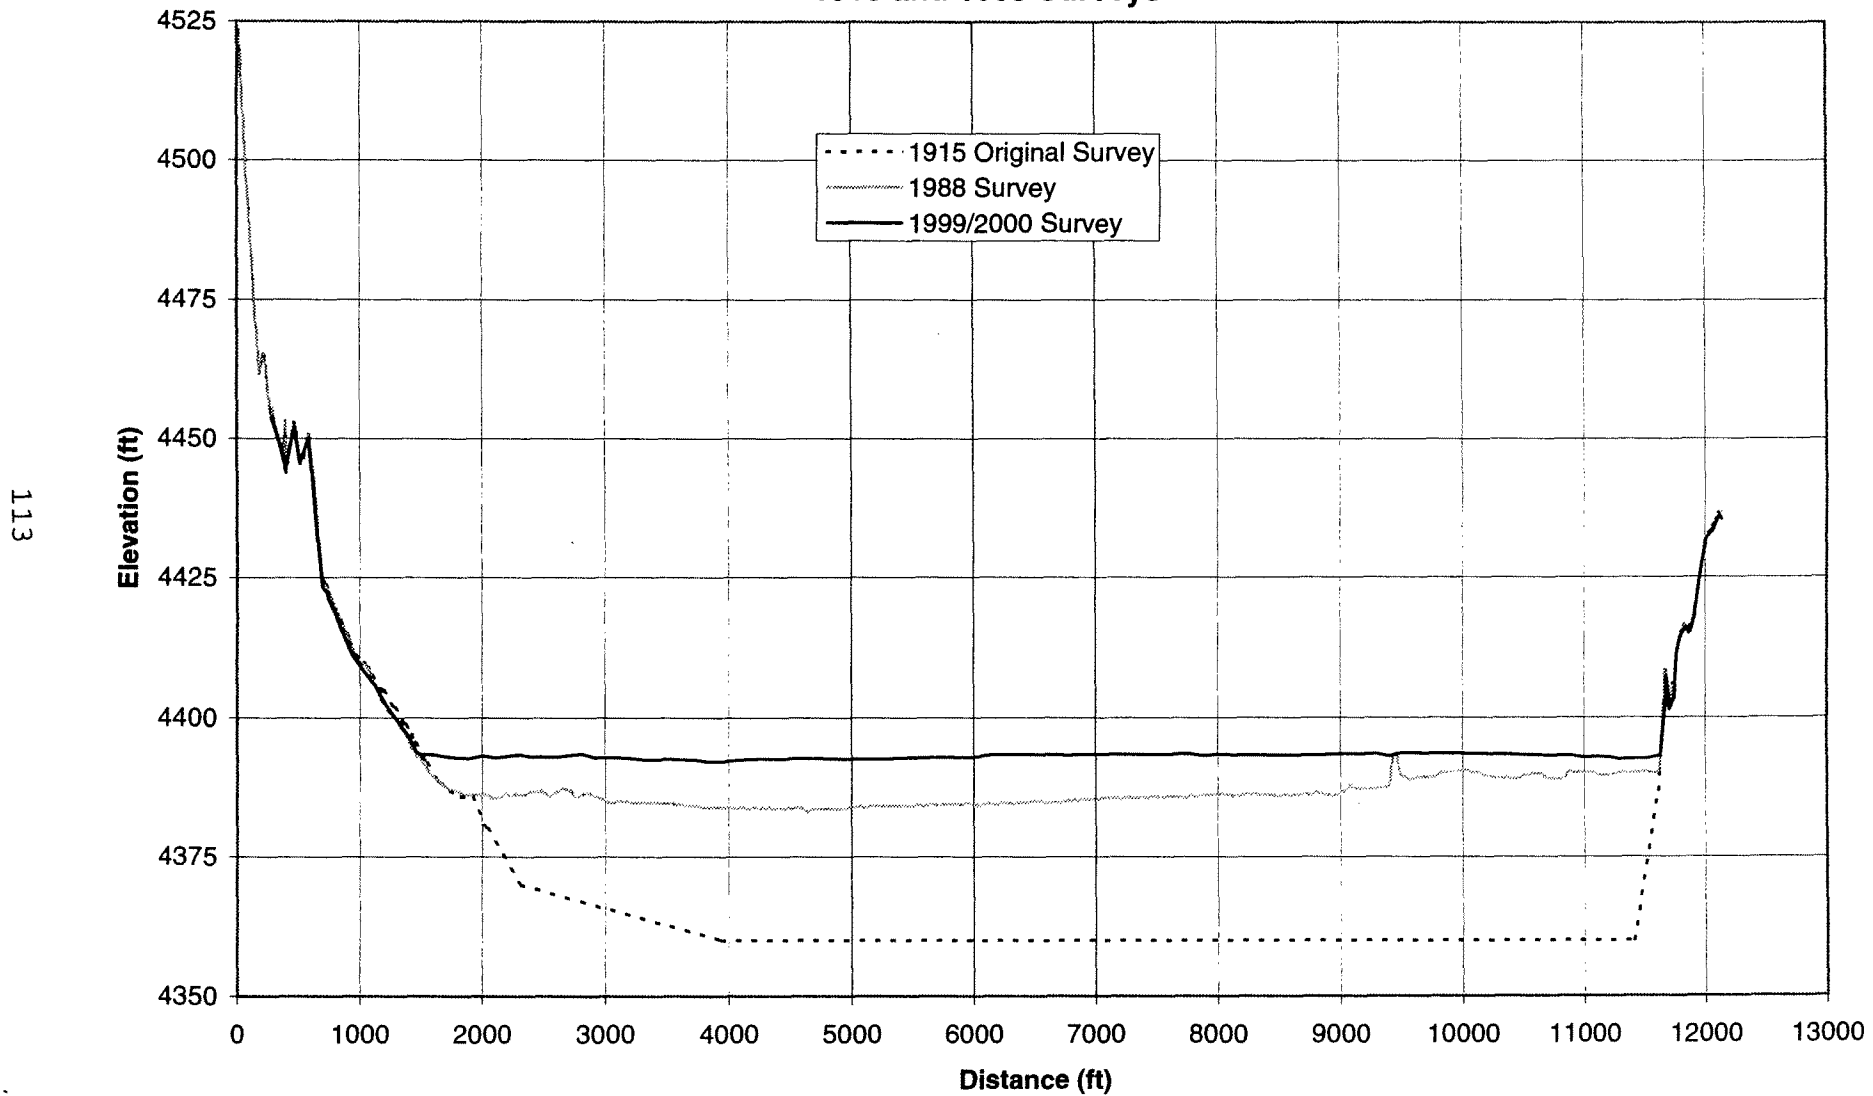
Figure 79. - Sedimentation range profiles for 1915, 1988, and 1999, range 30.

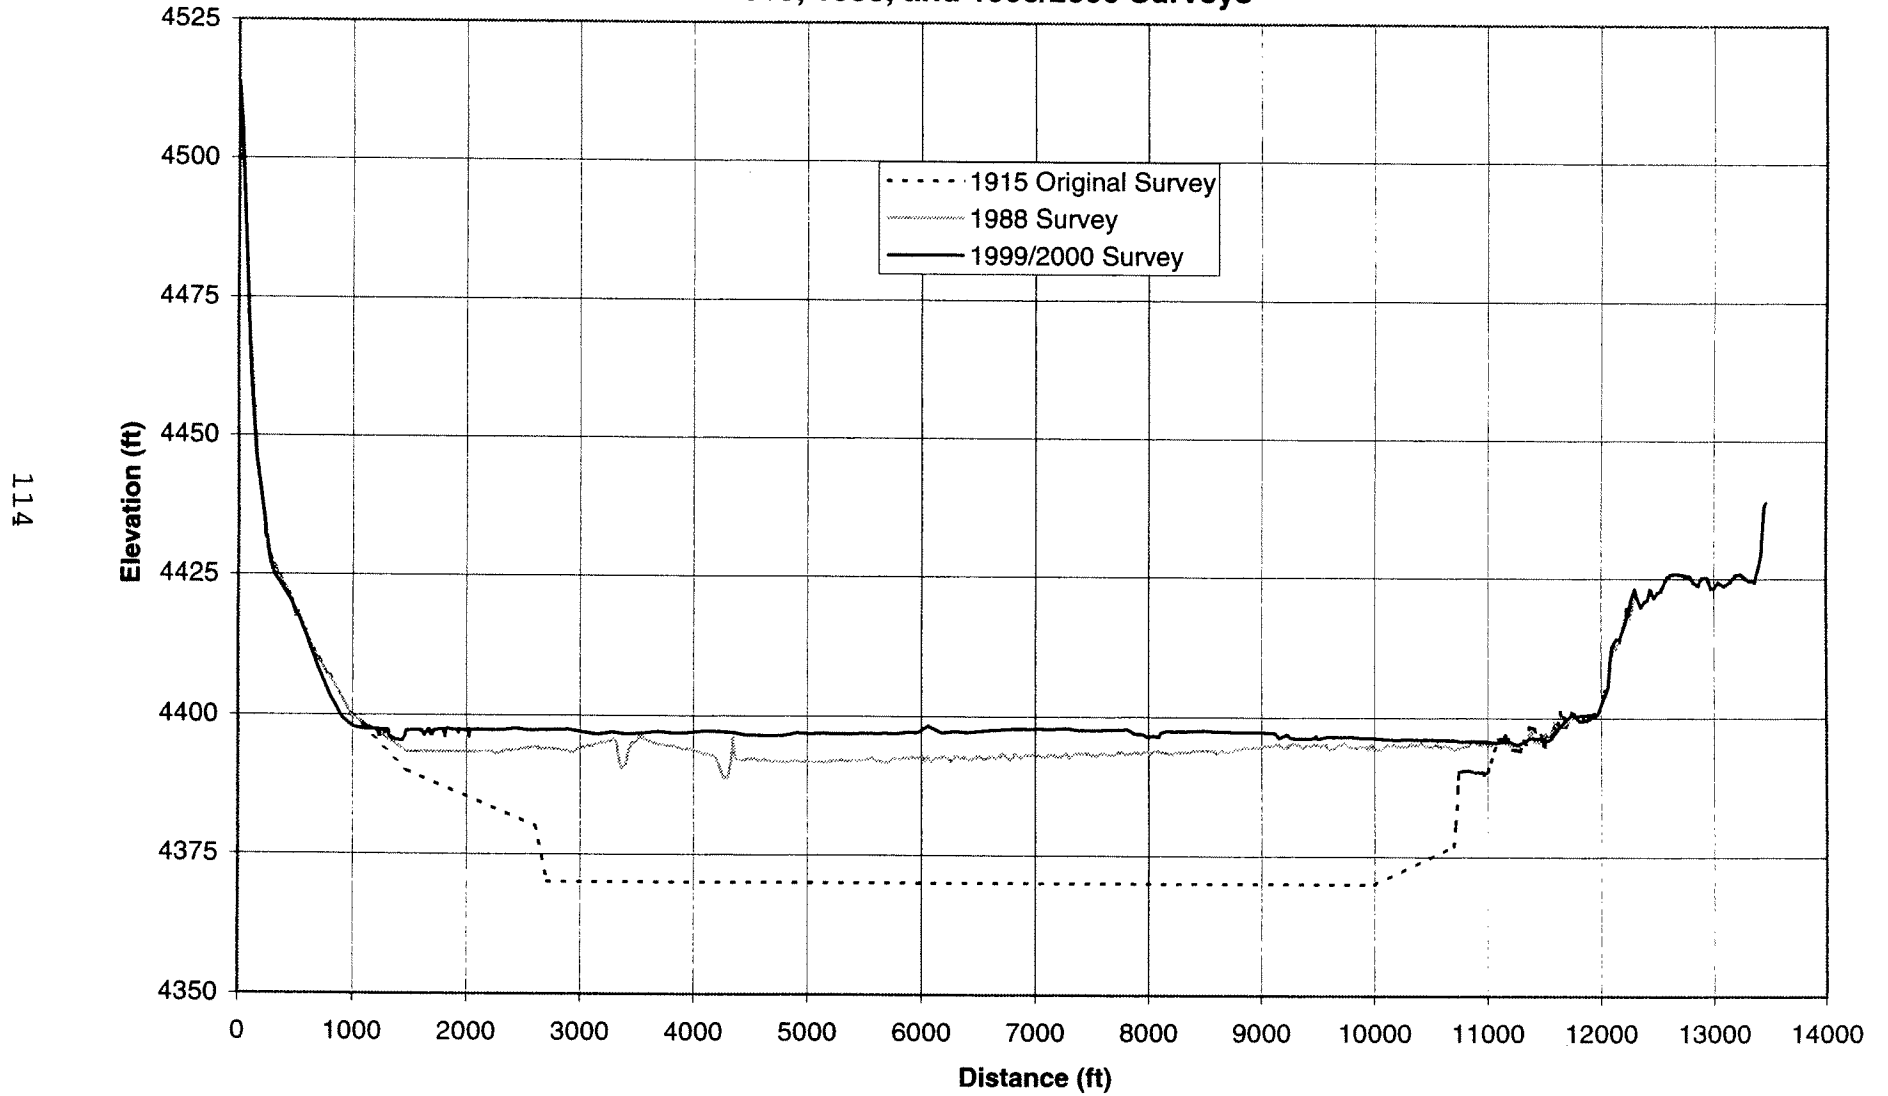
Figure 80. - Sedimentation range profiles for 1915, 1988, and 1999, range 29.

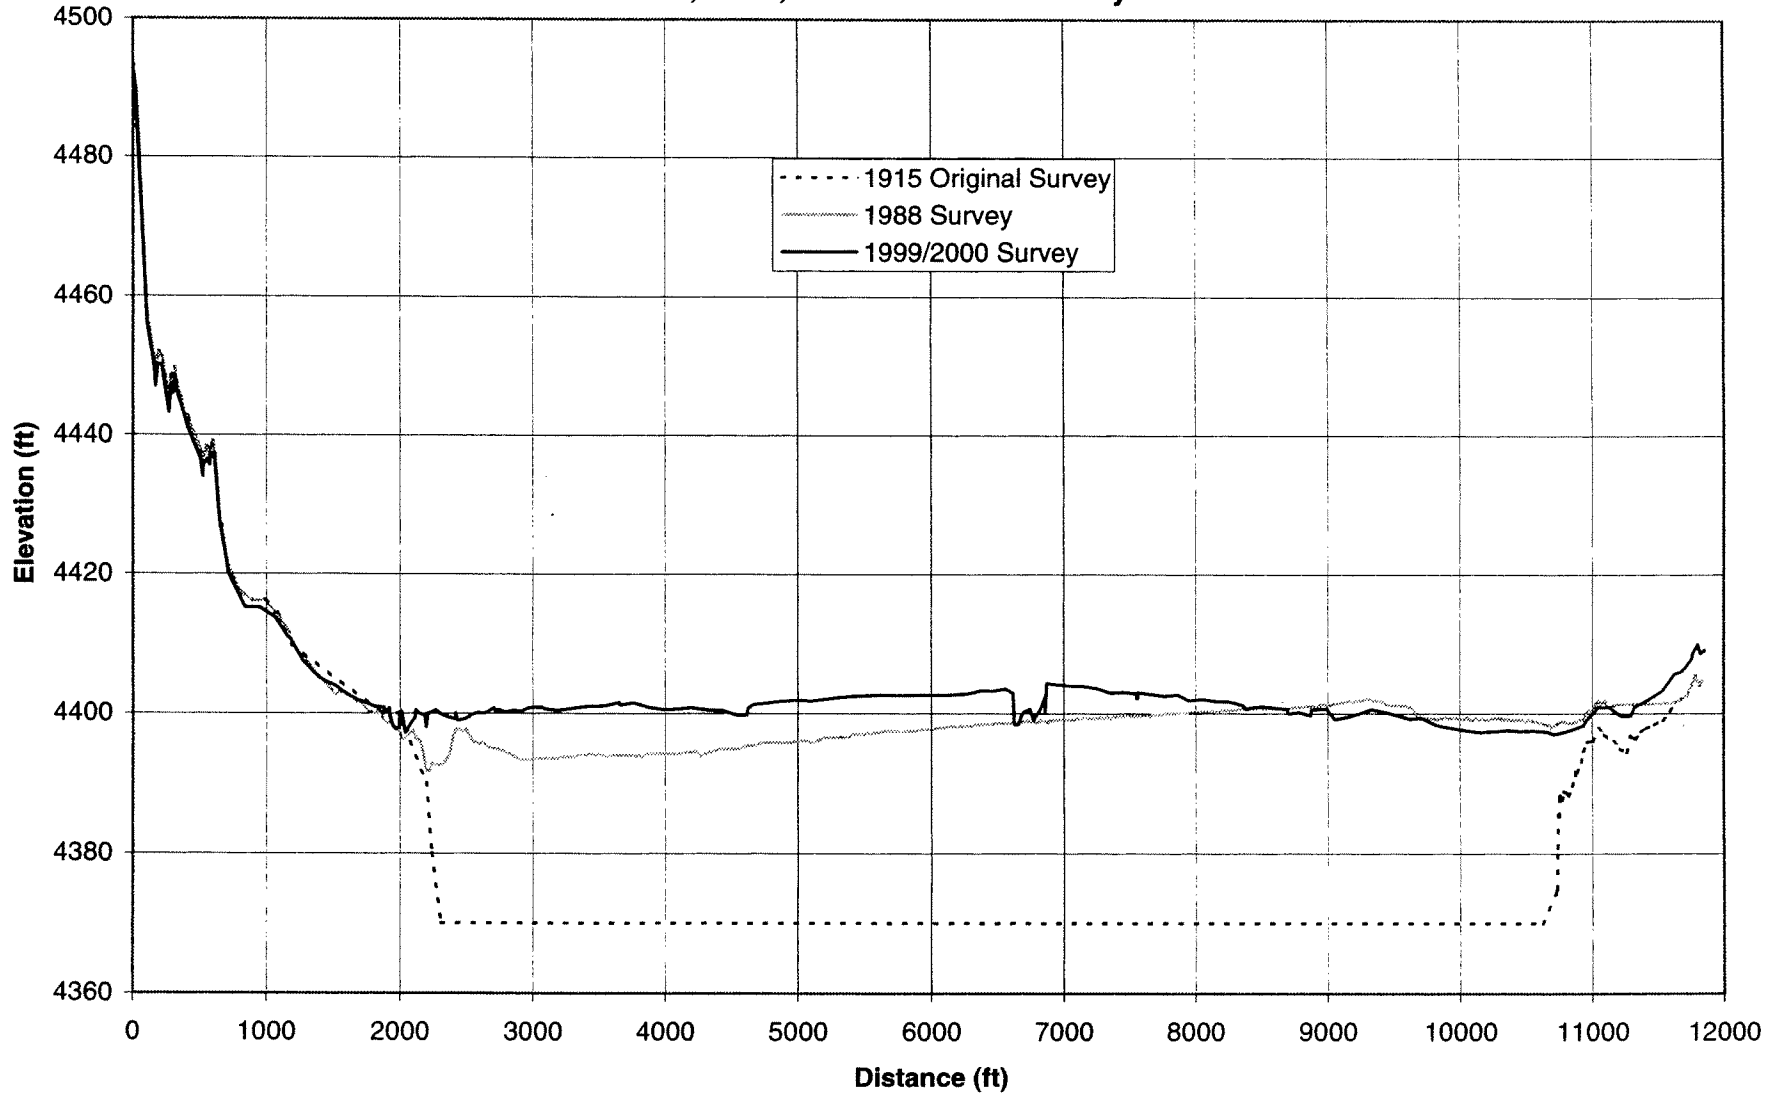
Figure 81. - Sedimentation range profiles for 1915, 1988, and 1999, range 28.

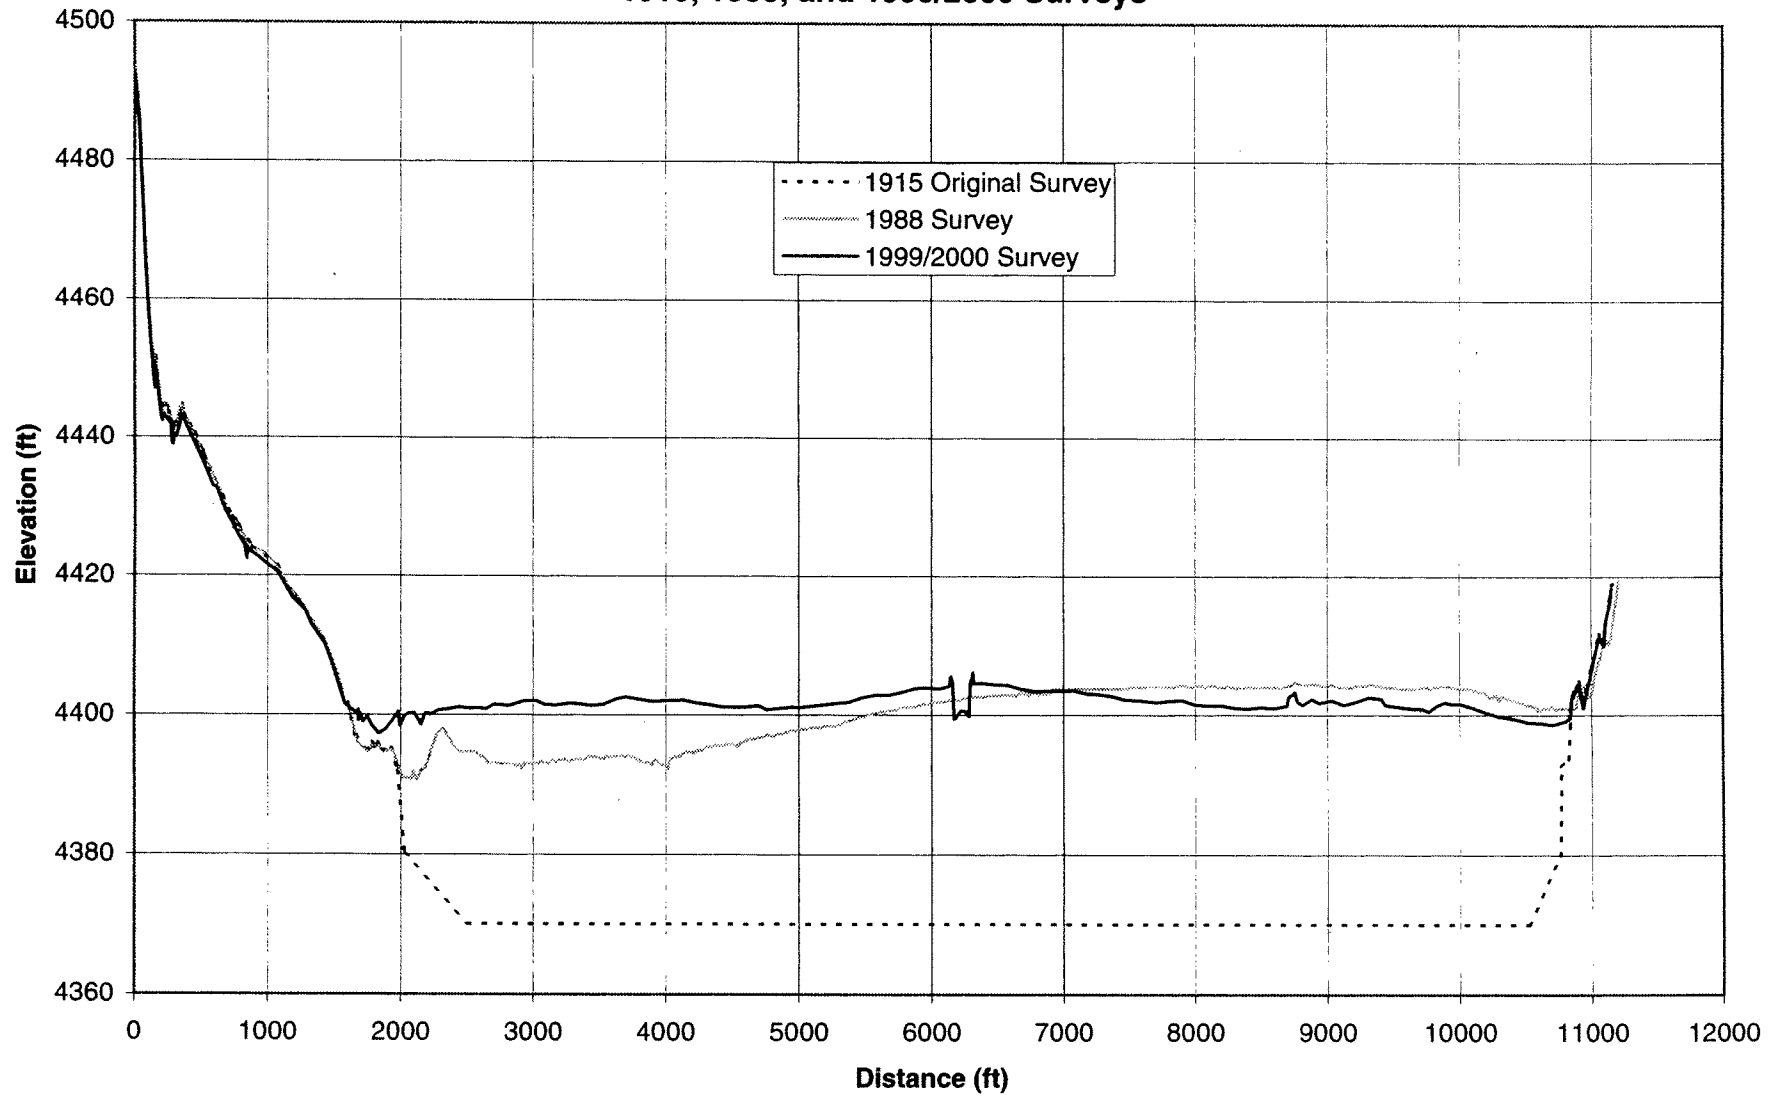
Figure 82. - Sedimentation range profiles for 1915, 1988, and 1999, range 27.

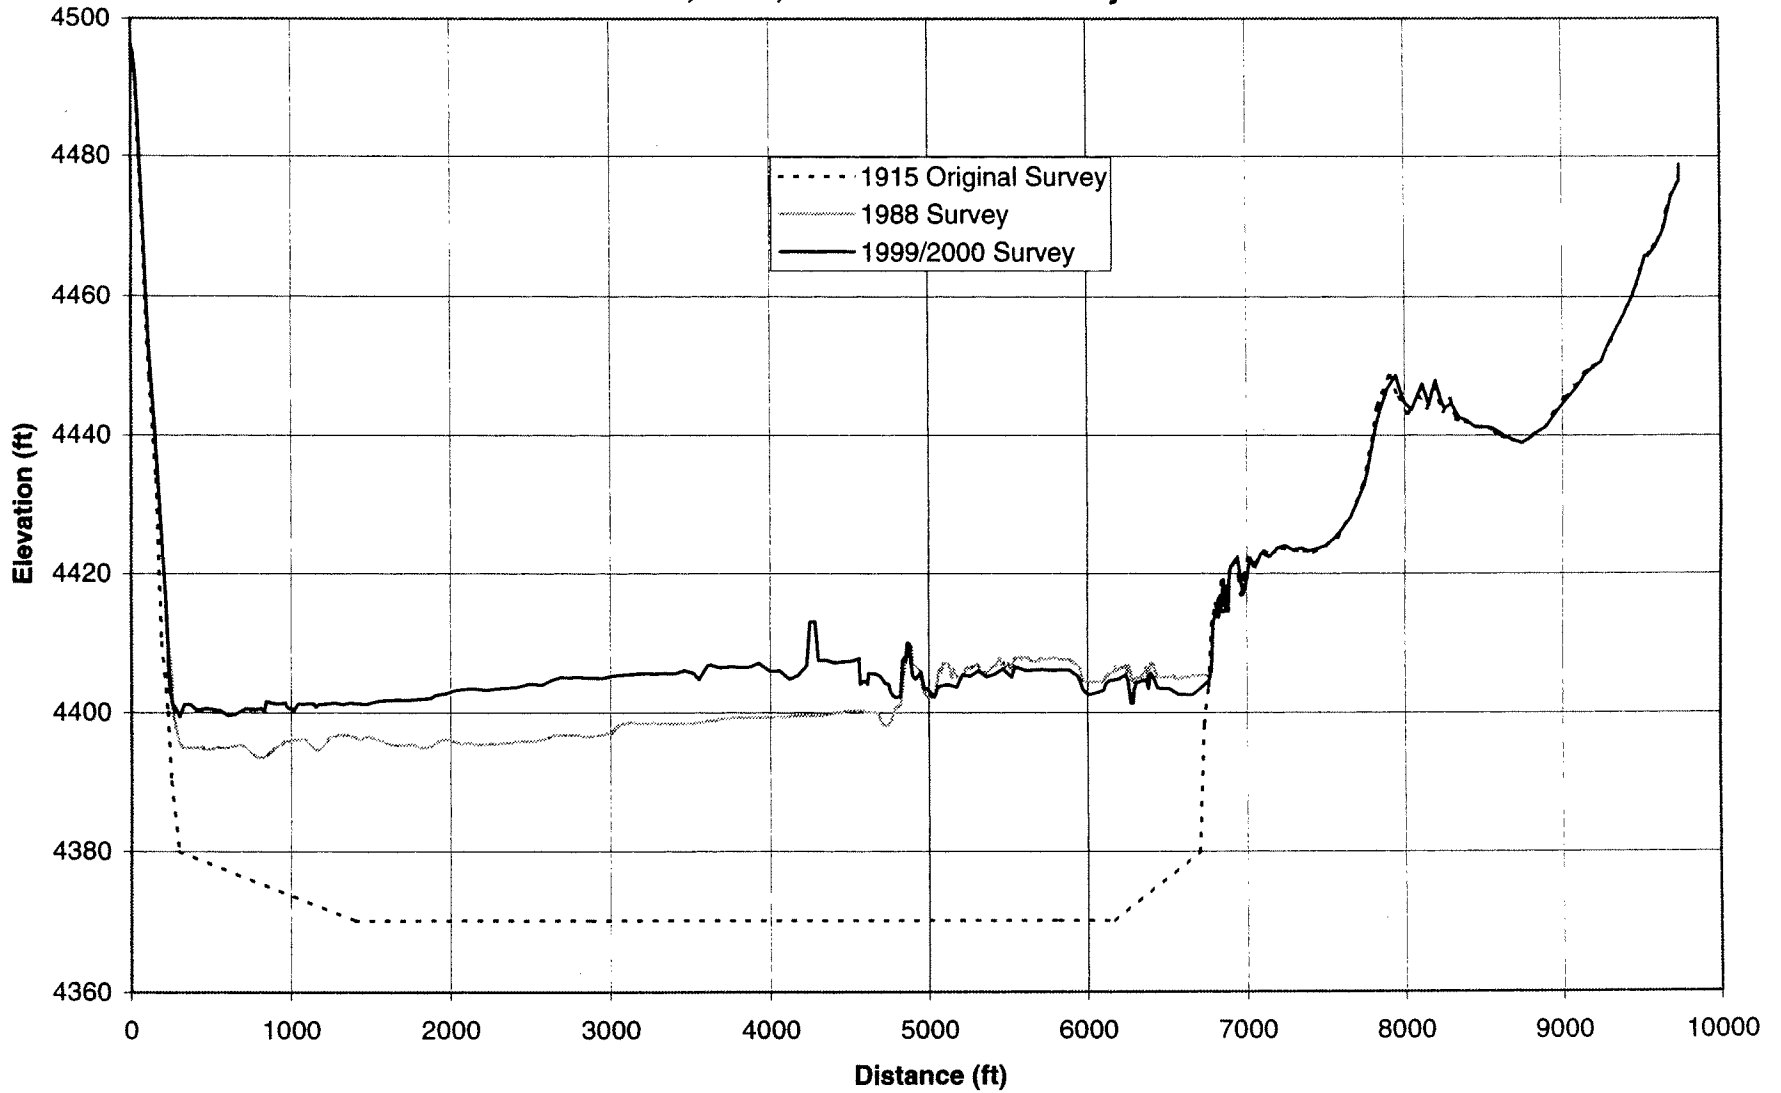
Figure 83. - Sedimentation range profiles for 1915, 1988, and 1999, range 26.

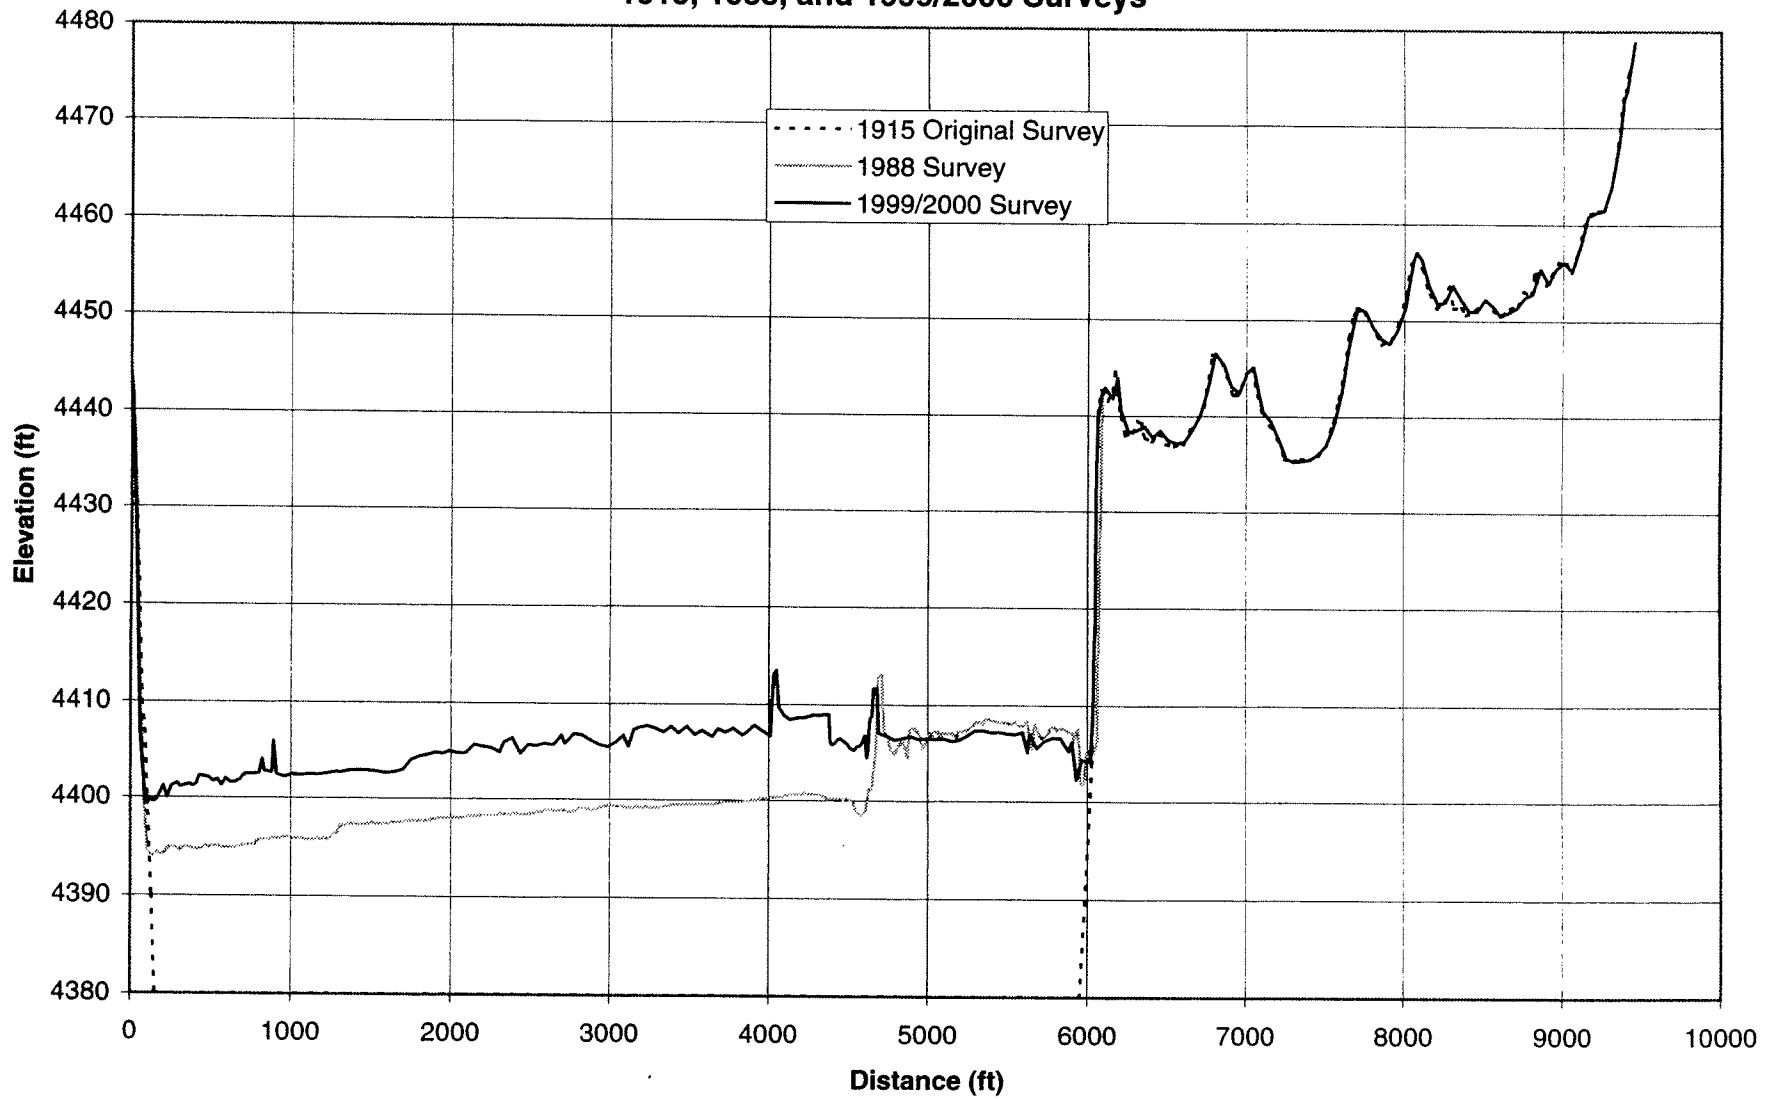
Figure 84. - Sedimentation range profiles for 1915, 1988, and 1999, range 25.

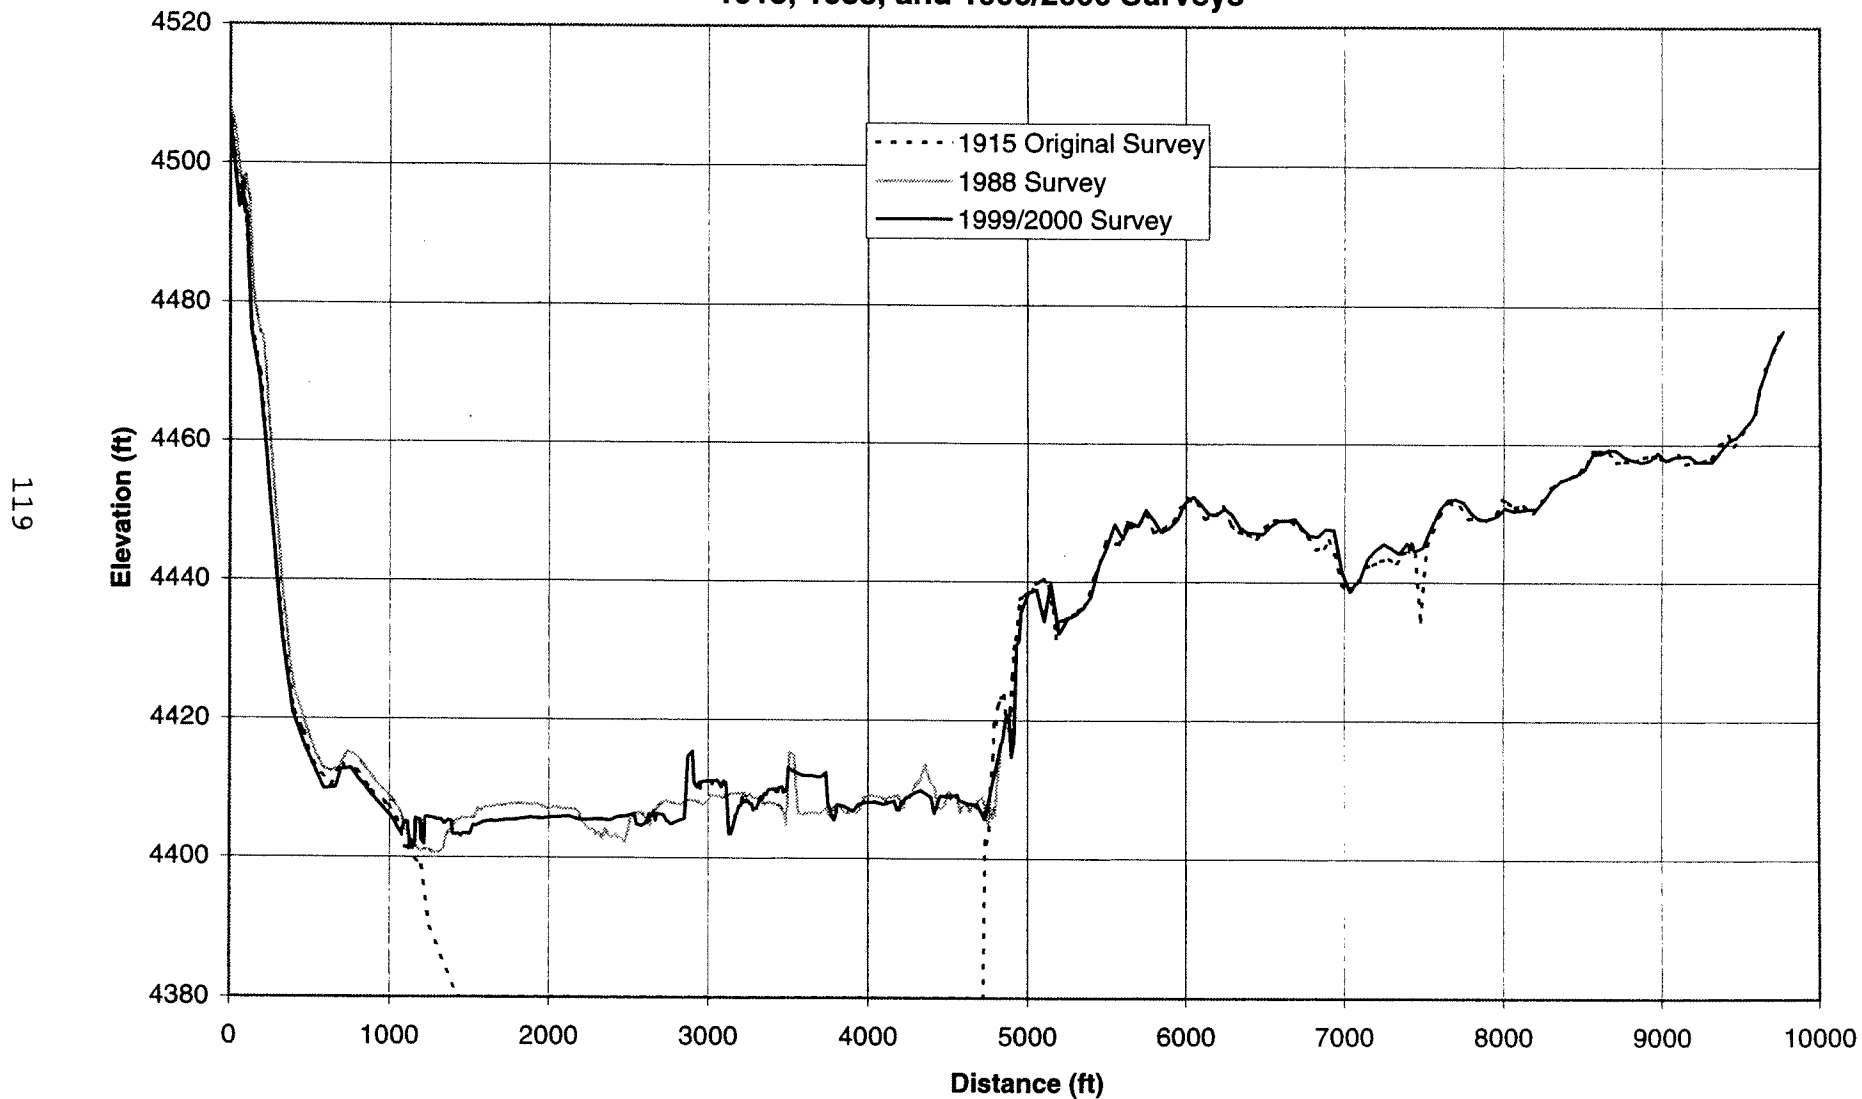
Figure 85. - Sedimentation range profiles for 1915, 1988, and 1999, range 24.

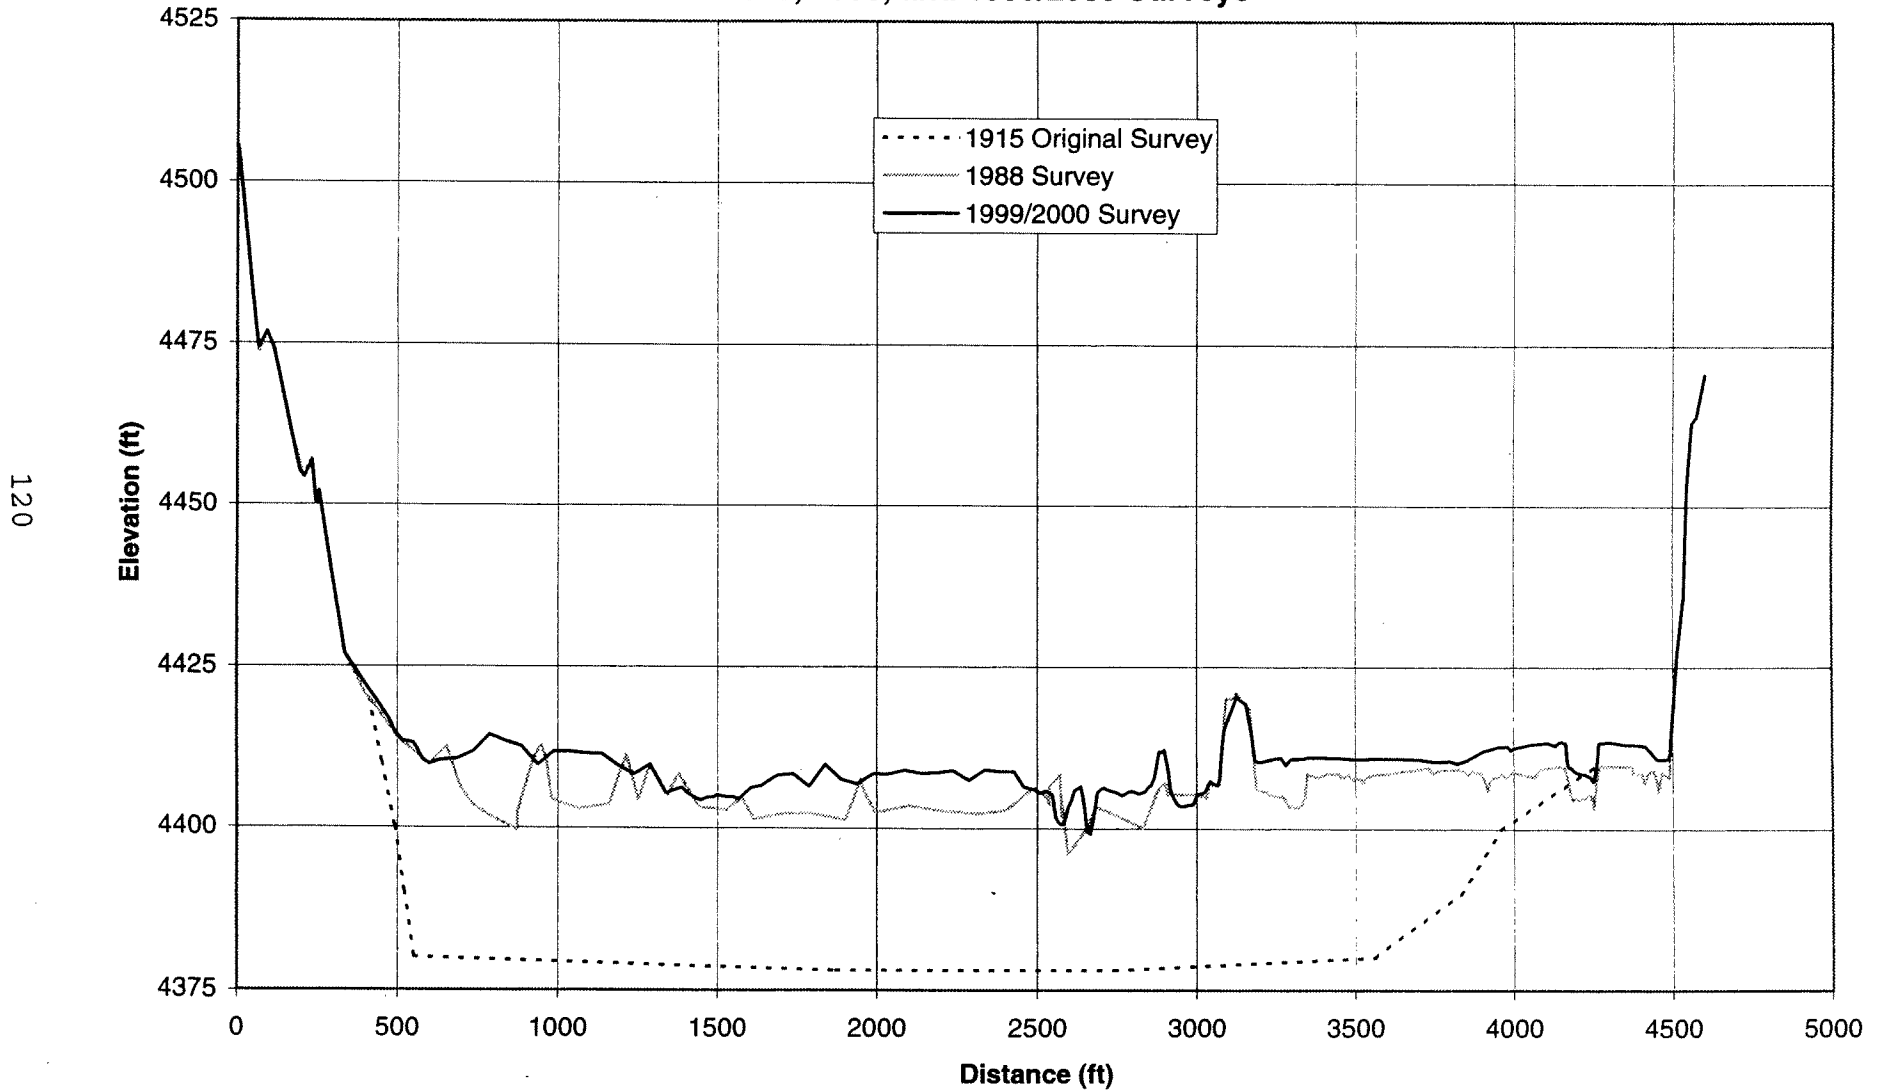
Figure 86. - Sedimentation range profiles for 1915, 1988, and 1999, range 23.
