ELEPHANT BUTTE RESERVOIR

1999 RESERVOIR SURVEY

U.S. Department of the Interior
Bureau of Reclamation

**Sedimentation and River Hydraulics Group
Water Resources Services
Technical Service Center
Denver, Colorado**

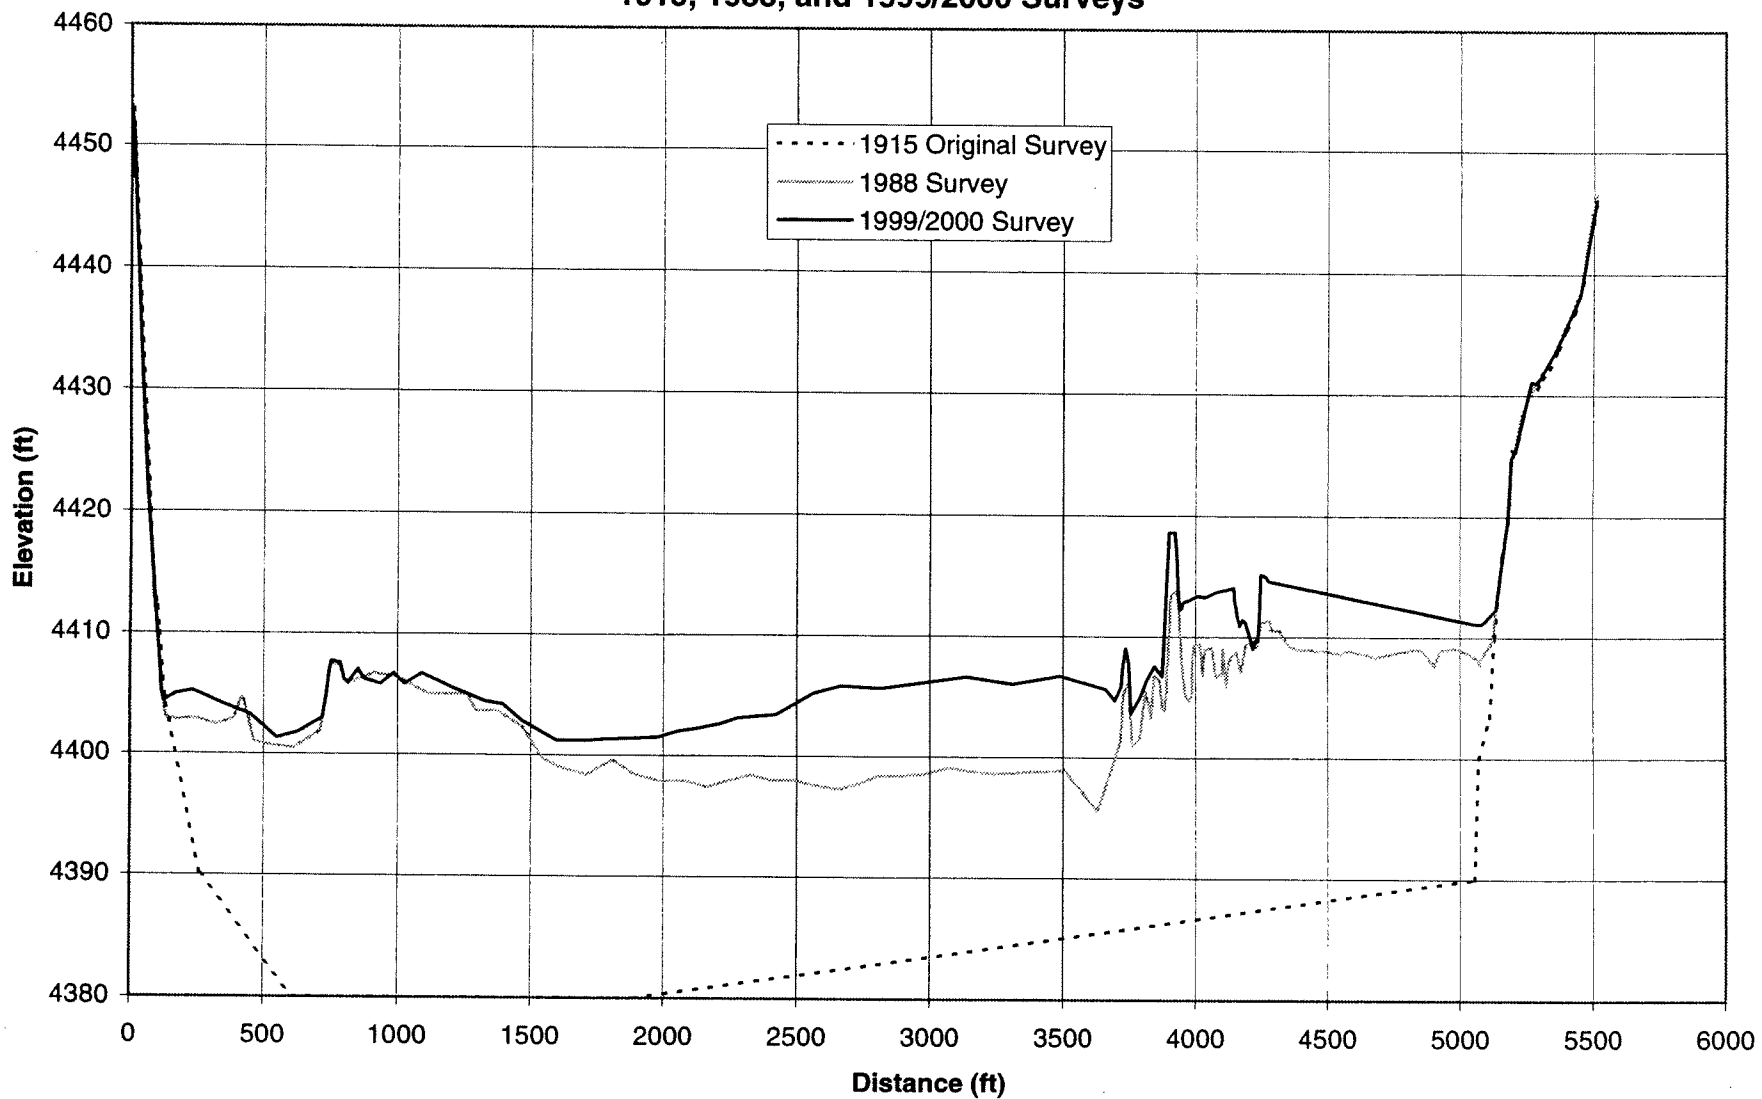
Figure 88. - Sedimentation range profiles for 1915, 1988, and 1999, range 22.

A comparison of the simultaneous plots of original range profiles against the resurveyed range profiles indicates the lateral distribution of the sediment at the measured points. Where these plots indicate changes have occurred on the side slopes of the reservoir, an engineering judgment decision was required to determine whether the change is due to survey inaccuracies or due to actual deposition or erosion. As noted previously the original range line data was scaled from the original 10-foot contour maps.

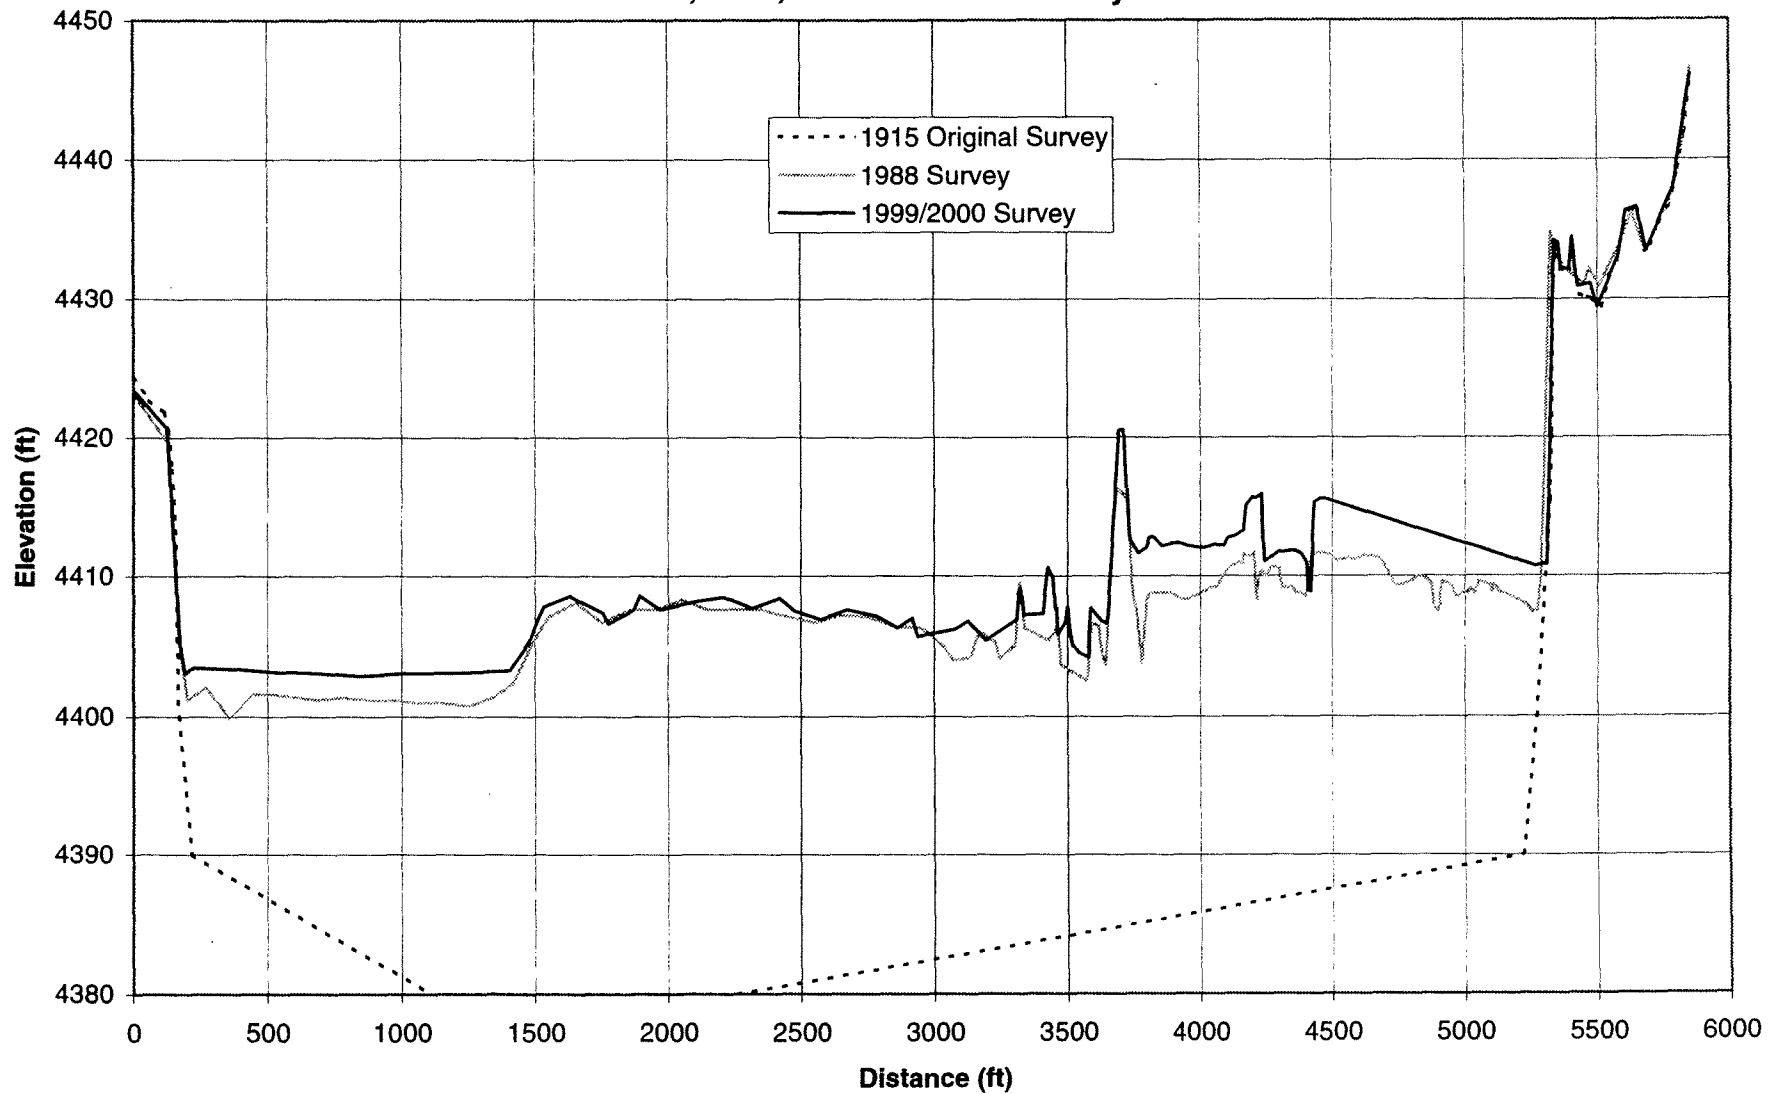
Figure 89. - Sedimentation range profiles for 1915, 1988, and 1999, range 21.

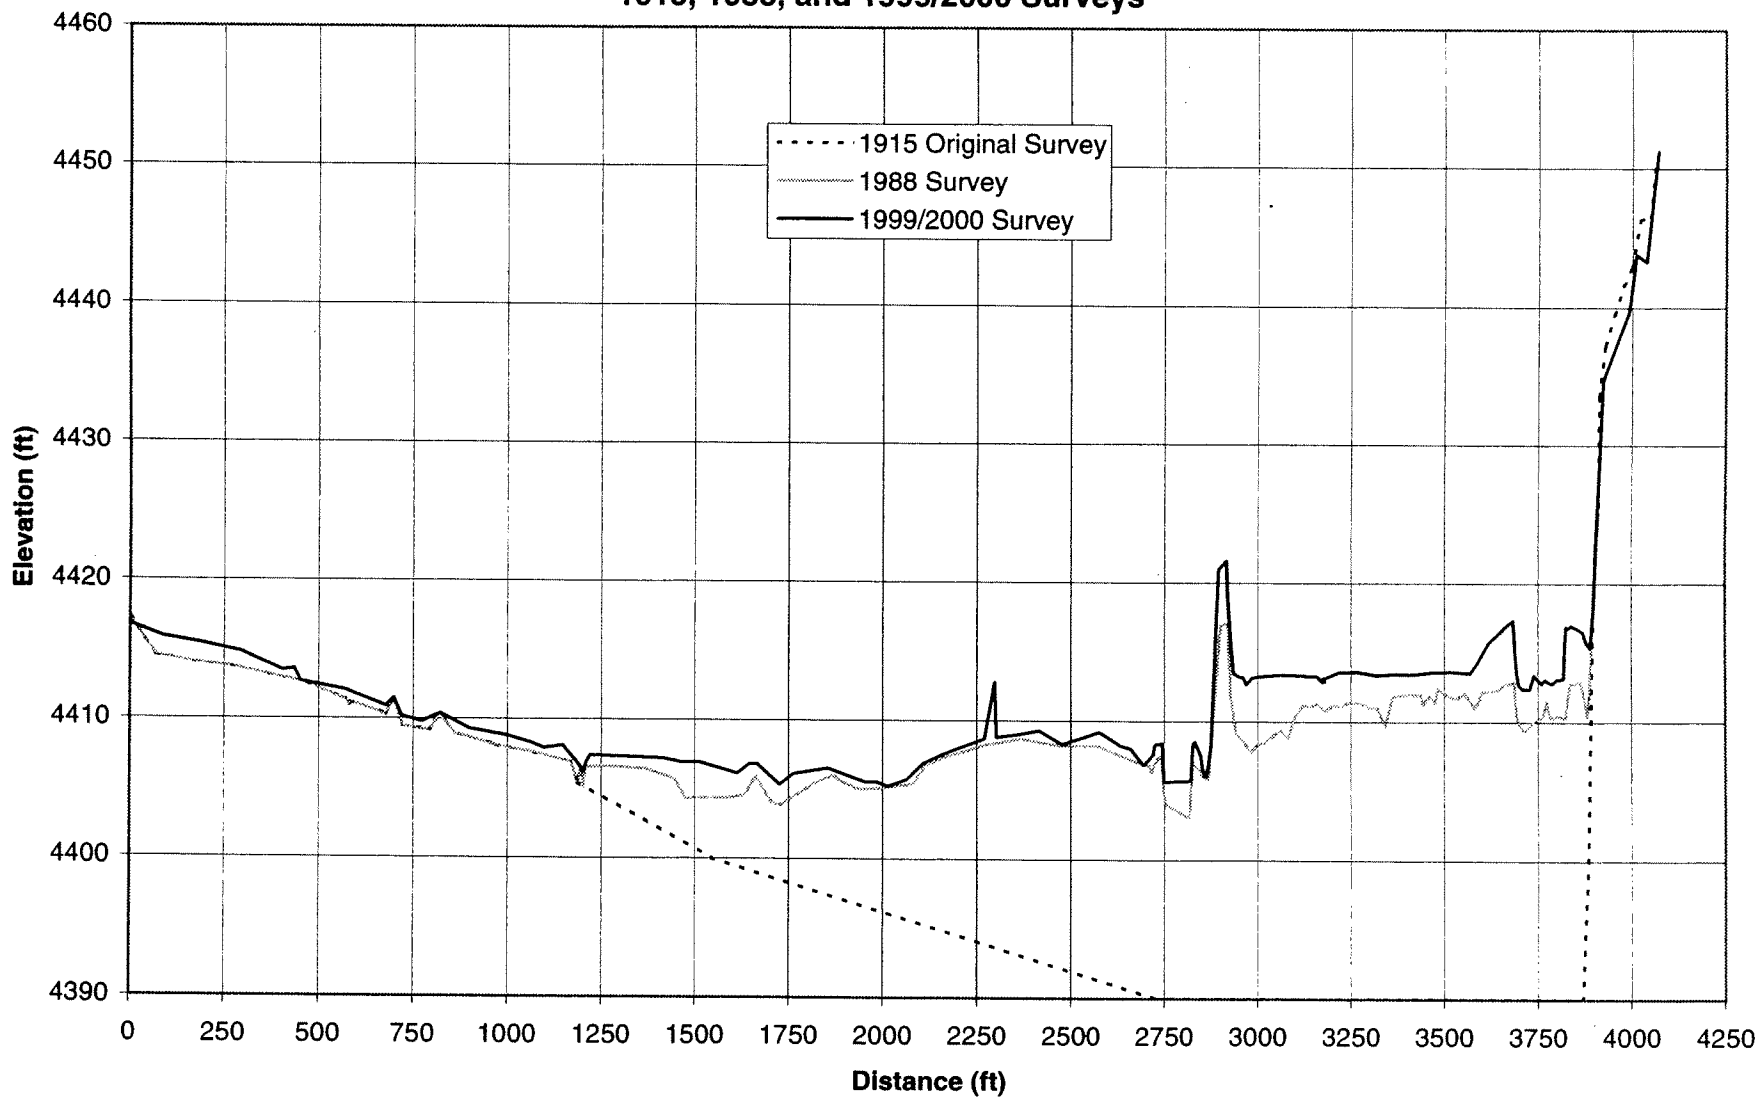
Figure 90. - Sedimentation range profiles for 1915, 1988, and 1999, range 20.

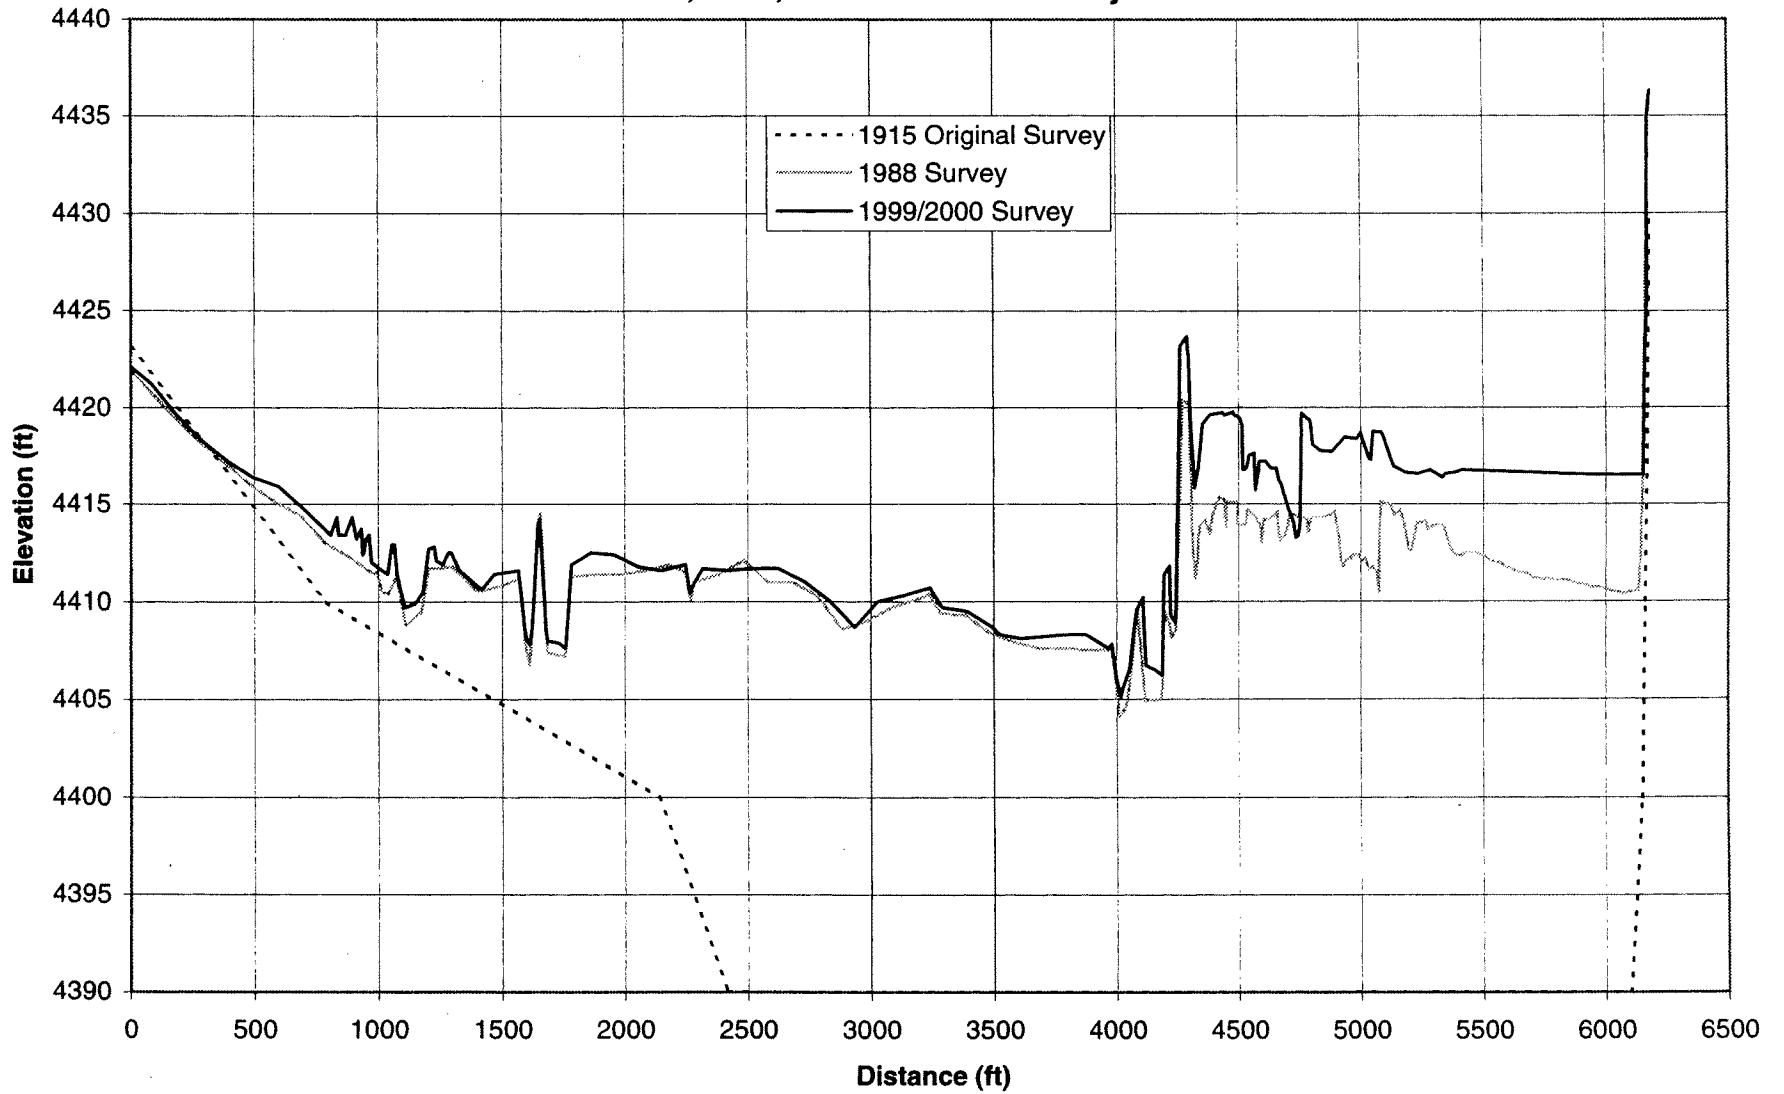
Figure 91. - Sedimentation range profiles for 1915, 1988, and 1999, range 19.

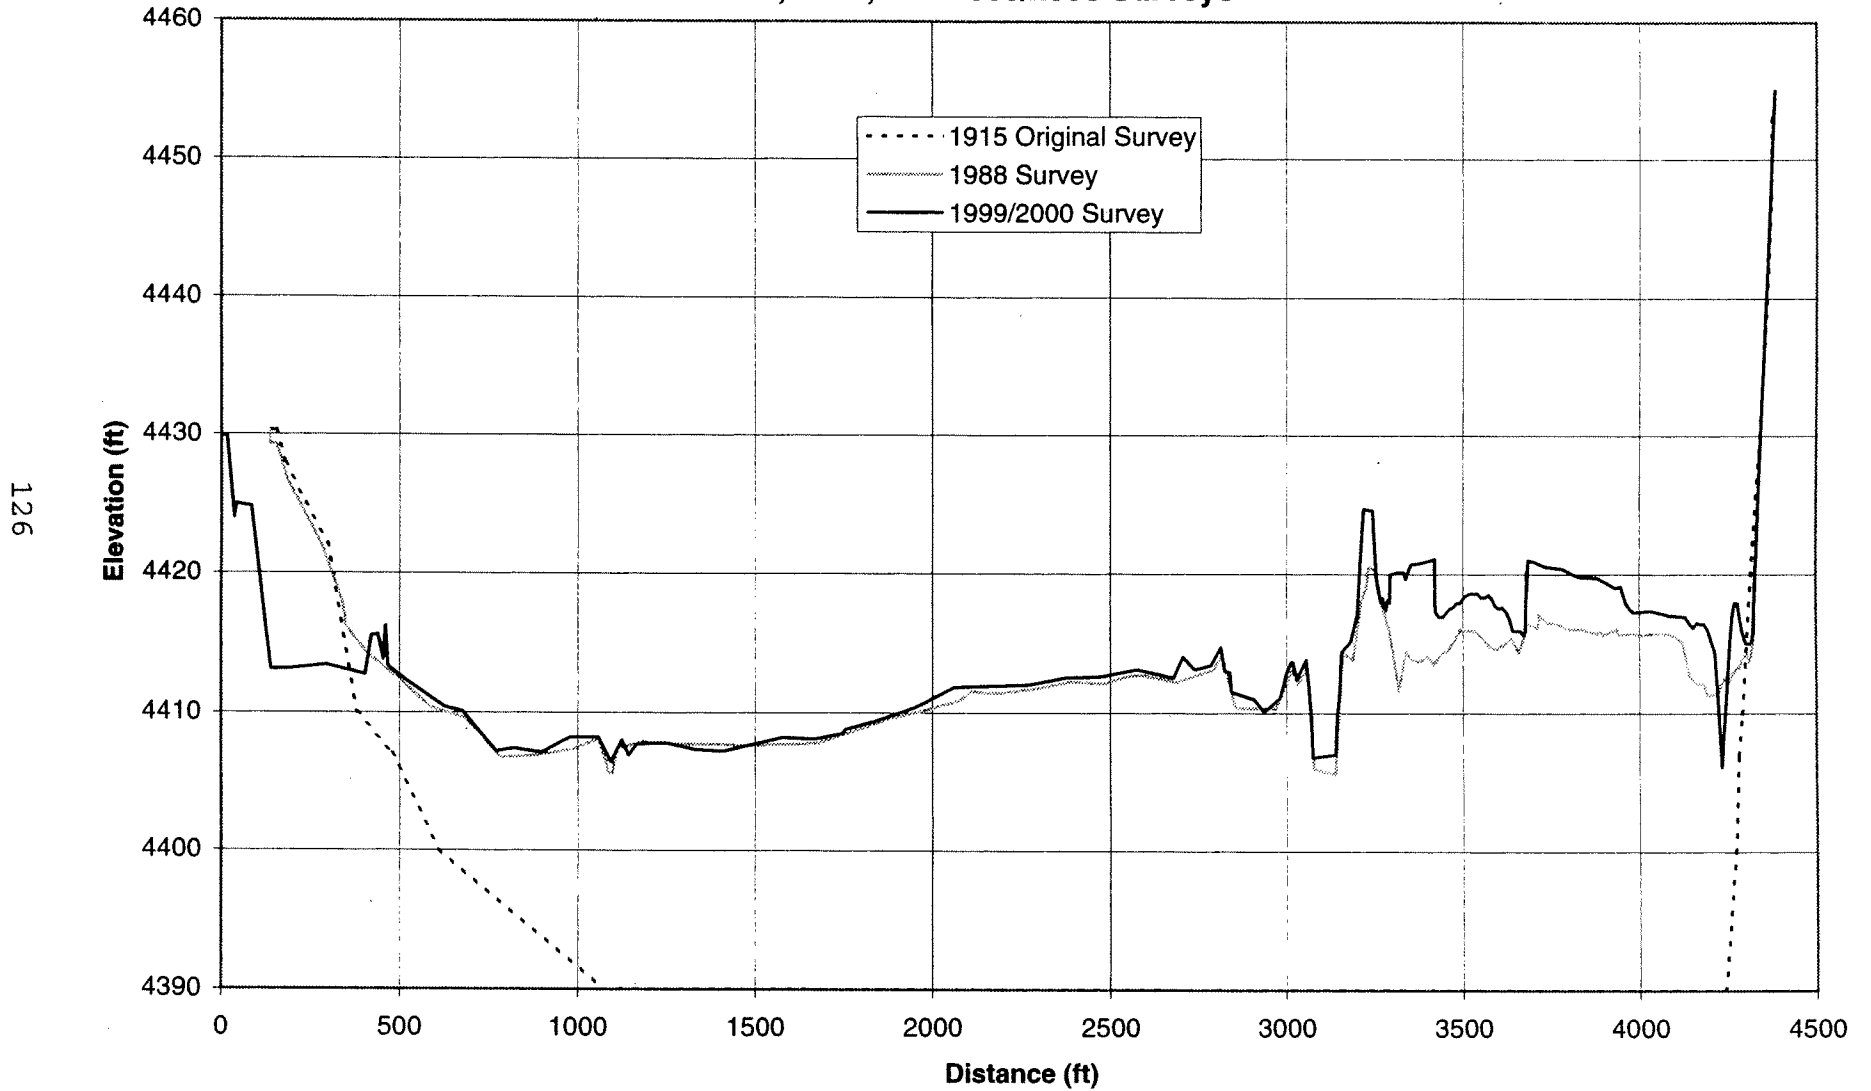
Figure 92. - Sedimentation range profiles for 1915, 1988, and 1999, range 18.

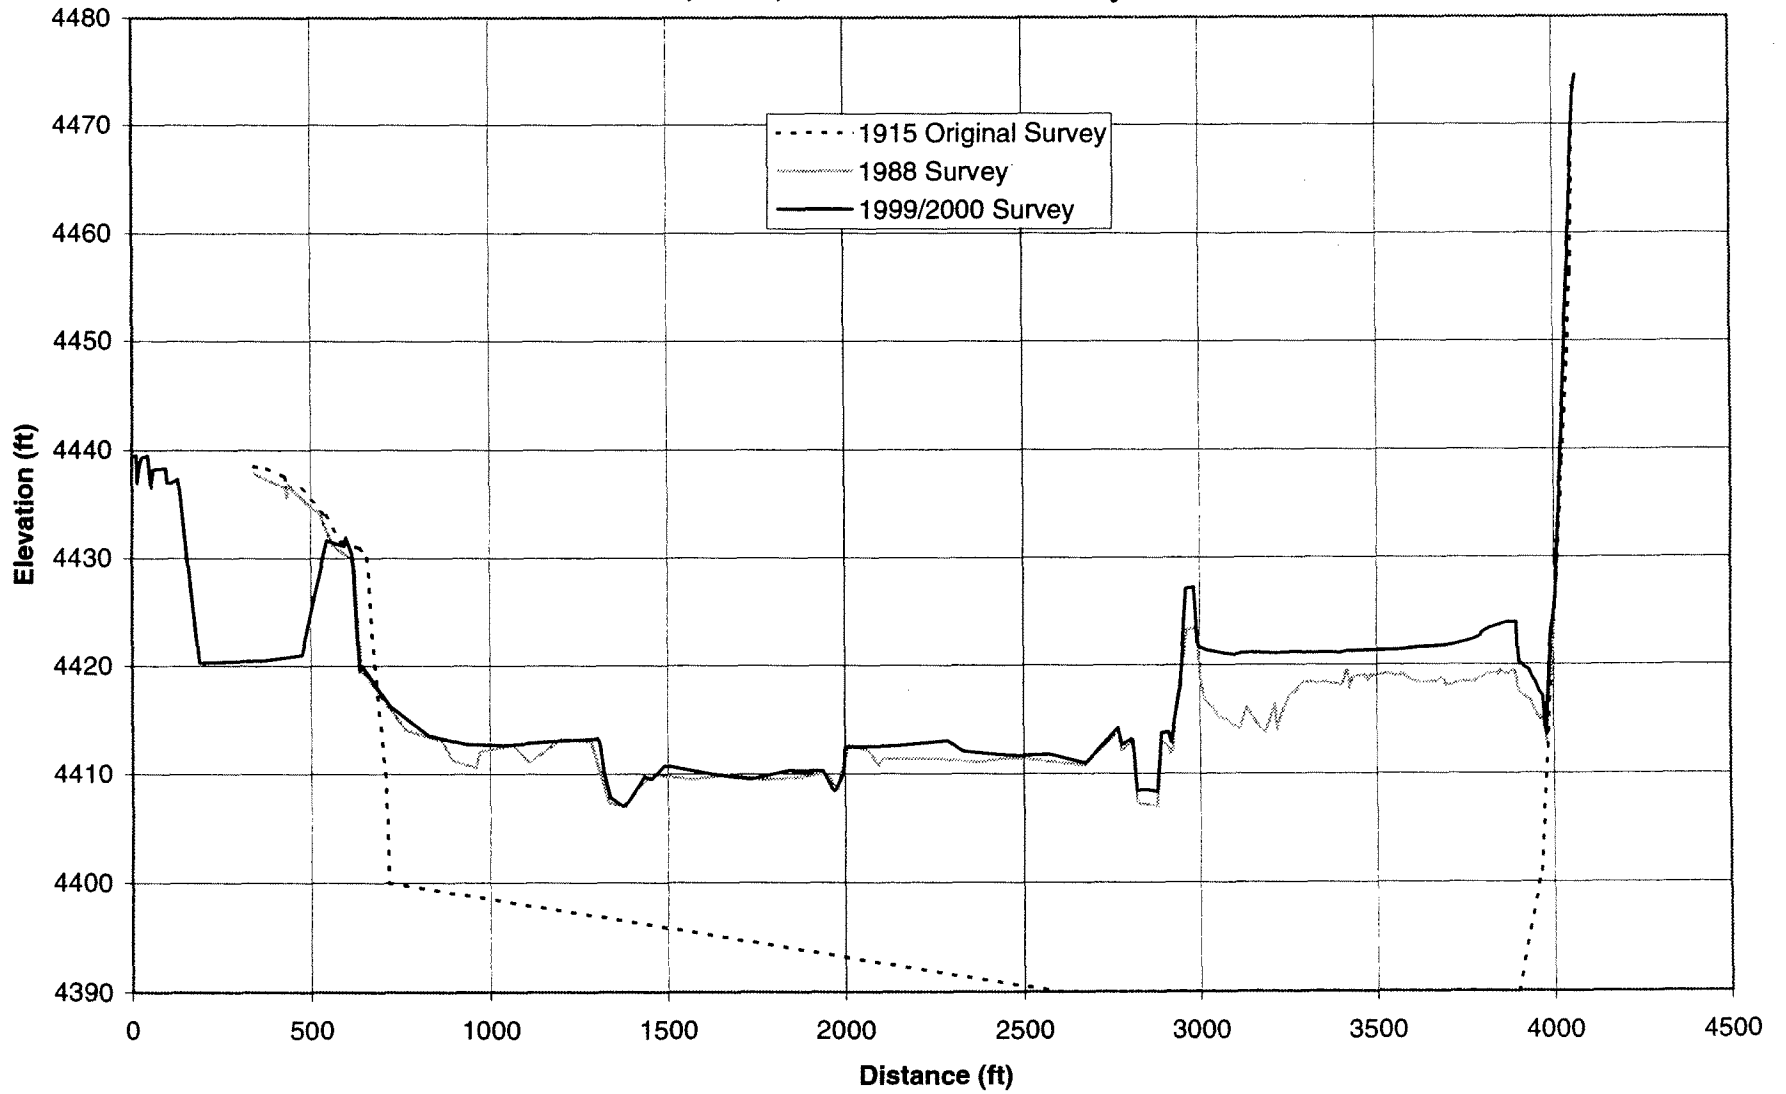
Figure 93. - Sedimentation range profiles for 1915, 1988, and 1999, range 17.

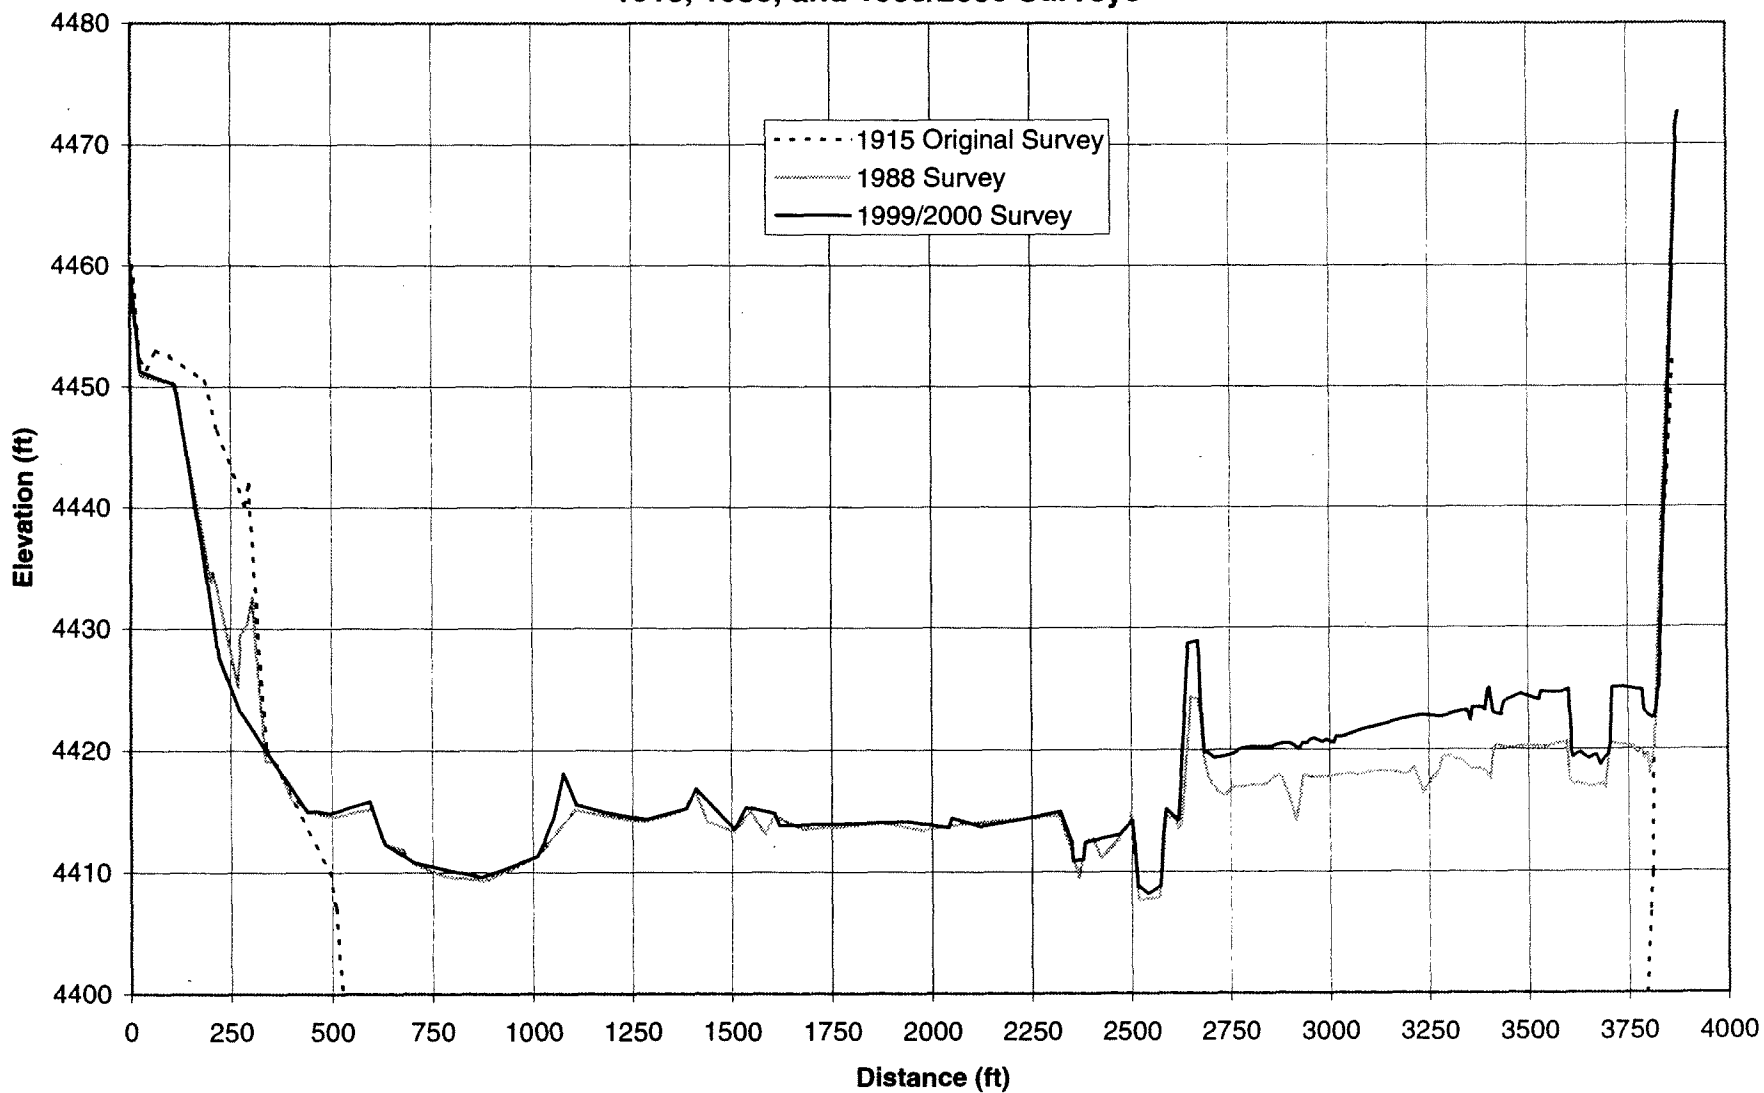
Figure 94. - Sedimentation range profiles for 1915, 1988, and 1999, range 16.

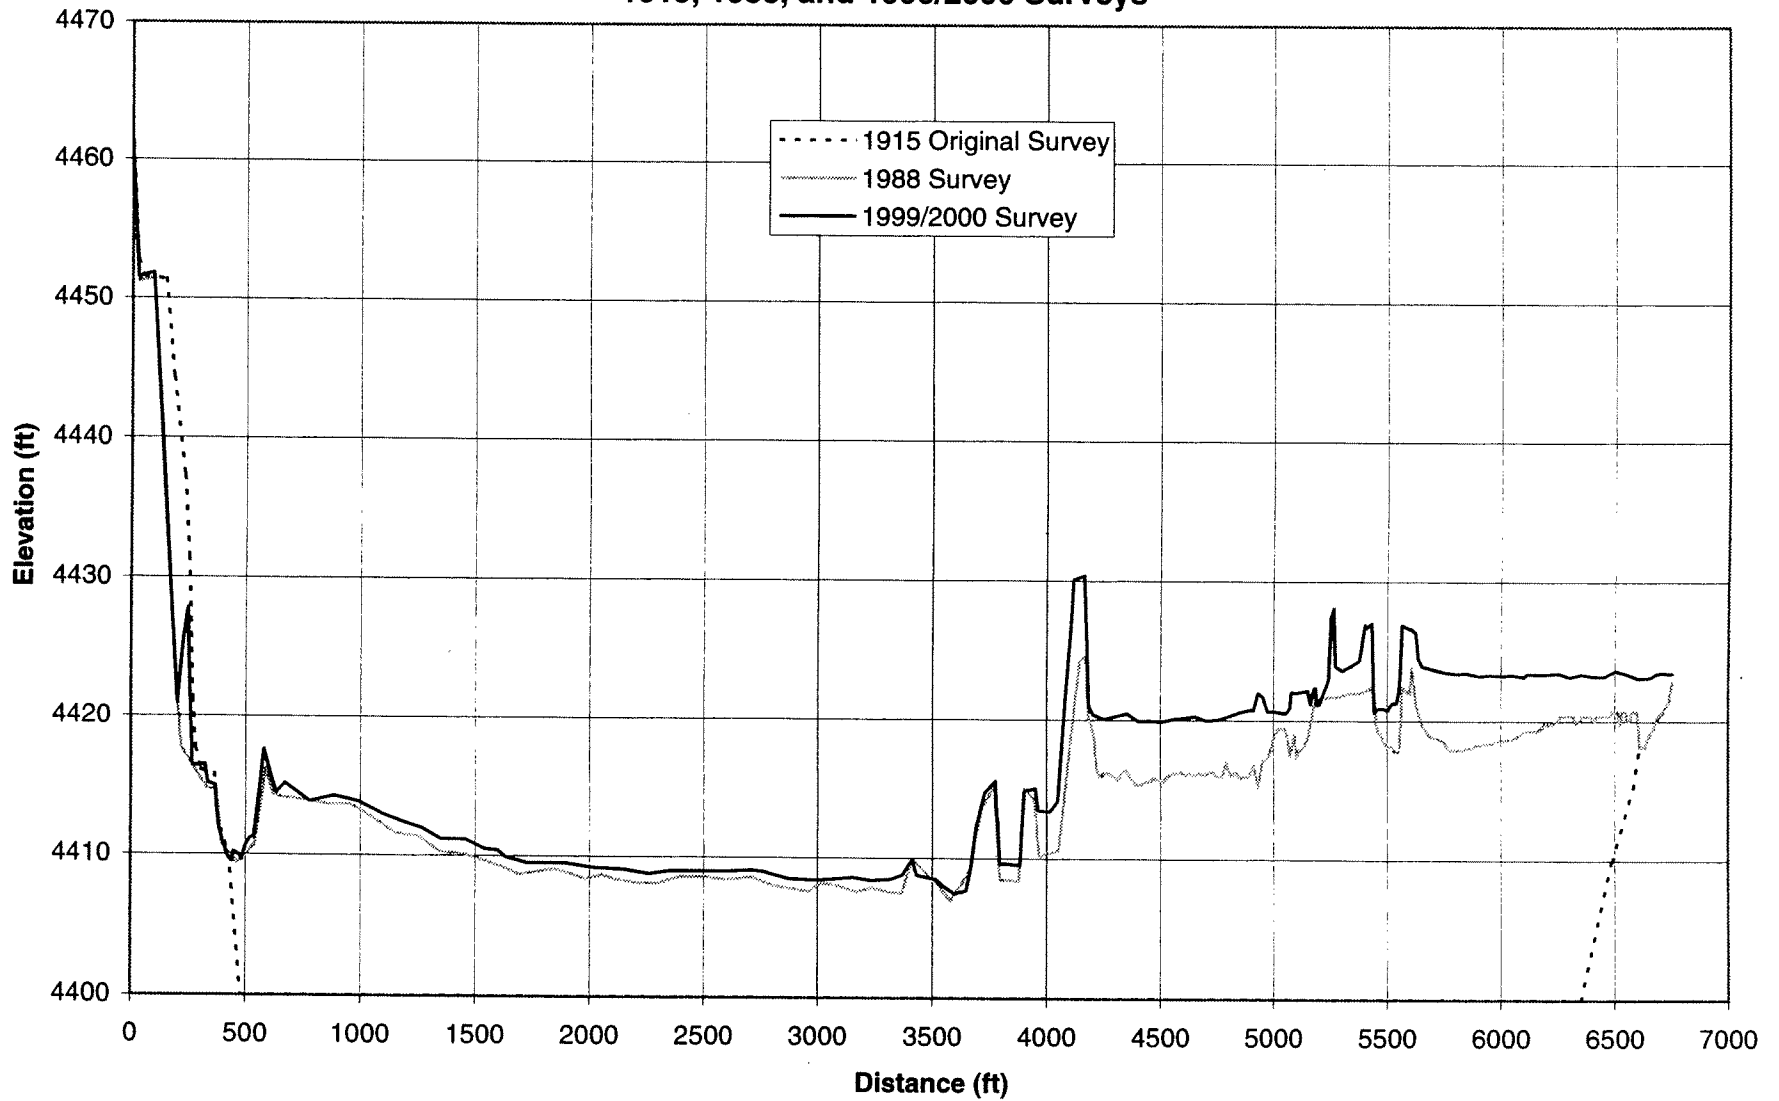
Figure 95. - Sedimentation range profiles for 1915, 1988, and 1999, range 15.

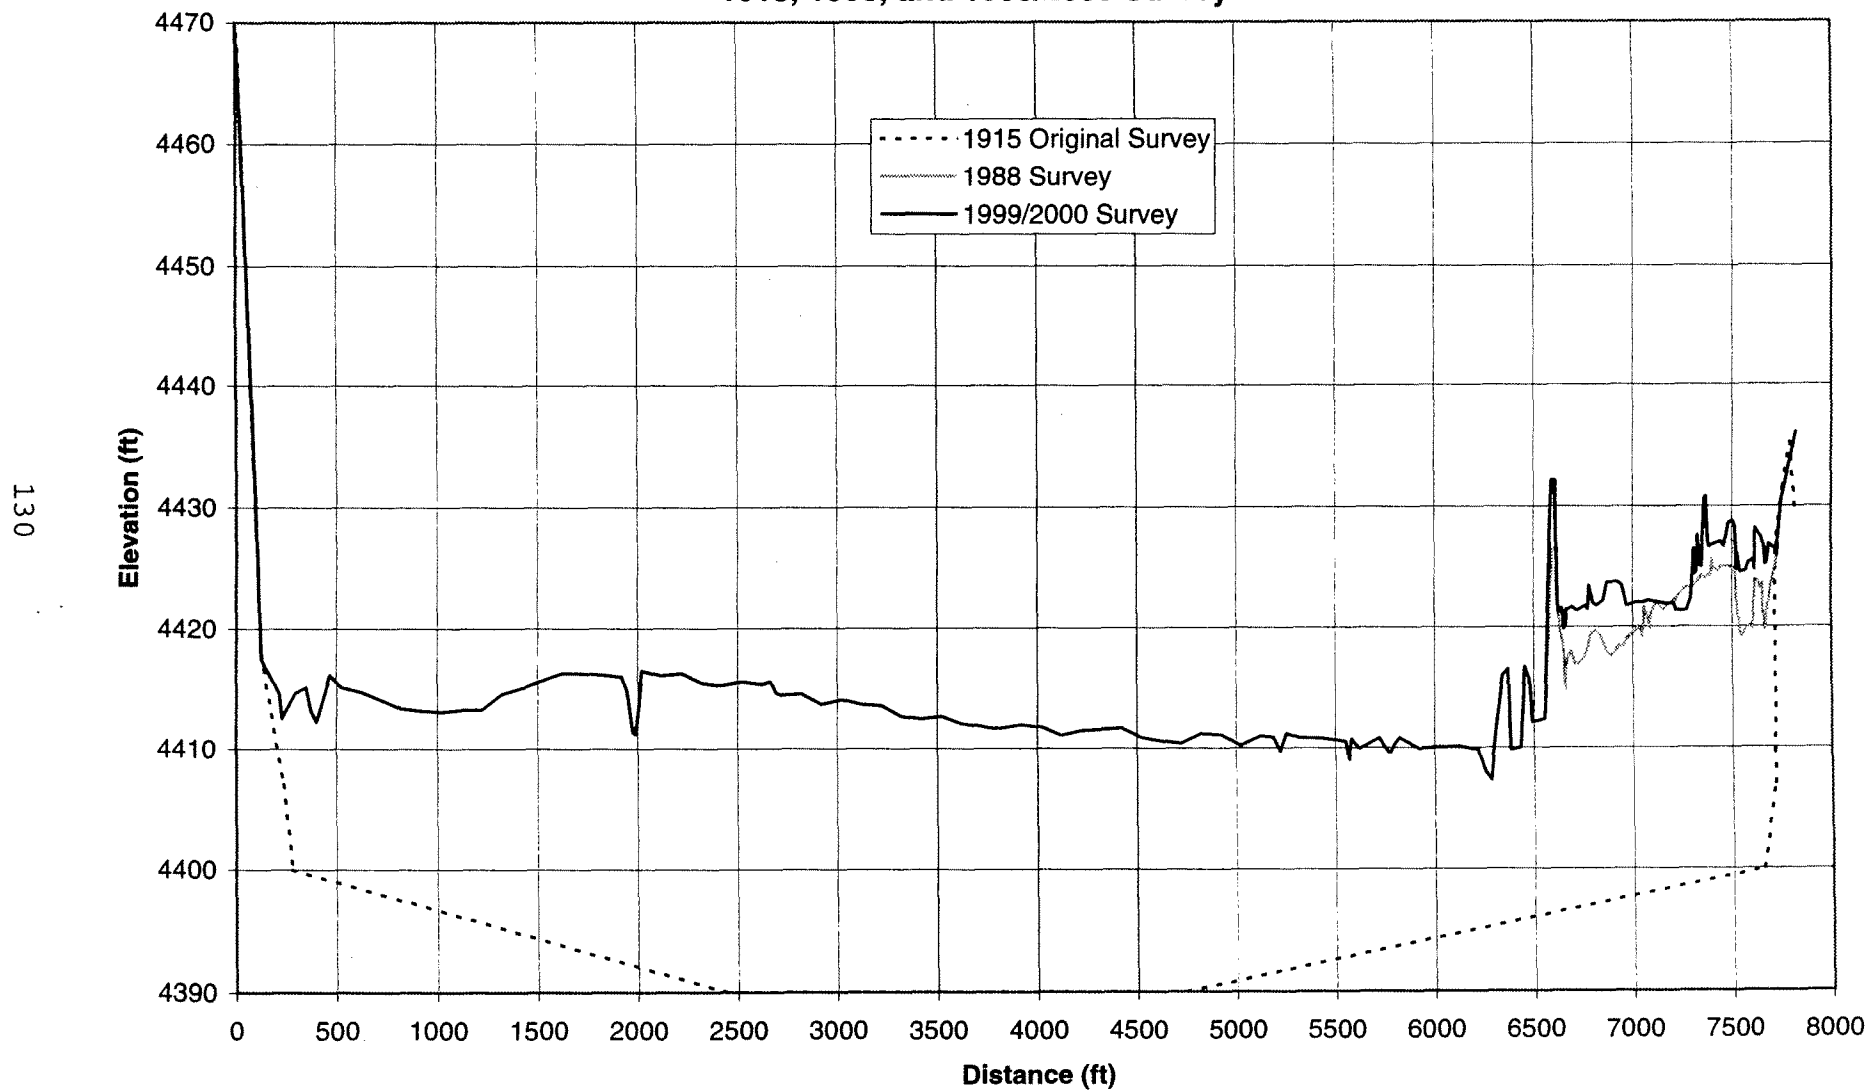
Figure 96. - Sedimentation range profiles for 1915, 1988, and 1999, range 14.

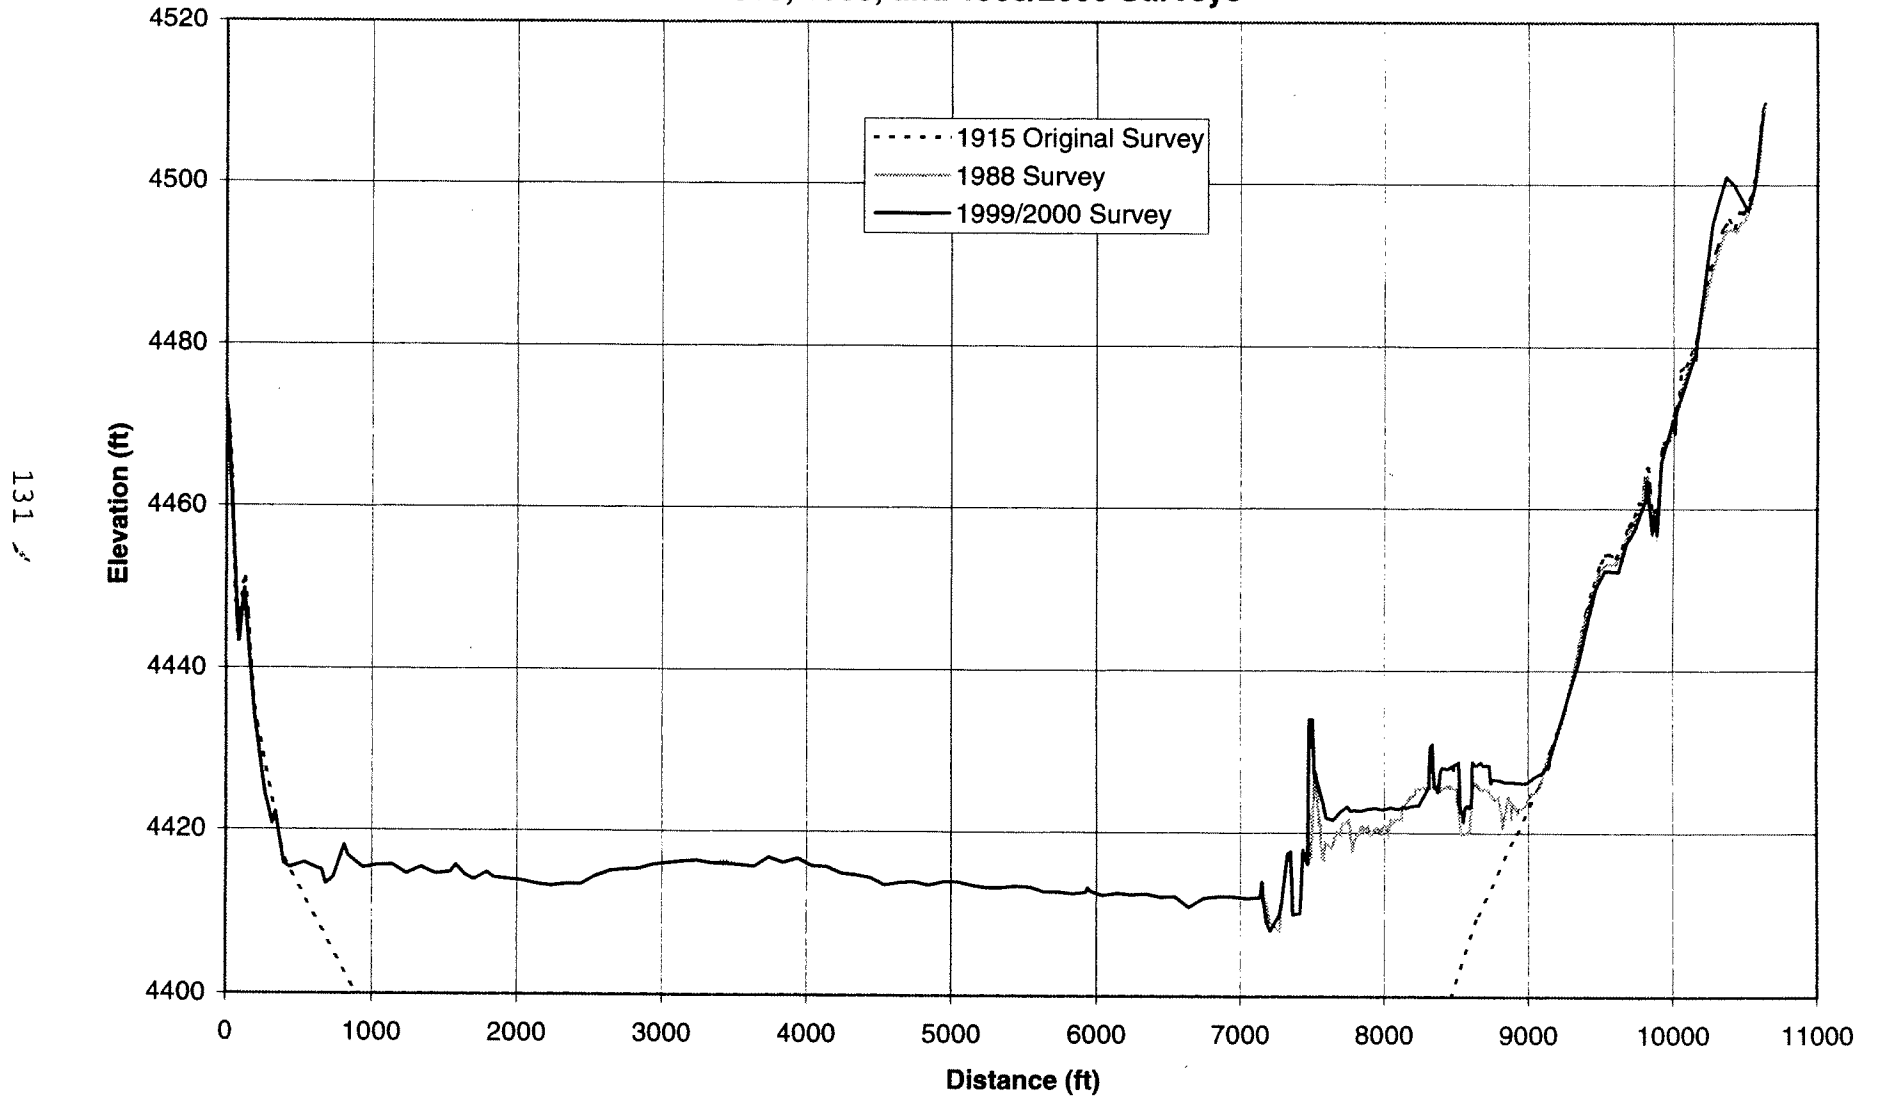
**Elephant Butte Sediment Range Profile: Rangeline 13
1915, 1988, and 1999/2000 Surveys**

Figure 97. - Sedimentation range profiles for 1915, 1988, and 1999, range 13.

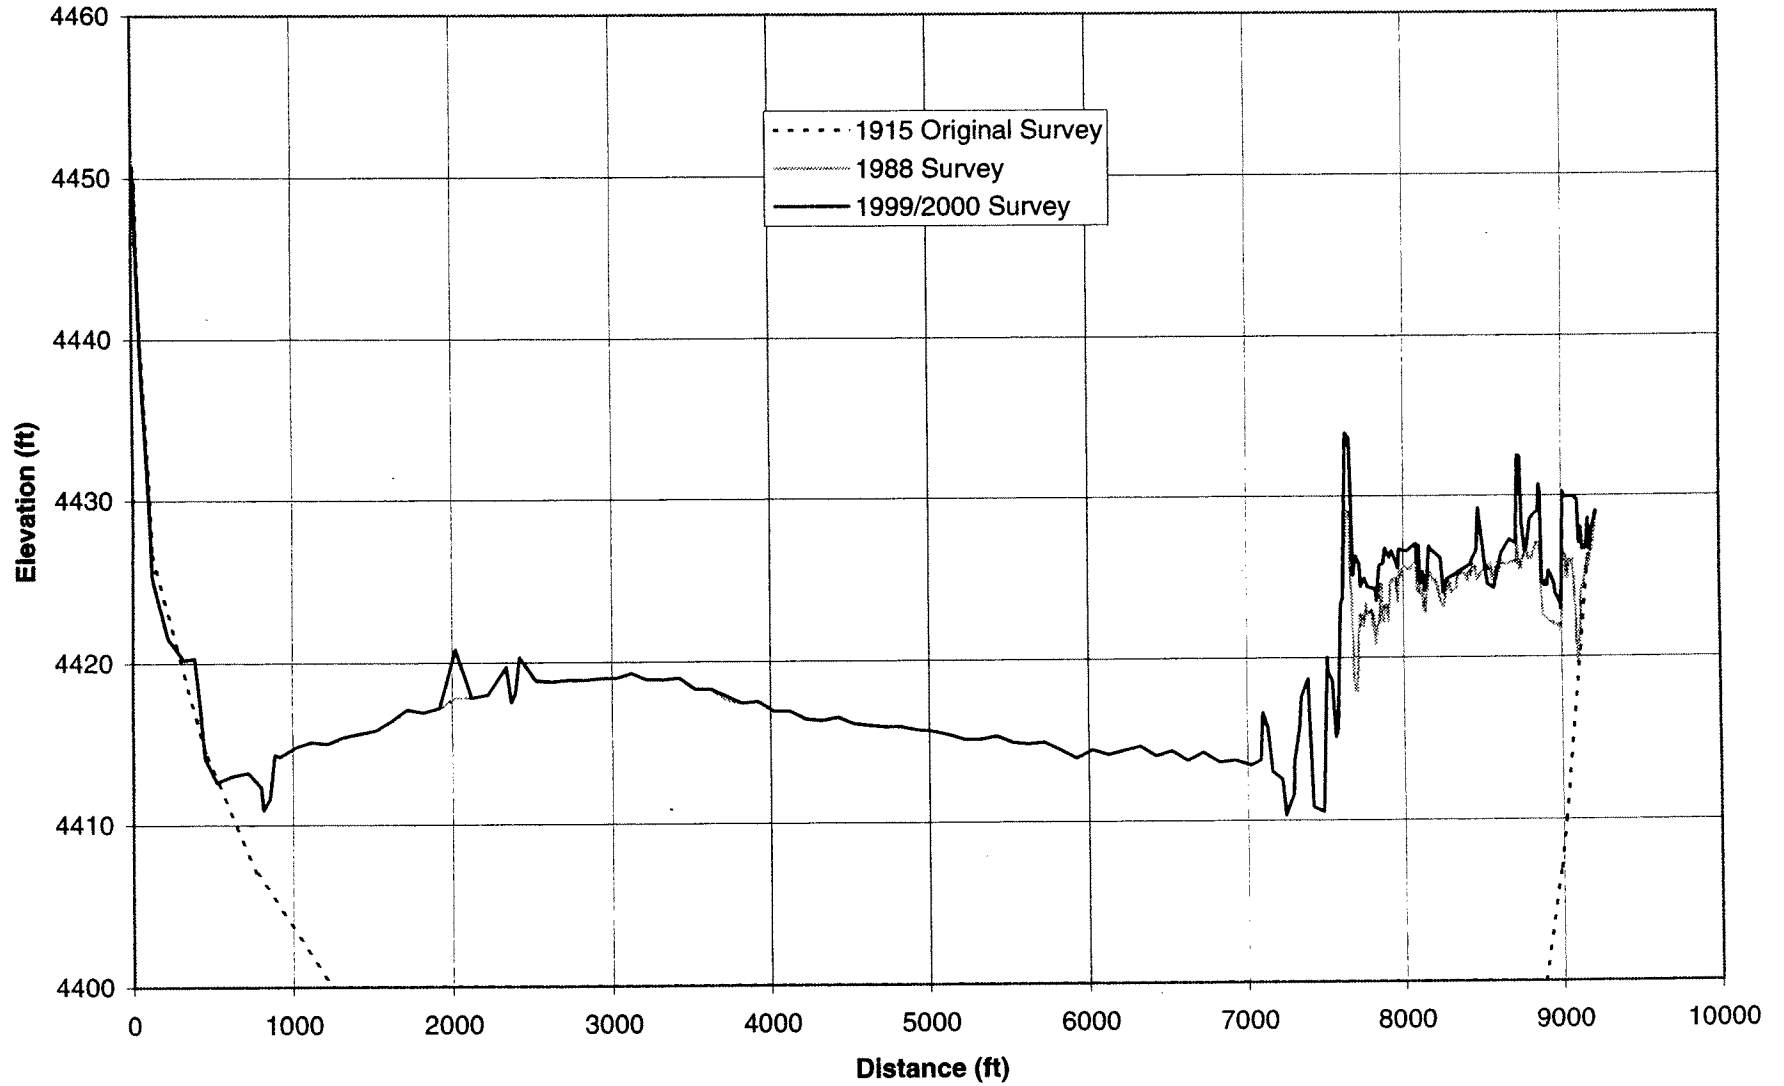
**Elephant Butte Sediment Range Profile: Rangeline 12
1915, 1988, and 1999/2000 Surveys**

Figure 98. - Sedimentation range profiles for 1915, 1988, and 1999, range 12.
