ELEPHANT BUTTE RESERVOIR

1999 RESERVOIR SURVEY

U.S. Department of the Interior
Bureau of Reclamation

**Sedimentation and River Hydraulics Group
Water Resources Services
Technical Service Center
Denver, Colorado**

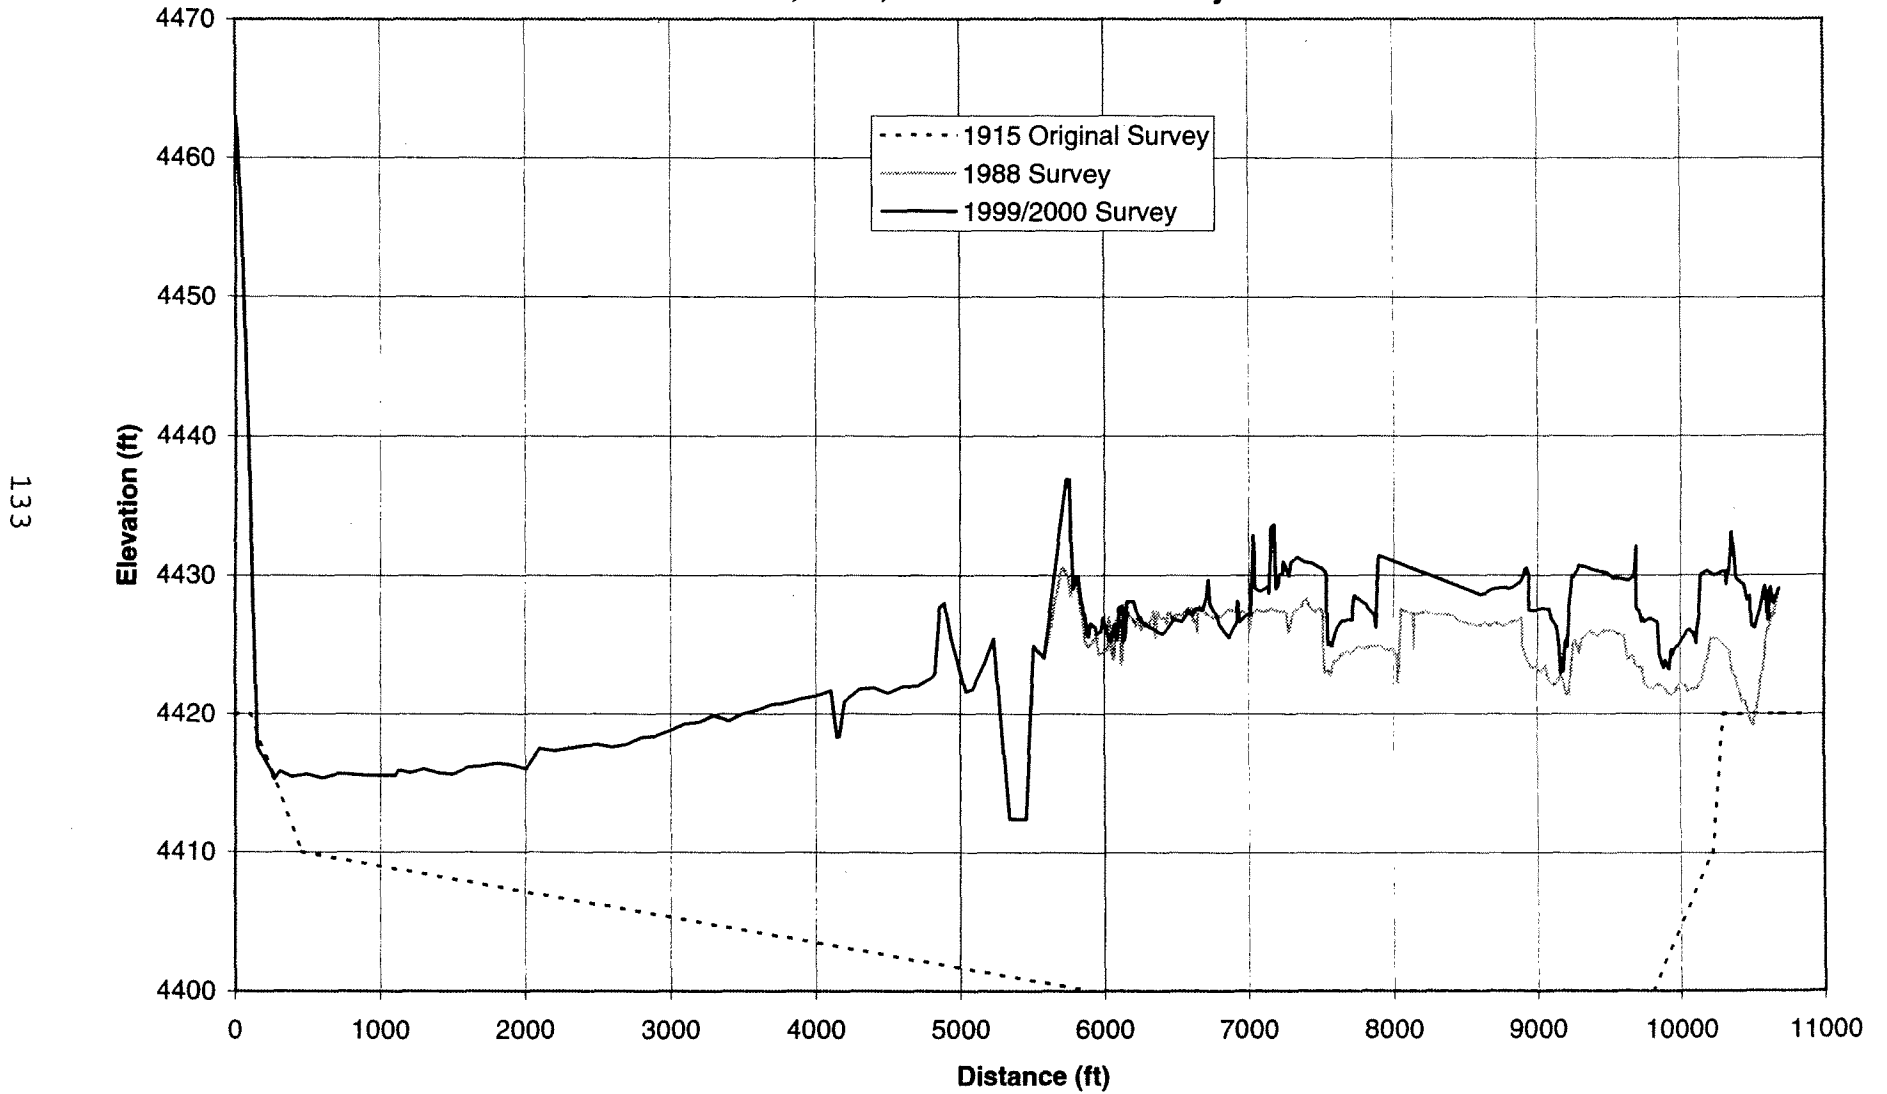
**Elephant Butte Sediment Range Profile: Rangeline 11
1915, 1988, and 1999/2000 Surveys**

Figure 99. - Sedimentation range profiles for 1915, 1988, and 1999, range 11.

A comparison of the simultaneous plots of original range profiles against the resurveyed range profiles indicates the lateral distribution of the sediment at the measured points. Where these plots indicate changes have occurred on the side slopes of the reservoir, an engineering judgment decision was required to determine whether the change is due to survey inaccuracies or due to actual deposition or erosion. As noted previously the original range line data was scaled from the original 10-foot contour maps.

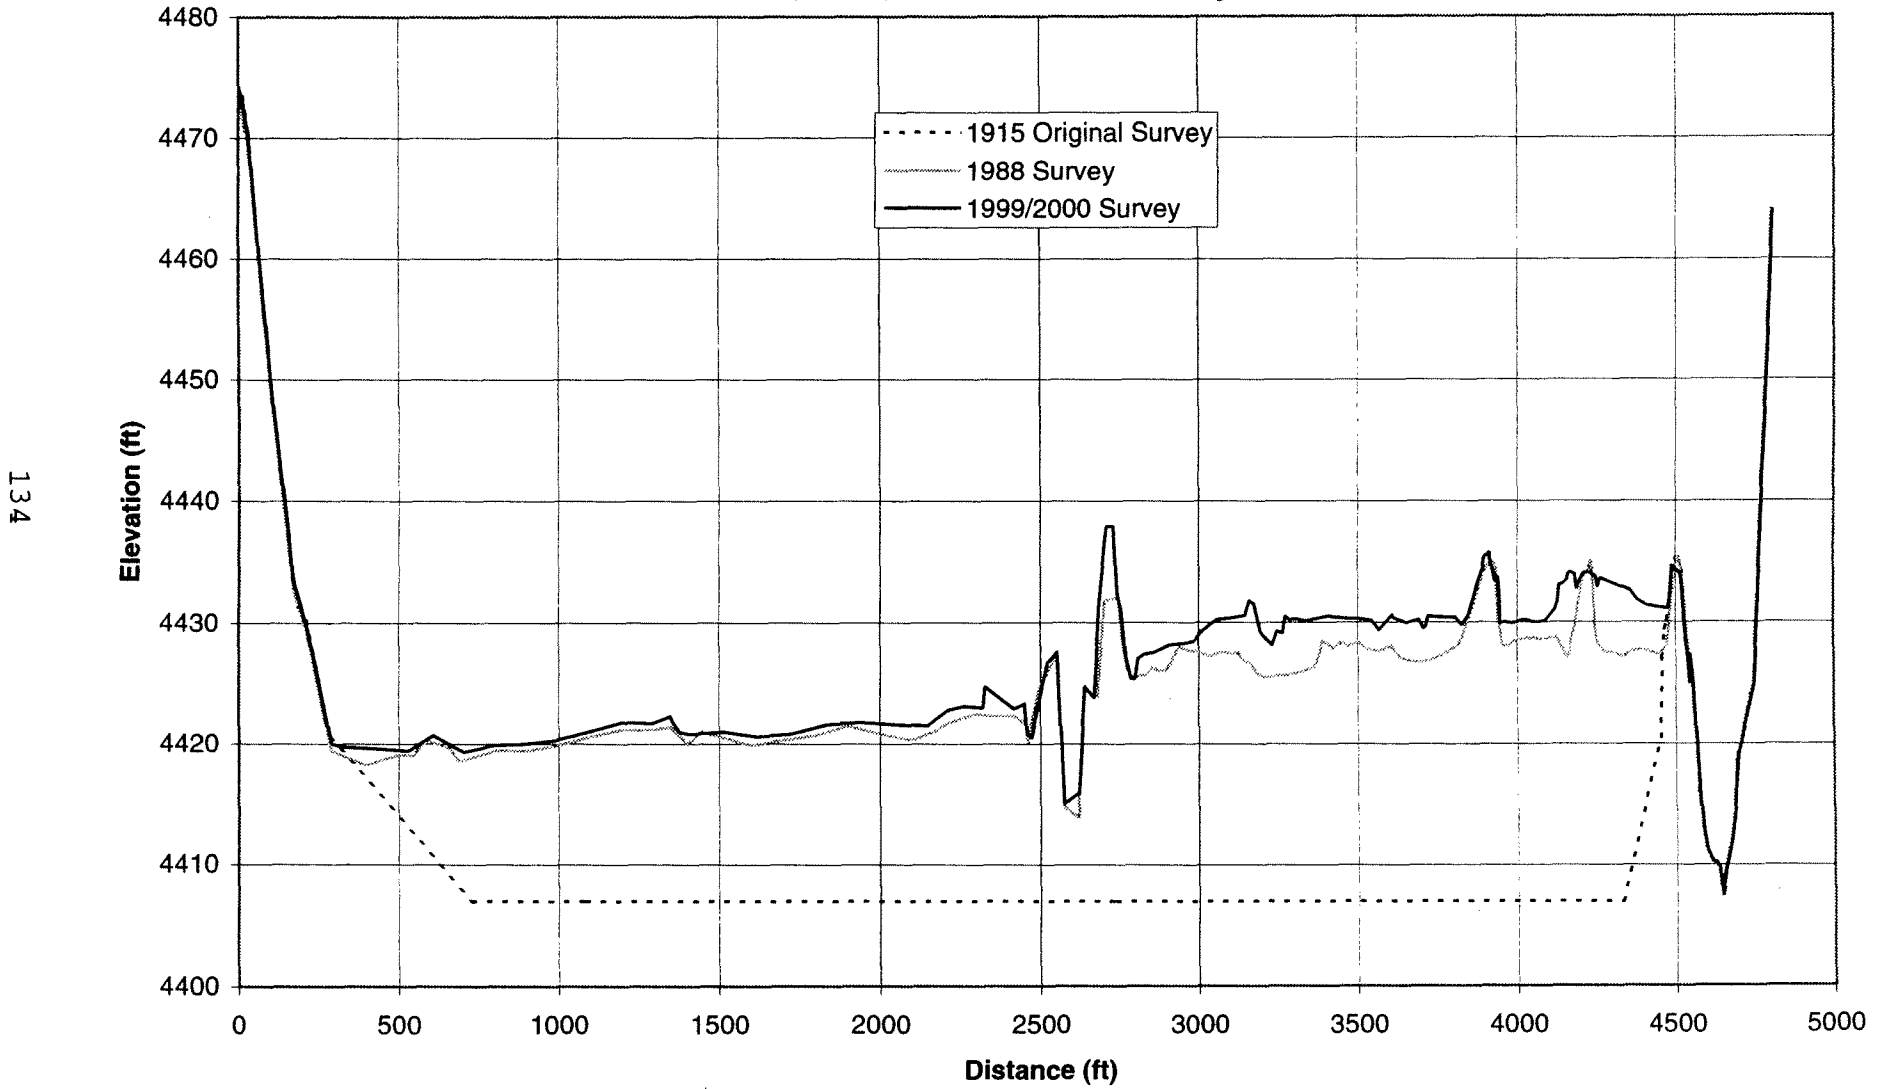
**Elephant Butte Sediment Range Profile: Rangeline 10
1915, 1988, and 1999/2000 Surveys**

Figure 100. - Sedimentation range profiles for 1915, 1988, and 1999, range 10.

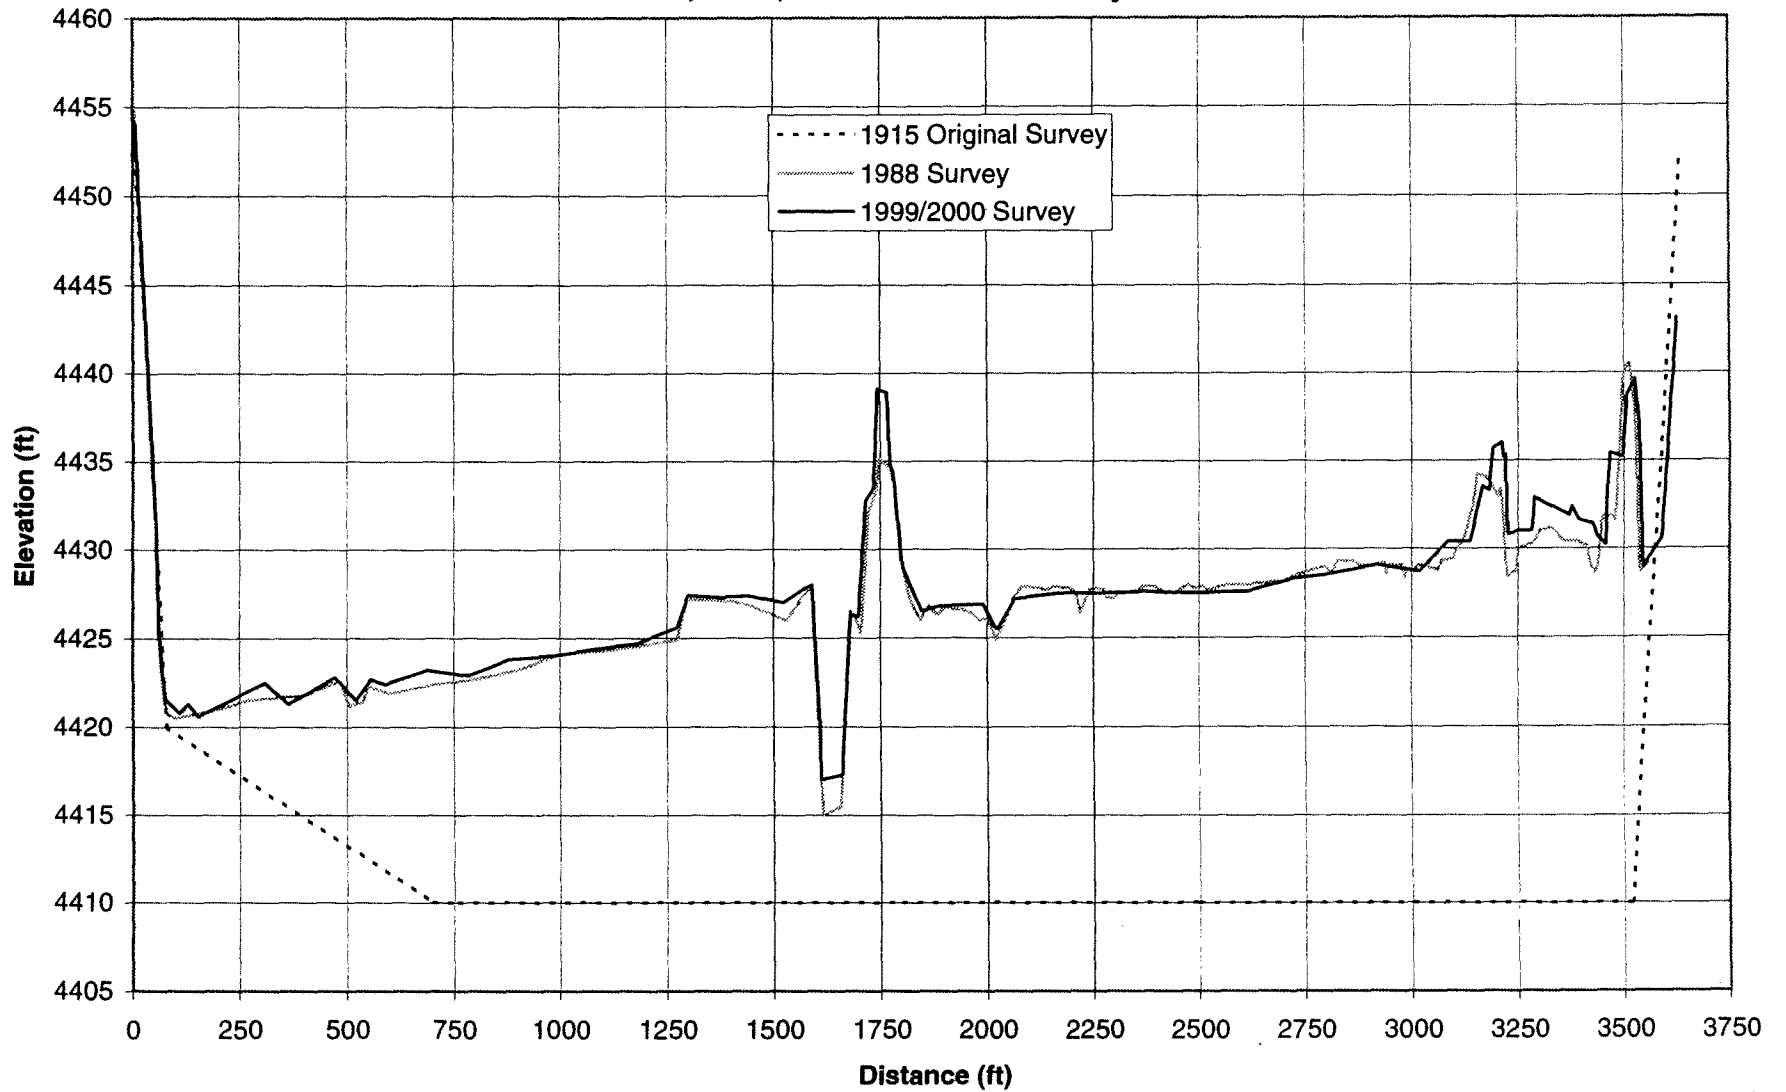
Elephant Butte Sediment Range Profile: Rangeline 9 1915, 1988, and 1999/2000 Surveys

Figure 101. - Sedimentation range profiles for 1915, 1988, and 1999, range 9.

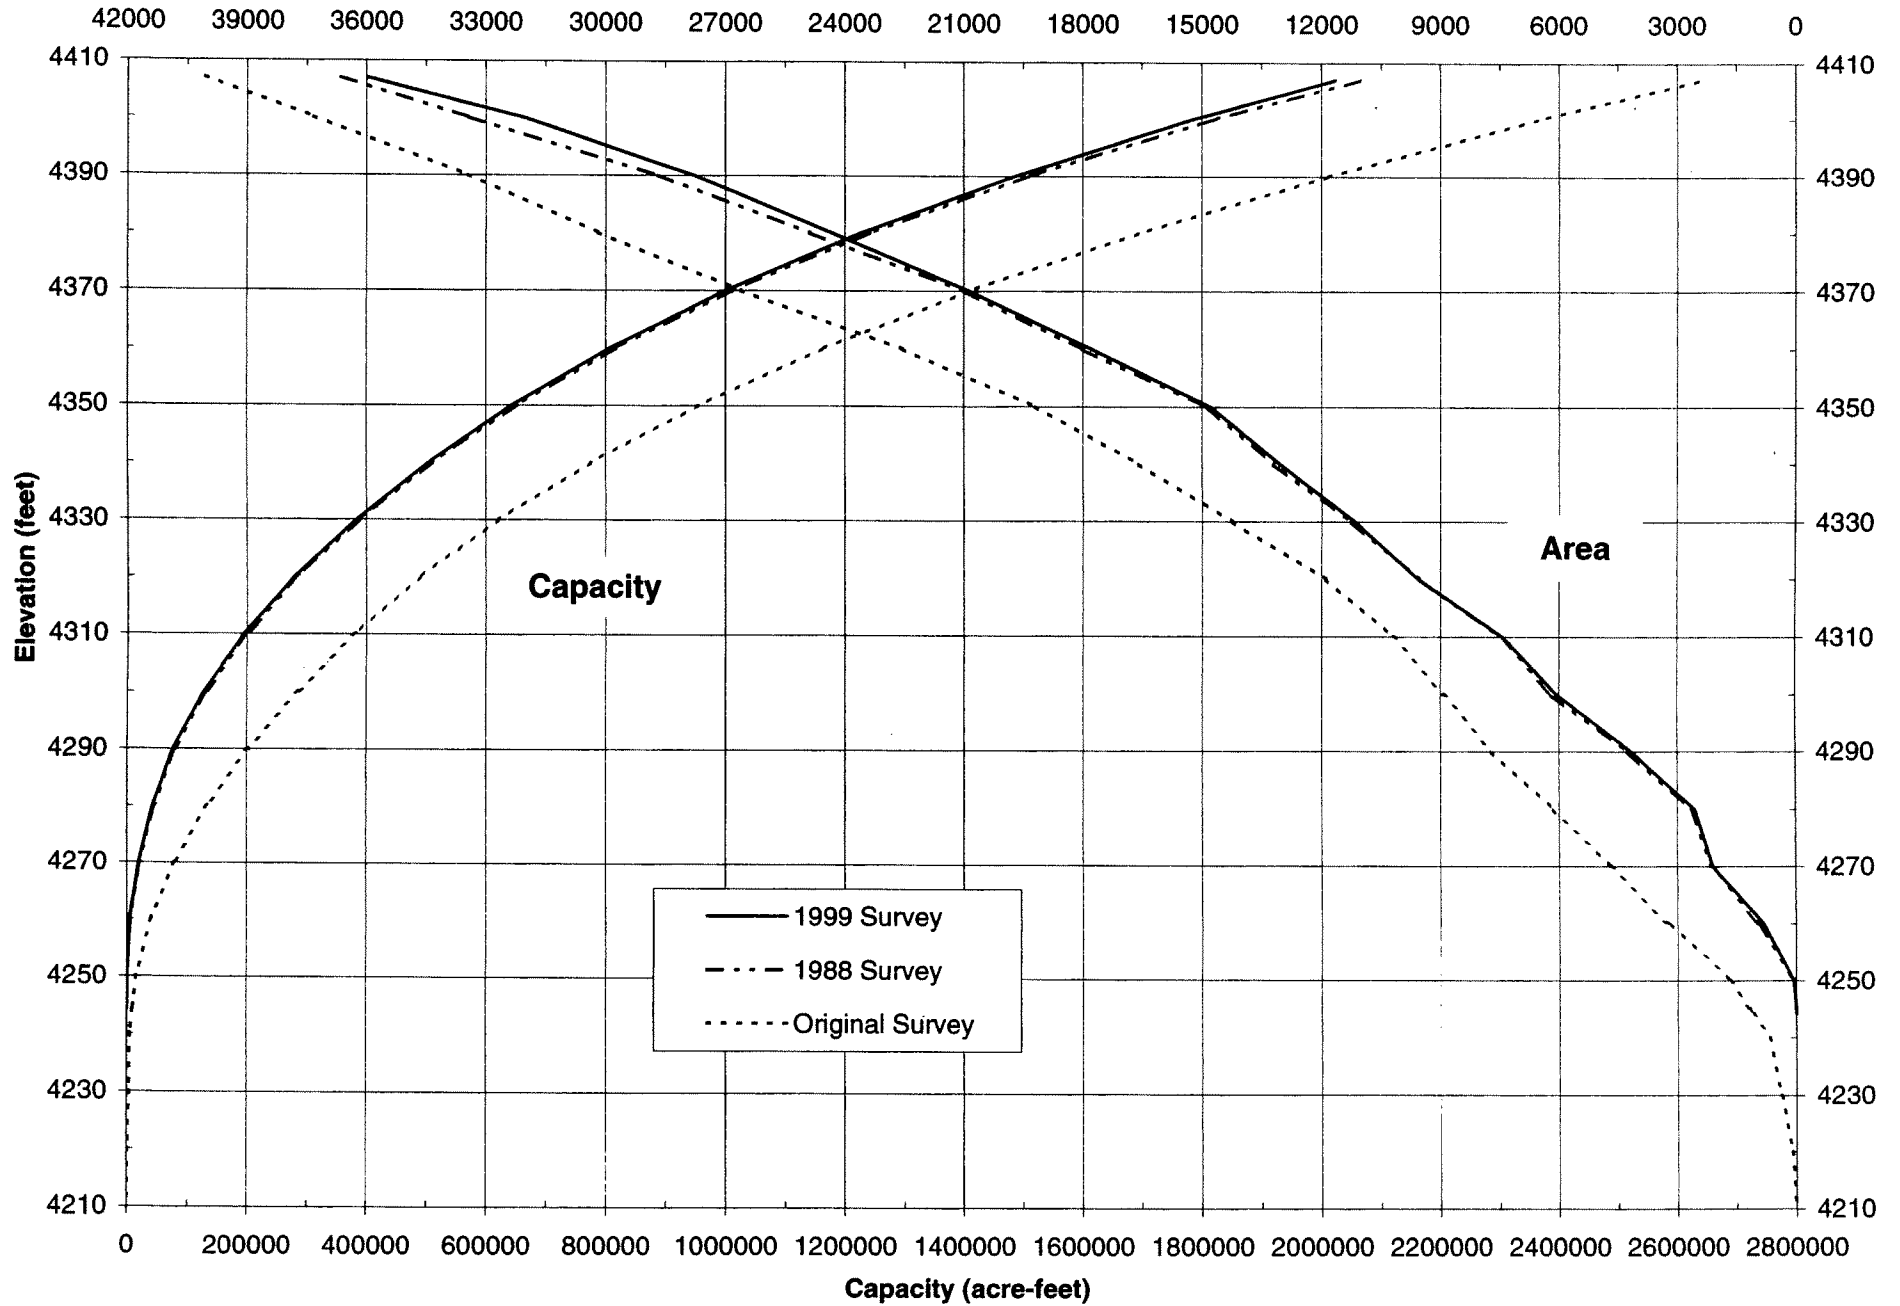
Area-Capacity Curves for Elephant Butte Reservoir

Area (acre)

The Elephant Butte Reservoir original and 1999 area and capacity values are illustrated on figures 19 and 103 and the results are listed on tables 2 and 3. These presentations illustrate the capacity difference that has occurred during the 84.3 years of reservoir operations. This study found that as of April 1999, at reservoir water surface elevation (feet) 4,407.0, the surface area was 35,984 acres with a total capacity of 2,023,358 acre-feet. Since the reservoir's initial filling in 1915, 611,442 acre-feet of sediment have accumulated in Elephant Butte Reservoir. Since the last reservoir survey in 1988, 41,652 acre-feet of sediment have been trapped. The average annual rate of sediment accumulation since 1915 is 7,253 acre-feet and since 1988 it is 3,719 acre-feet.
