**Heart
Mountain
Irrigation
District**

FY 2018

**Rattlesnake Canal Liner
Phase II Project**

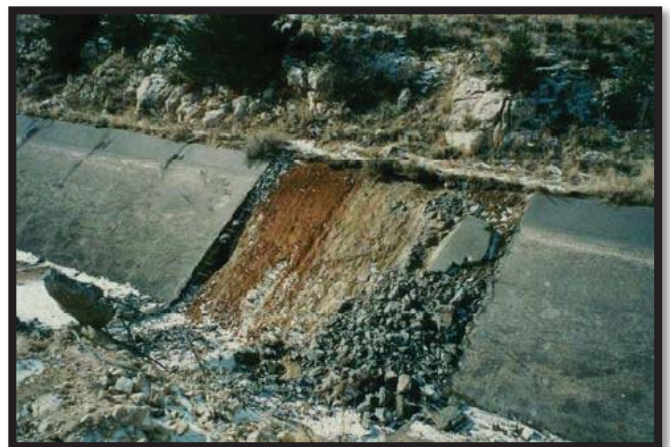
Photo 1 Breach of the Side of the canal of the Rattlesnake Liner

The Heart Mountain Irrigation District Rattlesnake Canal Liner Phase II Project will replace 637 feet of the existing open canal liner with new concrete liner and install a small crossfloat hydro turbine. The 70 plus-year-old liner has large cracks, exposed rebar, and deteriorating concrete that is leaking and creating massive voids beneath the concrete liner. The liner has come to the end of its useful life. Over the past 25 years, it has had many issues that have had detrimental effects on the stability of the canal. Voids, large water losses, and breaches have shut down the entire canal requiring the District to stop water flowing to irrigators for days during the hot summer months. Some of these breaches have been so large that entire ten-foot sections have crumbled away. The existing liner was constructed in 1938, and the District has made many attempts to fix and patch the liner, but to no avail. With multiple sections of the canal liner having leaks and voids beneath it, it has become impossible even to know where the leaks are. You do not see any of the water seeping out. The water disappears through a big, gaping hole and straight into the mountain.

Liner Failure: In 2011, a major failure of the canal liner occurred, causing a breach. The water flowed over the top of the liner and eroded the material behind it to the point that a portion of the liner collapsed. The District shut down the canal for days to repair the collapse, leaving over 30,000 acres without irrigation water. A more recent canal failure occurred multiple times during the 2017 irrigation season, prompting days without water during this critical time. This has been happening over the past twenty years, but over the past five to ten years, the number of shutdowns has been increasing with each irrigation season. When a leak occurs, it causes massive voids under the liner that initiate the failure of the liner.

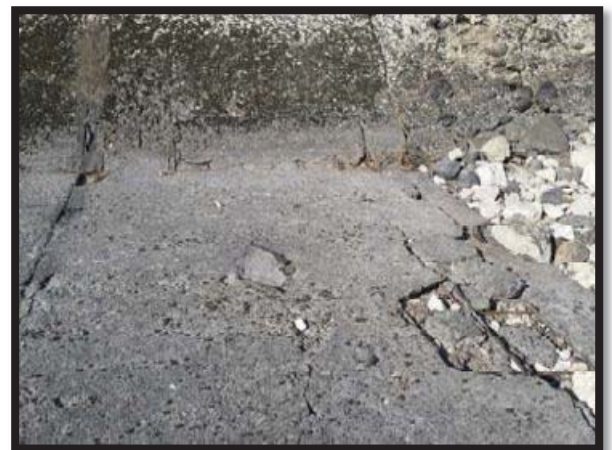
Photo 4 Exposed Rebar

In 2018, the canal liner is still continually cracking and shrinking, and being undermined by the cold joints that are set every ten feet within the liner. These issues, along with the exposed rebar, massive voids, and crumbling 70-plus-year-old concrete will continue to be the source for shutdowns during the irrigation season. A major failure of the concrete liner that would require a longer time for a shutdown would impact the District and their users in catastrophic ways. Since this canal is located at the top of the system, every user is impacted every time they shut down the canal to fix the leaks in the liner. The possibility of a week or more without water during July or August could mean a complete loss of irrigated crops. This would be economically and financially crippling to both the irrigators and Park County.

In November of 2015, the entire concrete-lined section of the HMID canal was visually inspected in dry condition. During the dry inspection, large cracks, exposed rebar, and deteriorating concrete were located. Figure 2 indicates a sampling of the locations of cracked panels. The cracked panels are indicated in gray. This is just one area of the canal shown, and it indicates that the canal invert and sidewalls are cracked for almost the entire length along both

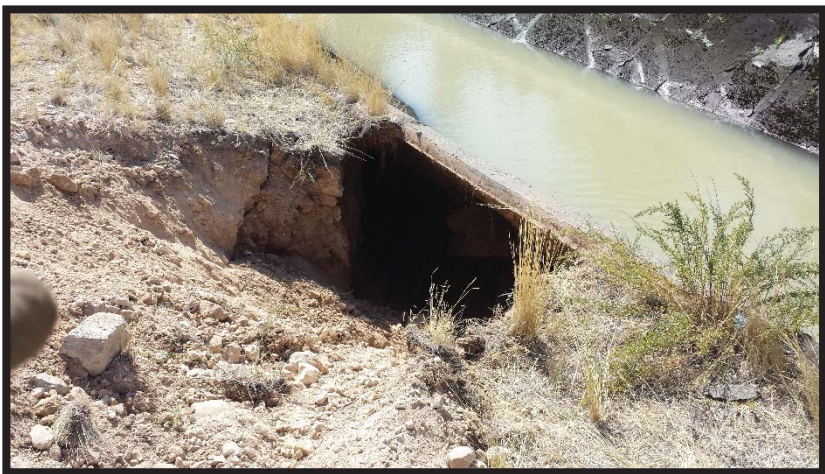
Photo 6 Canal Liner Void

The District shut down the canal for two days to repair the void. From discussions with the current District Manager, a void that was found like this in 2017 was filled with cement grout so

that they could get the canal up and running again. This is just one of a number of these type of voids that have been happening. The water losses could be much greater. However, based on the best information available to HMDI, they feel that this estimate of 211 acre-feet will be saved as a direct result of this phase of the project.

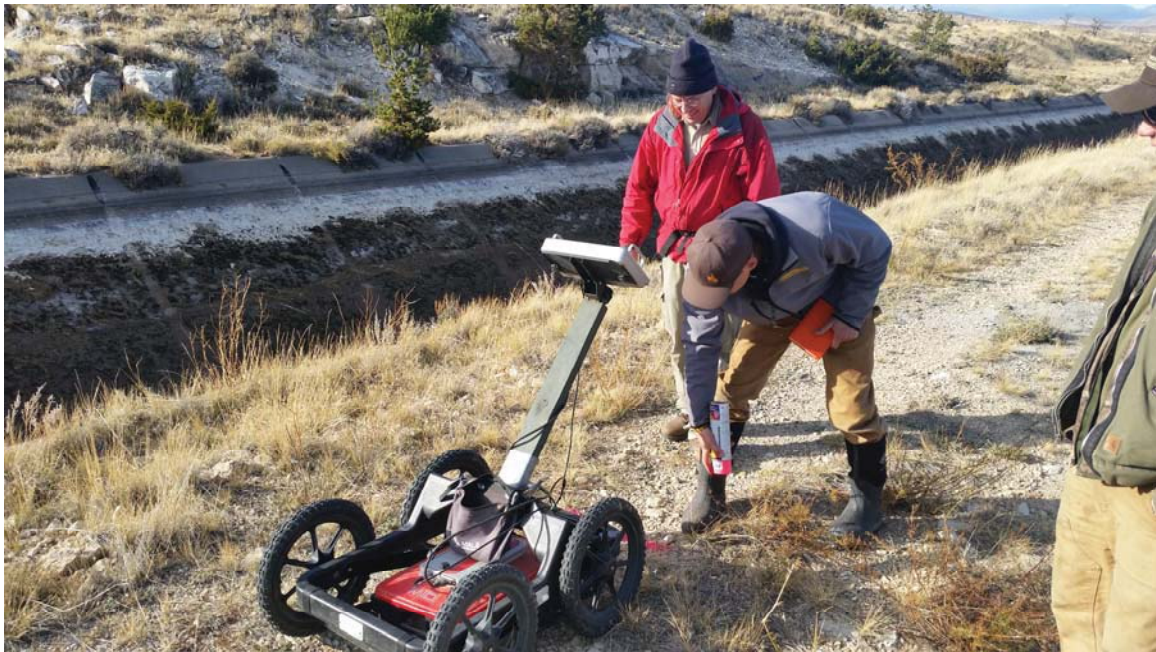
Figure 3

When using the GPR, any anomaly found was marked in the field with spray paint and then surveyed and recorded with GPS. During this mapping with the GPR, the bedding planes of the bedrock were visible in multiple locations. See the report found in Appendix A of the Final Report for the complete information on the GPR investigation.

A total of nine possible void areas were identified by correlation with other investigation efforts. Other anomalies that were not identified as possible void areas could be the result of large boulders, small voids, reflection of rebar, change in material composition, or change in material moisture content.

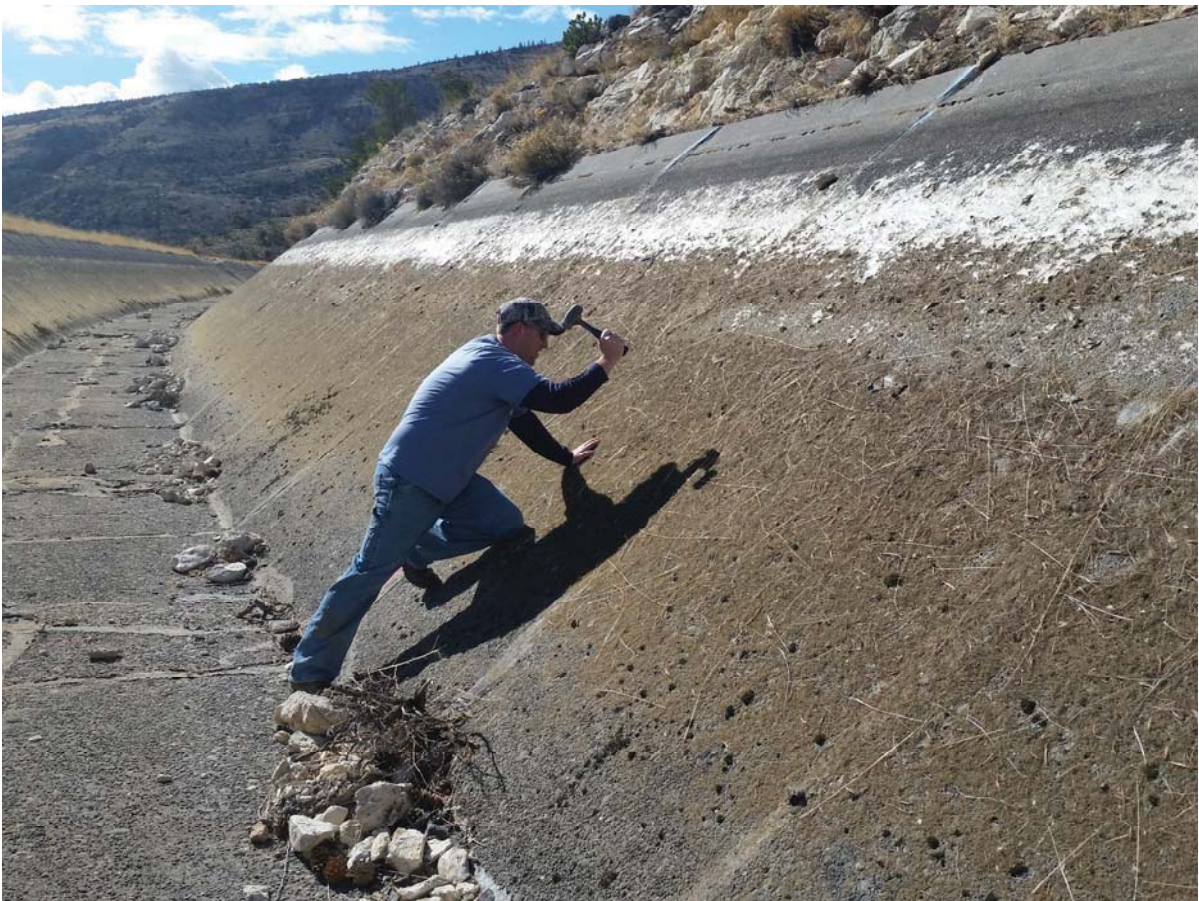
Figure 4

After using the ground penetrating radar method, EA decided to use another non-destructive exploration approach to evaluate the current physical conditions of the canal liner. This method used a 4-pound sledge hammer and a chain to conduct sounding tests. Sounding involves striking the concrete surface and interpreting the sound produced. Solid concrete will produce a ringing sound, while concrete that is delaminated, spalled, or has separation from the base material will produce a flat or hollow sound. Subgrade voids will also produce a flat or hollow sound. Sounding of vertical areas is best achieved by using a hammer or steel rod. A steel chain was drugged over the floor of the canal. Results from the hammer and chain tests located twenty-nine sections of the wall and floor of the liner with suspected hollow areas.
